**NCHRP REPORT 350 TEST 3-11 OF THE
NEW YORK DOT PORTABLE CONCRETE BARRIER
WITH I-BEAM CONNECTION (RETEST)**

Contract No. DTFH61-97-C-00064
Project No. 473220-14

July 2001

**TEXAS TRANSPORTATION INSTITUTE
THE TEXAS A & M UNIVERSITY SYSTEM
COLLEGE STATION, TEXAS 77843**

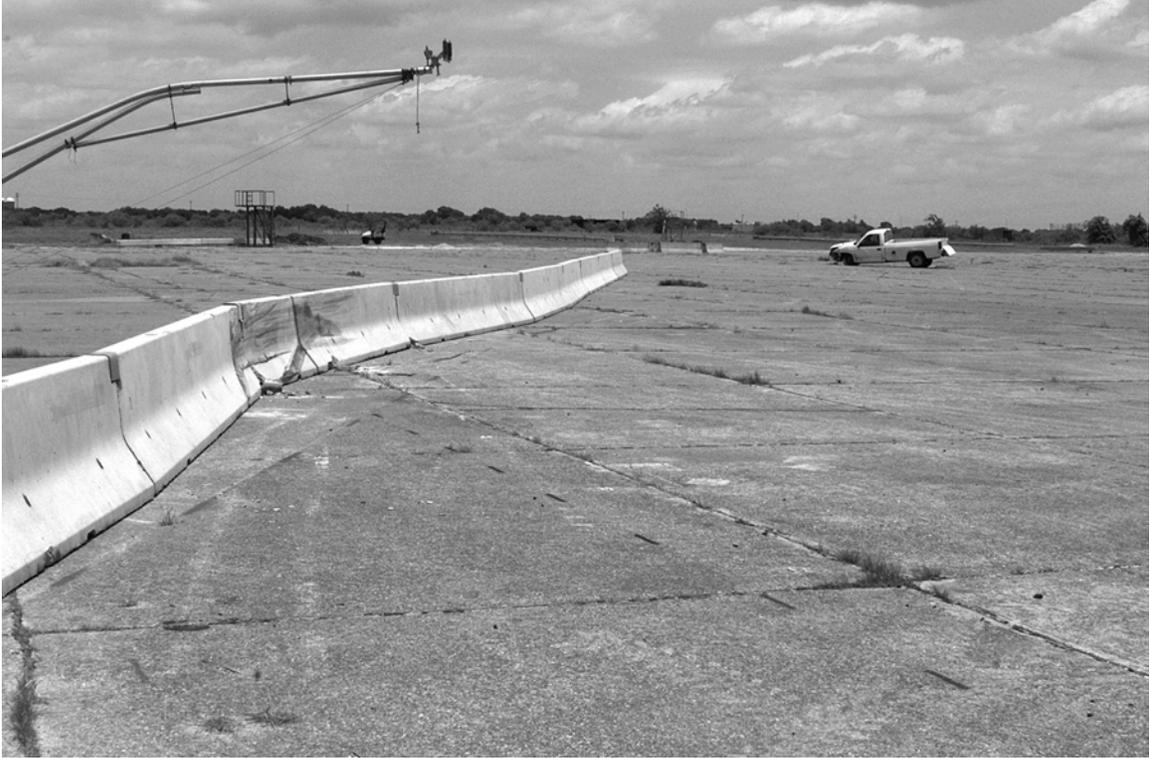
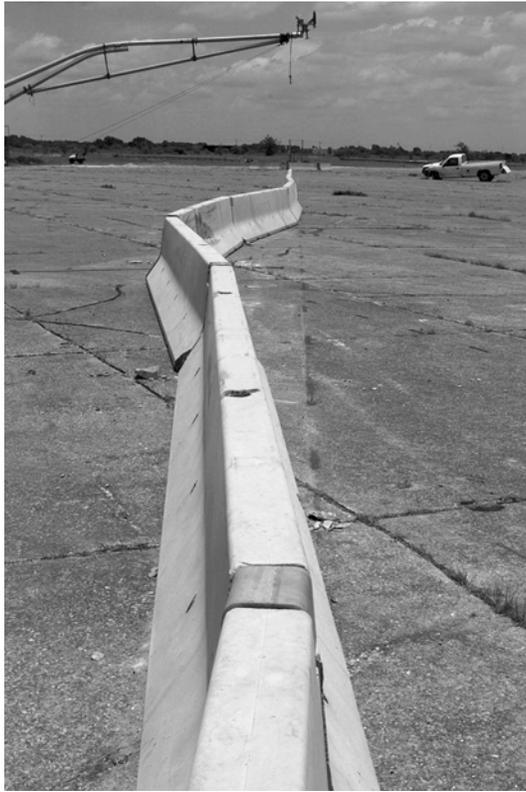
Figure 7. Vehicle trajectory after test 473220-14.

K.	After collision, it is preferable that the vehicle's trajectory not intrude into adjacent traffic lanes.	The vehicle may have intruded into adjacent traffic lanes as it came to rest 7.6 m forward of the face of the barriers.	Fail*

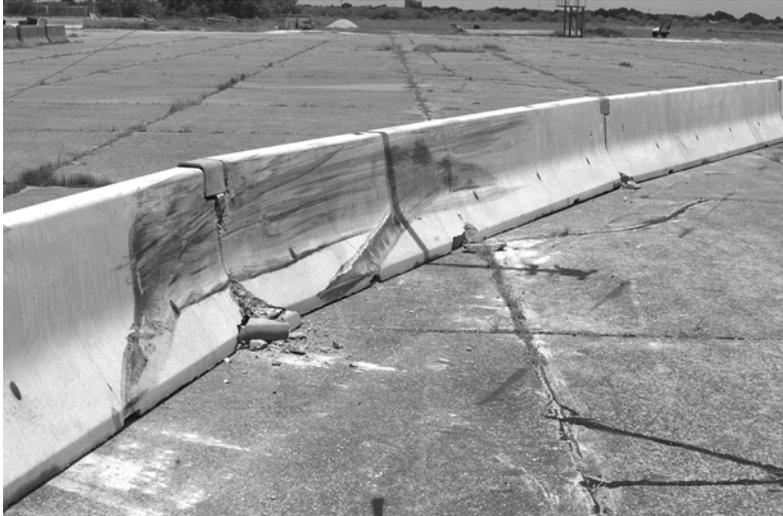
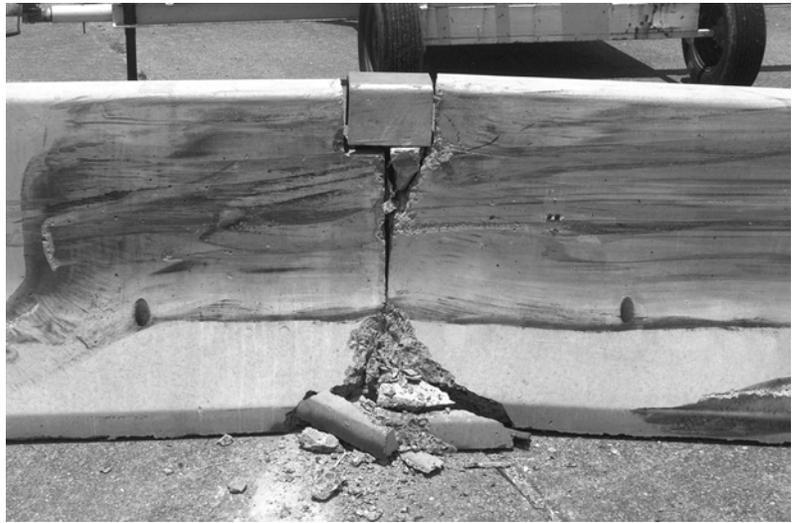
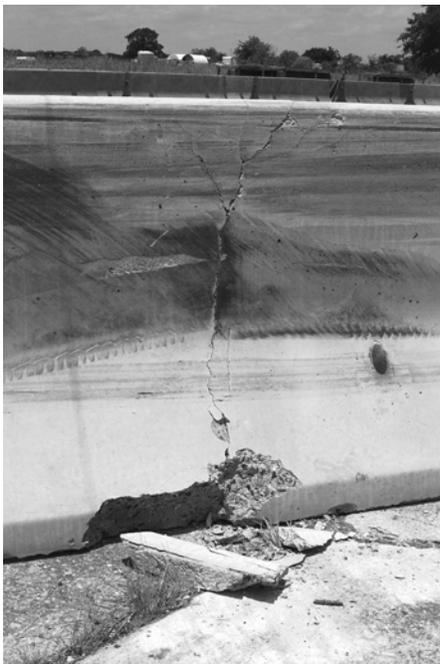
Figure 8. Installation after test 473220-14.

As shown in figures 7 and 8, the NYDOT PCB sustained moderate damage. The upstream end was displaced 148 mm downstream, and the downstream end was pulled 5 mm upstream. Tire marks were observed along the end of segment 3, across the face of segment 4, and the top of segment 5. Some spawling and cracking of concrete occurred in segments 3, 4, and 5. Total length of contact of the vehicle with the barrier was 9.2 m. Maximum lateral permanent deflection was 1.27 m at the joint between segments 3 and 4. Maximum lateral dynamic deflection was also 1.27 m.

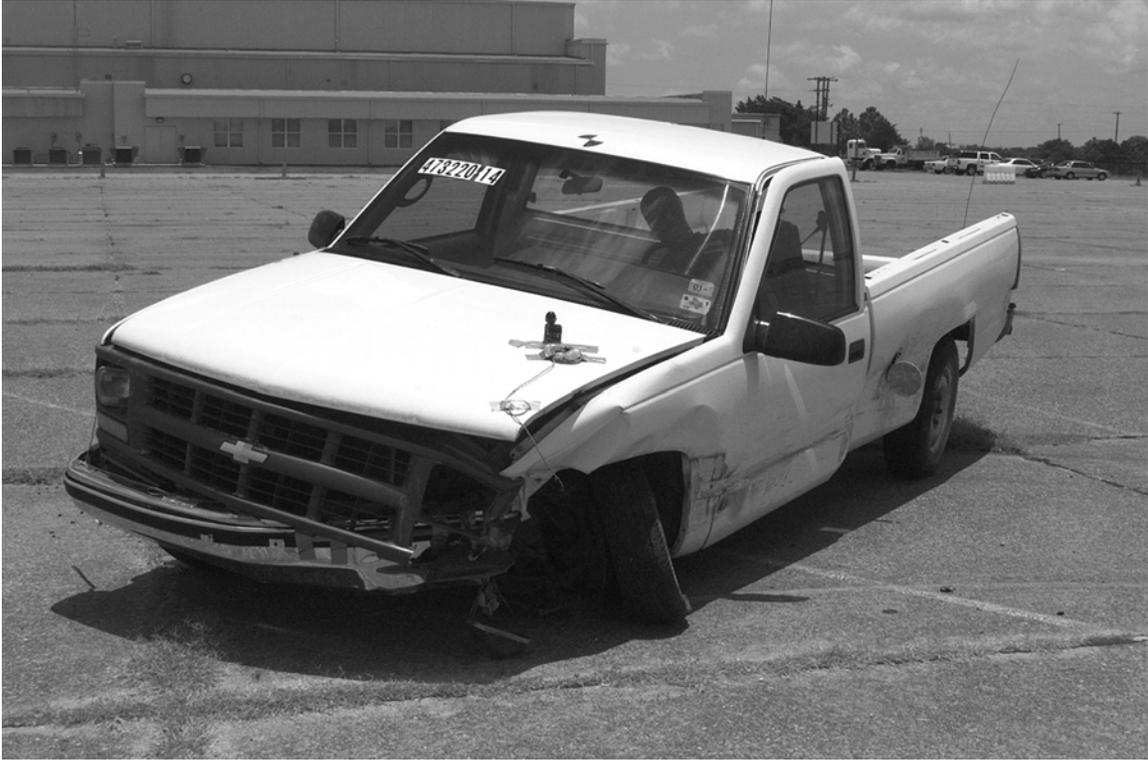
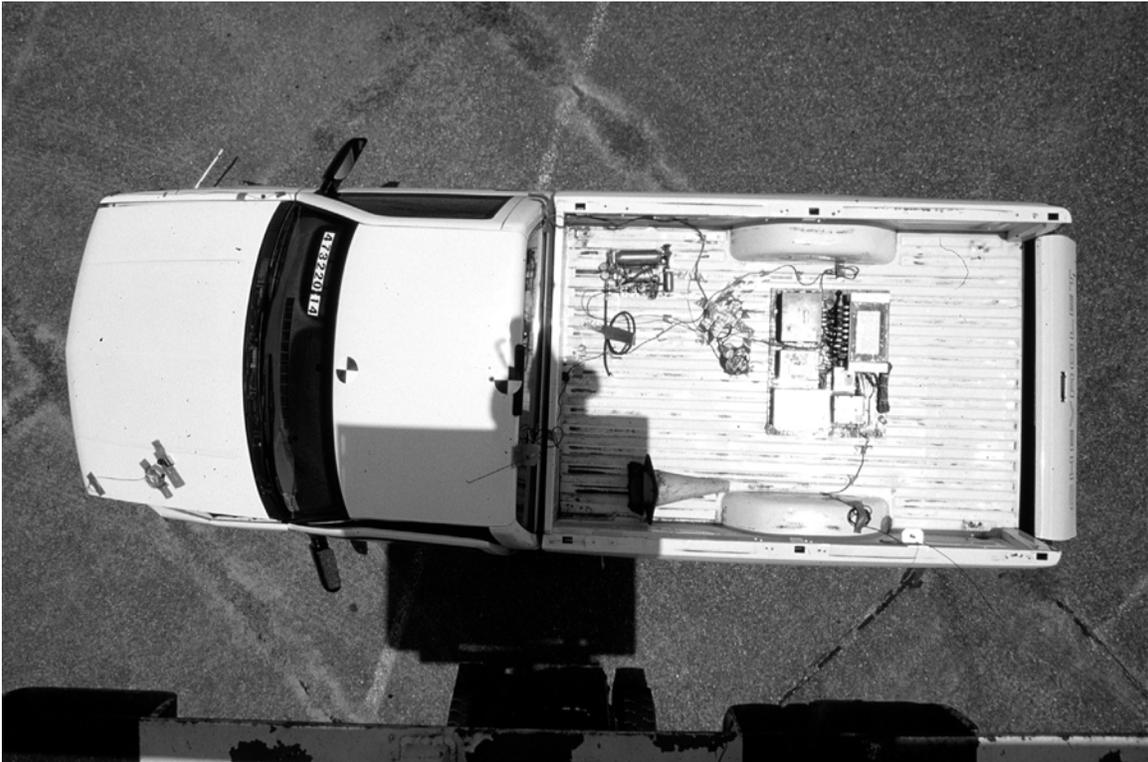
Figure 9. Vehicle after test 473220-14.

The following vehicle components were structurally damaged: stabilizer bar, rod ends, left upper and lower A-arms, left front frame rail, and left side firewall and floor pan. Also damaged were the front bumper, fan, radiator, left front quarter panel, left front tire and wheel rim, left door, left side of bed, and the left rear tire and wheel rim. Exterior crush to the vehicle was 420 mm in the frontal plane and 330 mm in the left side plane, both at the left front corner at bumper height. Damage to the vehicle is shown in figure 9. Maximum occupant compartment deformation was 60 mm in the center floor pan area. Photographs of the interior of the vehicle are shown in figure 10. Exterior vehicle crush and occupant compartment measurements are shown in appendix B, tables 2 and 3.

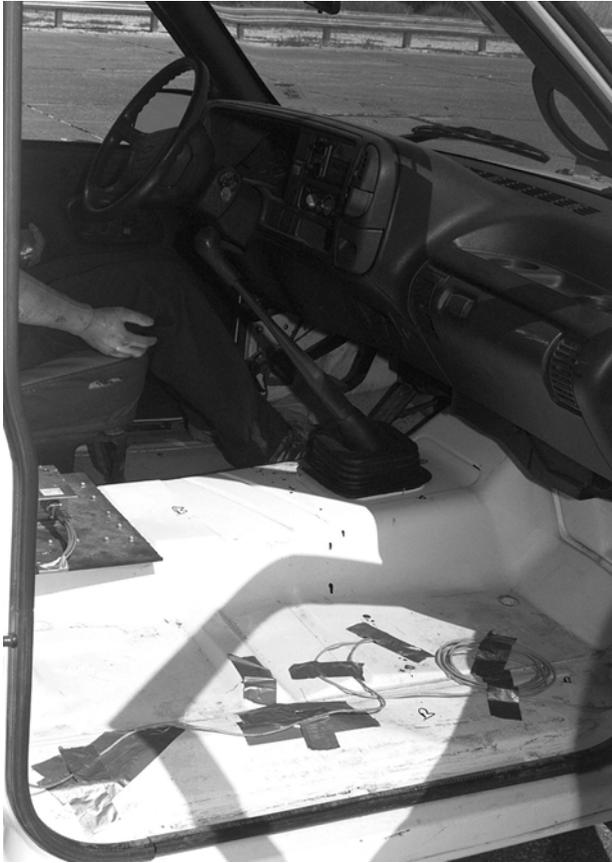
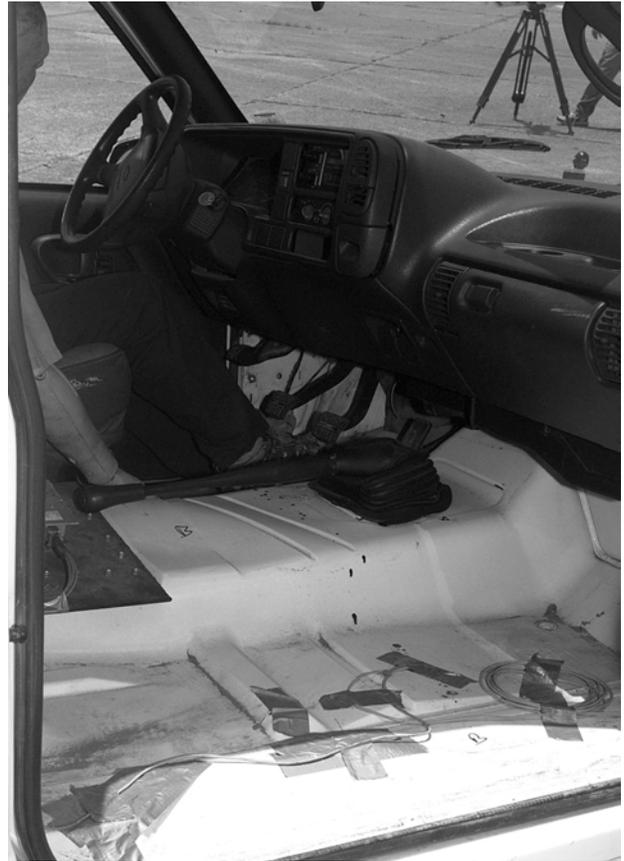
Figure 10. Interior of vehicle for test 473220-14.

Results: No detached elements, fragments, or other debris was present to penetrate, or to show potential for penetrating the occupant compartment, or to present a hazard to others in the area. Maximum occupant compartment deformation was only 60 mm in the center floor pan area. *(pass)*
