1. Report No. FHWA-RD-96-		2. Government Accession No.		3. Recipient's Catalog No.	
4. Title and Subtitle TESTING AND EVALUATION OF THE WYOMING 740WYBRAIL BRIDGE RAILING SYSTEM			5. Report Date May 1996

6. Performing Organization Code		
7. Author(s) King K. Mak, D. Lance Bullard, Jr., and Wanda L. Menges			8. Performing Organization Report No. Project 472610-4

9. Performing Organization Name and Address Texas Transportation Institute The Texas A&M University System College Station, Texas 77843-3135			10. Work Unit No. NCP No.

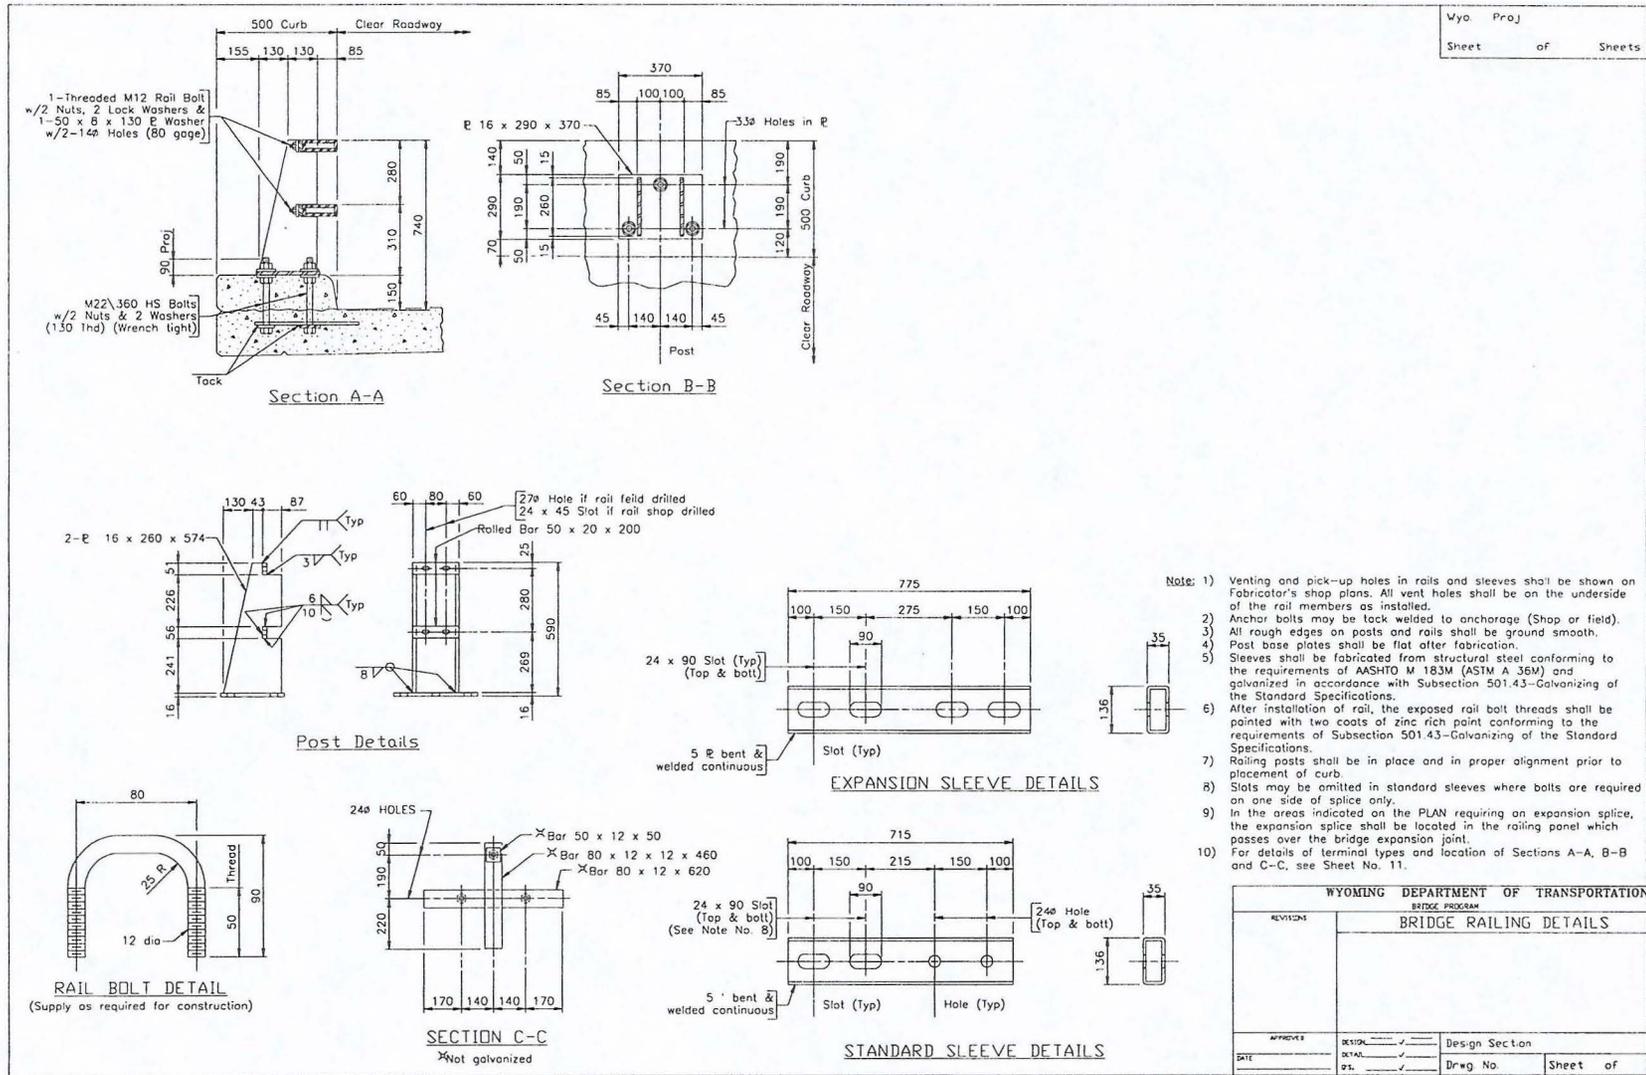
Figure 1. Details of the Wyoming 740WYBRIL bridge railing design.

The existing 740WYBRAIL bridge railing system is a post-and-rail design, details of which are shown in figure 1. The overall height of the bridge rail is 740 mm, including a 150 mm high, 500 mm wide concrete curb. The posts were fabricated from two 16-mm thick steel plates with nominal dimensions of 574 mm tall x 260 mm wide, spaced 200 mm apart (outside to outside) and welded to a 370 mm x 290 mm x 16 mm thick base plate. The posts are attached to the concrete curb section by three cast-in-place 22-mm diameter high strength steel anchor bolts. The maximum allowable spacing between adjacent posts is 3 m. There are two horizontal rail elements fabricated from TS 152 mm x 51 mm x 6.4 mm structural steel. The rail elements are attached to the posts with 12 mm diameter U-bolts, 80 mm wide and 90 mm long. The face of the rail elements are flush with the face of the curb. A minimum yield stress of 250 Mpa is specified for the steel posts and rail elements. Details of the bridge deck and curb section are shown in figure 2. Minimum yield strengths of 400 Mpa is specified for the steel reinforcement and 26 Mpa for the concrete.

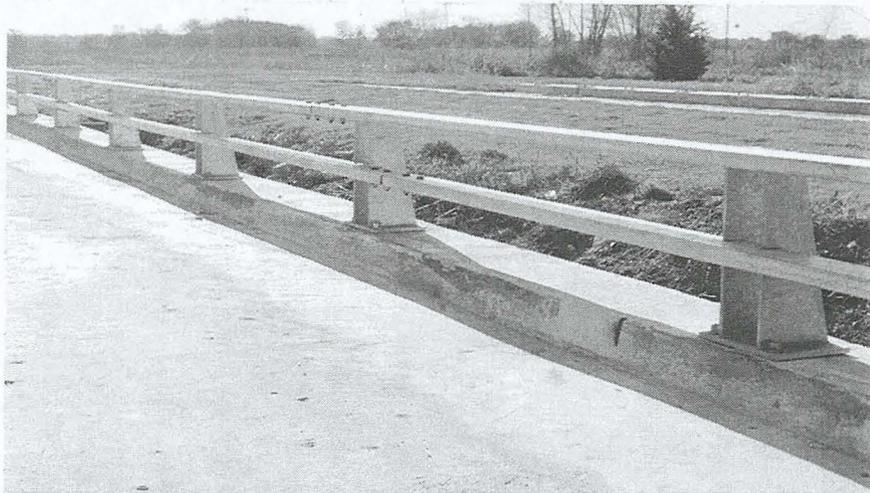
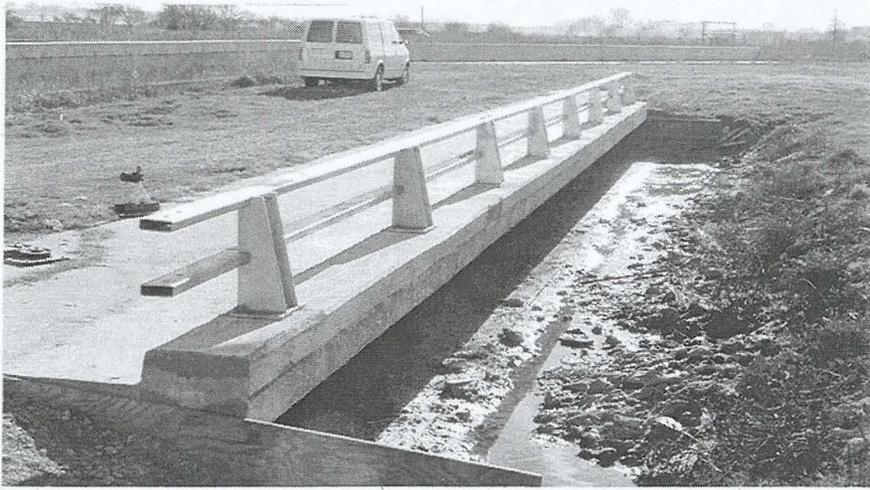
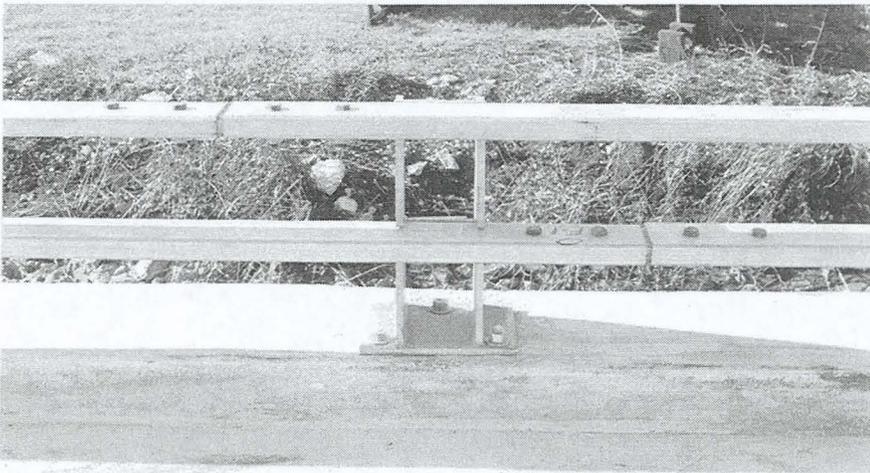
Figure 3. Wyoming 740WYBRAIL installation before test 472610-4.

A 23-m long test installation was constructed in accordance with standard bridge specifications used by the Wyoming Department of Transportation, including steel reinforcement and anchorage details. The test installation consisted of a 1 m wide, 200 mm thick cantilevered concrete simulated bridge deck, with a 500 mm wide and 150 mm high concrete curb. The maximum post spacing of 3 m was used since it represents the most critical condition. Photographs of the completed 740WYBRAIL installation are presented in figure 3.

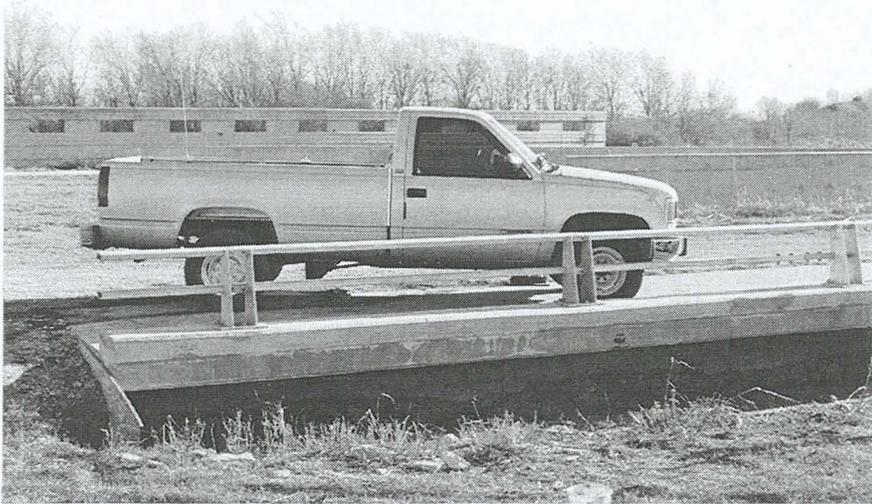
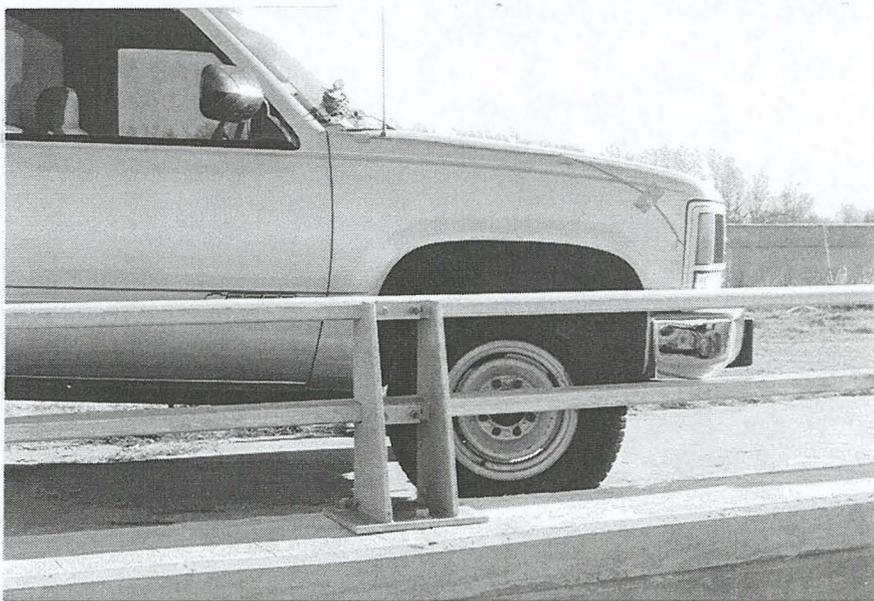
Figure 4. Vehicle/installation geometrics for test 472610-4.

A 1989 Chevrolet 2500 pickup truck, shown in figures 4 and 5, was used for the crash test. Test inertia weight of the vehicle was 2000 kg, and its gross static weight was 2000 kg. The height to the lower edge of the vehicle bumper was 440 mm and it was 670 mm to the upper edge of the bumper. Additional dimensions and information on the vehicle are given in figure 6. The vehicle was directed into the installation using the cable reverse tow and guidance system, and was released to be free-wheeling and unrestrained just prior to impact.

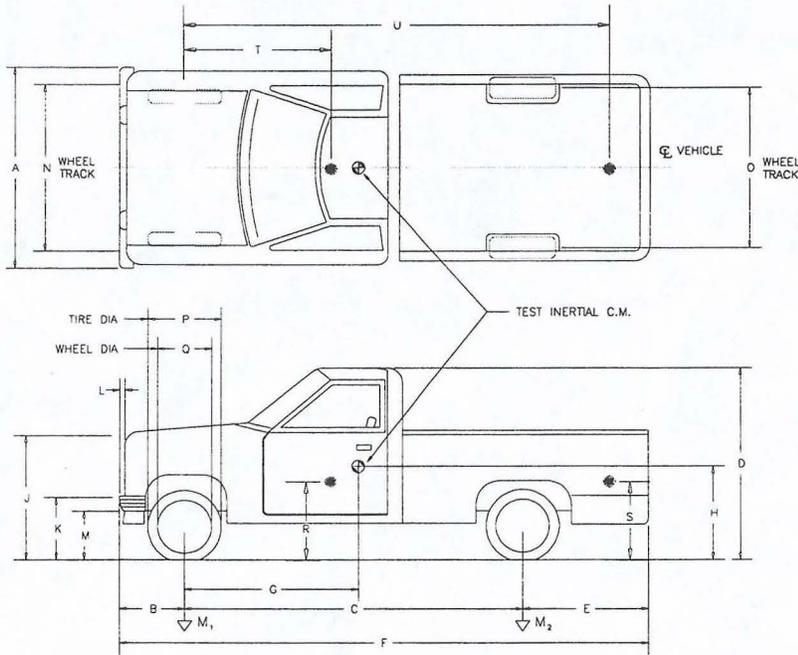
Figure 6. Vehicle properties for test 472610-4.

● Denotes accelerometer location.

A	<u>1870</u>	E	<u>1320</u>	J	<u>1070</u>	N	<u>1595</u>	R	<u>740</u>
B	<u>780</u>	F	<u>5440</u>	K	<u>670</u>	O	<u>1620</u>	S	<u>940</u>
C	<u>3340</u>	G	<u>1529.7</u>	L	<u>75</u>	P	<u>760</u>	T	<u>1500</u>
D	<u>1840</u>	H	_____	M	<u>440</u>	Q	<u>440</u>	U	<u>4060</u>

MASS - (kg)	CURB	TEST INERTIAL	GROSS STATIC
M ₁	<u>1163</u>	<u>1084</u>	_____
M ₂	<u>917</u>	<u>916</u>	_____
M _T	<u>2080</u>	<u>2000</u>	_____

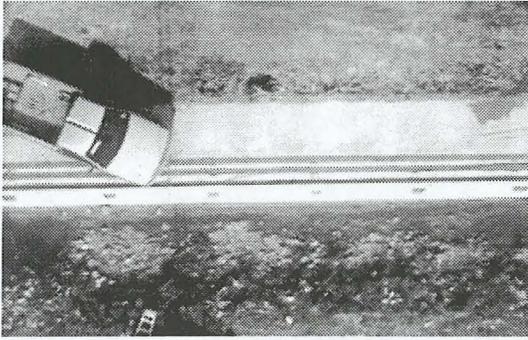
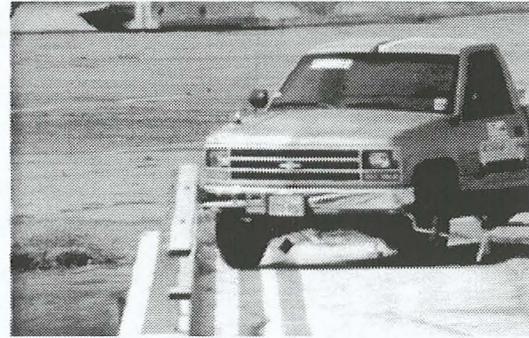
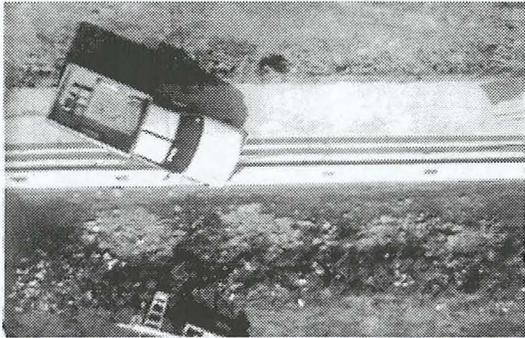
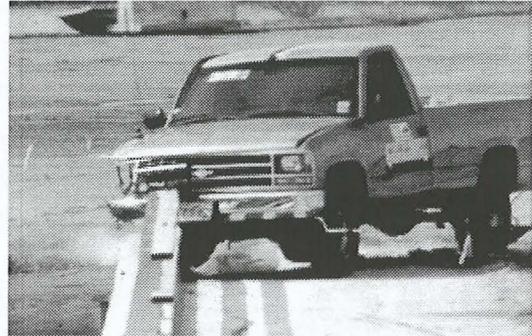
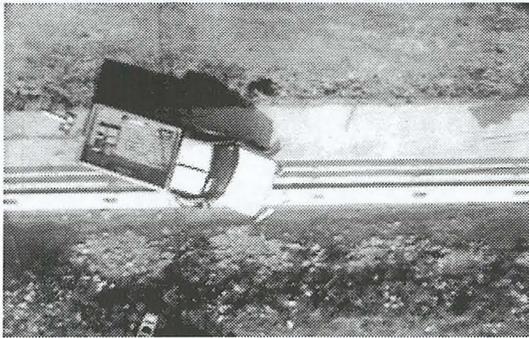
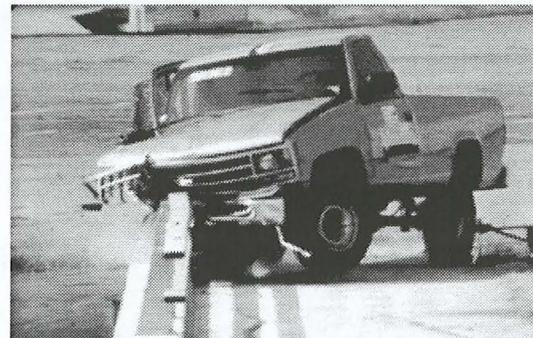
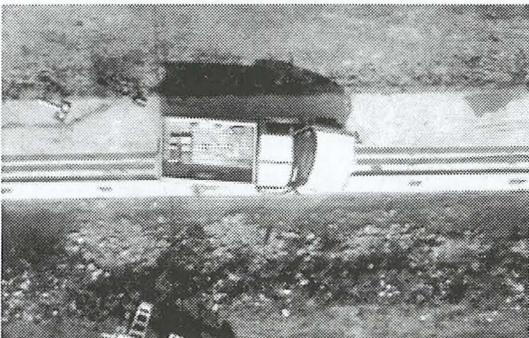
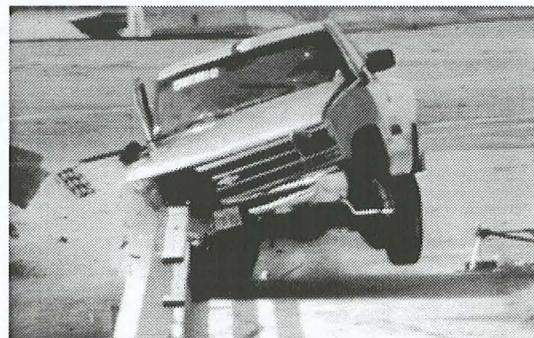
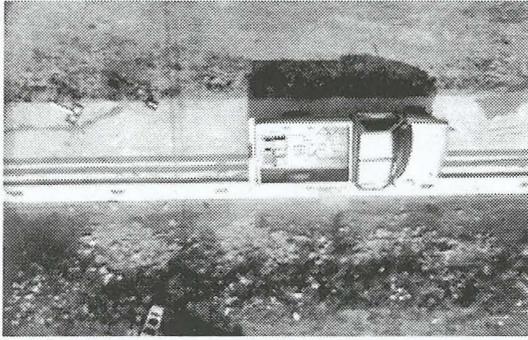
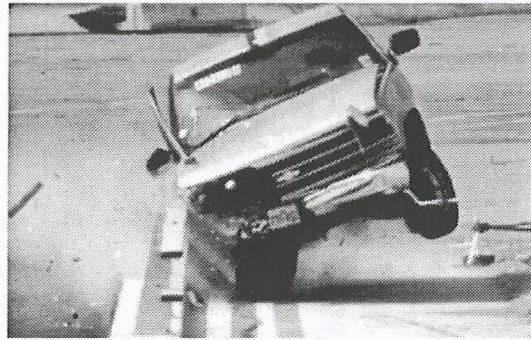
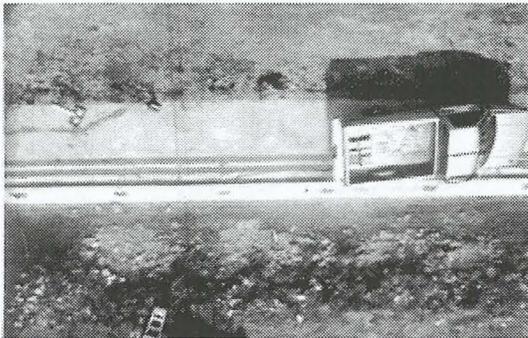
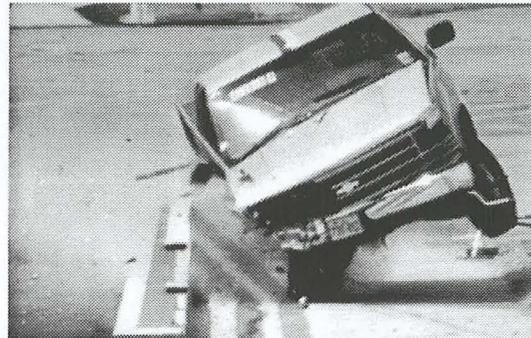
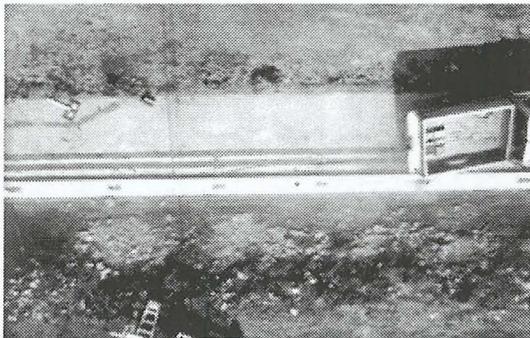
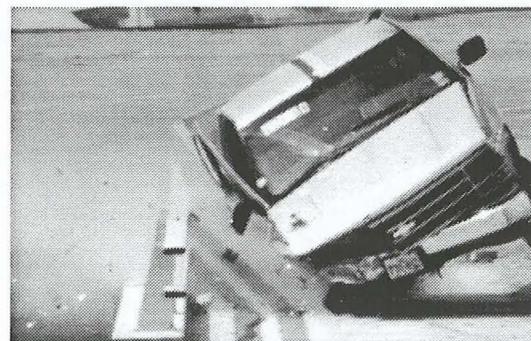
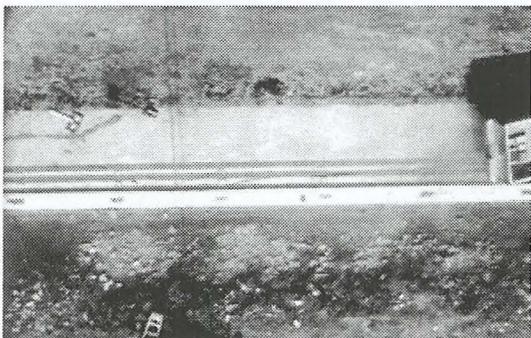
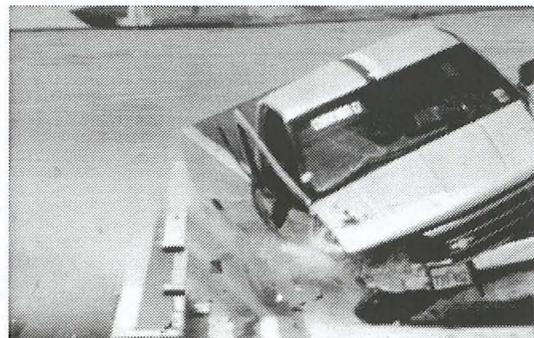
Figure 7. Sequential photographs for test 472610-4 (overhead and frontal views).

The vehicle impacted the 740WYBRAIL test installation 1.9 m upstream of post 3, traveling at a speed and angle of 101.7 km/h and 25.2 degrees. At 0.036 second after impact, the right front tire aired out and, at 0.047 second, the vehicle began to redirect. The front of the vehicle contacted post 3 at 0.060 second and the left front tire lost contact with the ground at 0.100 second. At 0.168 second, the left rear tire lost contact with the ground and, at 0.184 second, the front of the vehicle contacted post 4. The vehicle became parallel with the bridge railing at 0.301 second, traveling at a speed of 80.2 km/h. At 0.327 second, the front of the vehicle contacted post 5. The vehicle lost contact with the bridge railing at 0.624 second and was traveling at a speed approximately 65.5 km/h and at an exit angle of 9.2 degrees. Brakes on the vehicle were applied at 1.45 seconds, the vehicle spun counterclockwise 180 degrees and subsequently came to rest facing toward the installation 52.7 m down from the point of impact and 3.7 m toward the traffic lanes. Sequential photographs of the test period are shown in figures 7 and 8.

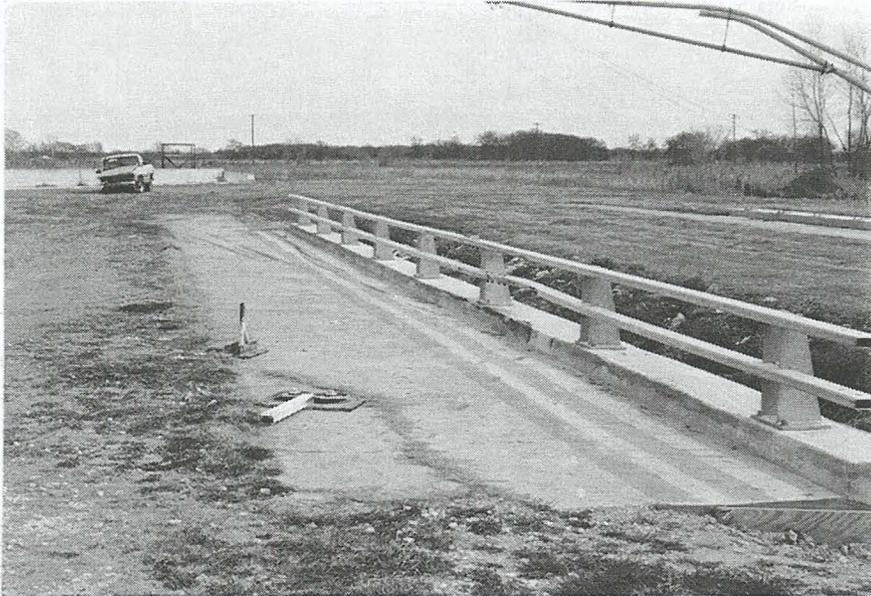
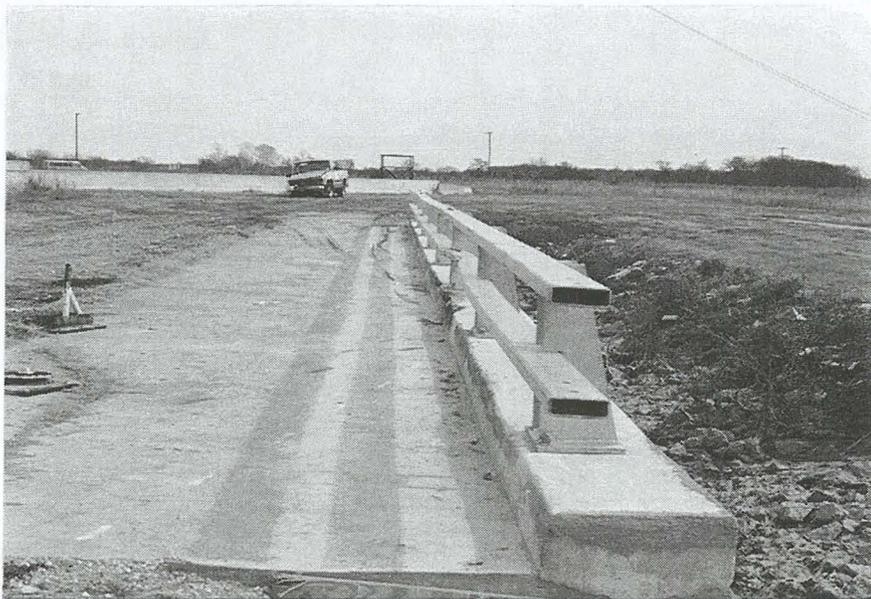
Figure 9. After impact trajectory for test 472610-4.

Most of the damage to the 740WYBRAIL bridge railing was near post 3 as shown in figures 9 through 11. The base plate at post 3 was moved back and laterally 6 mm and a crack in the curb radiated out from the right rear anchor bolt. Both flanges on post 3 were bent. The maximum permanent deformations were 16 mm for the top rail element and 51 mm for the bottom rail element. Total length of contact of the vehicle with the rail elements was 2.7 m and the total length of contact with the curb was 3.7 m.

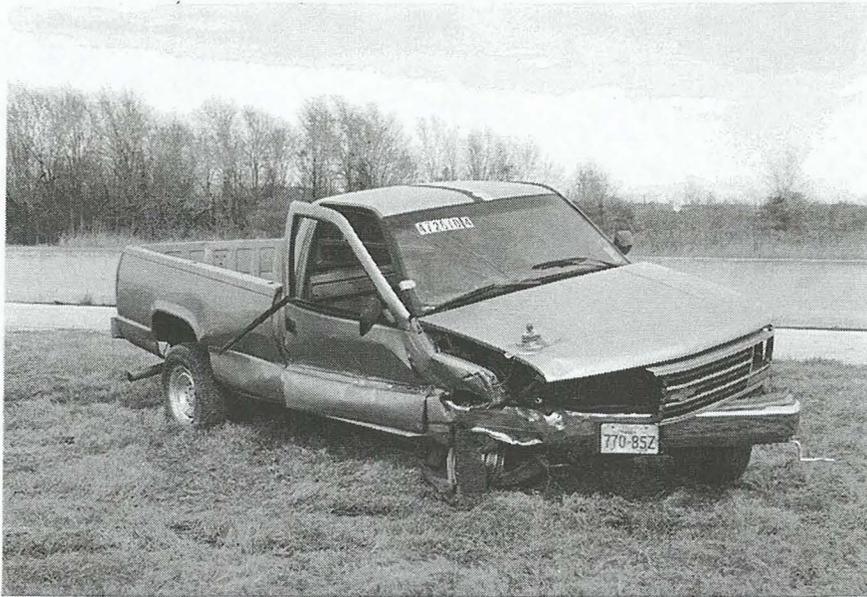
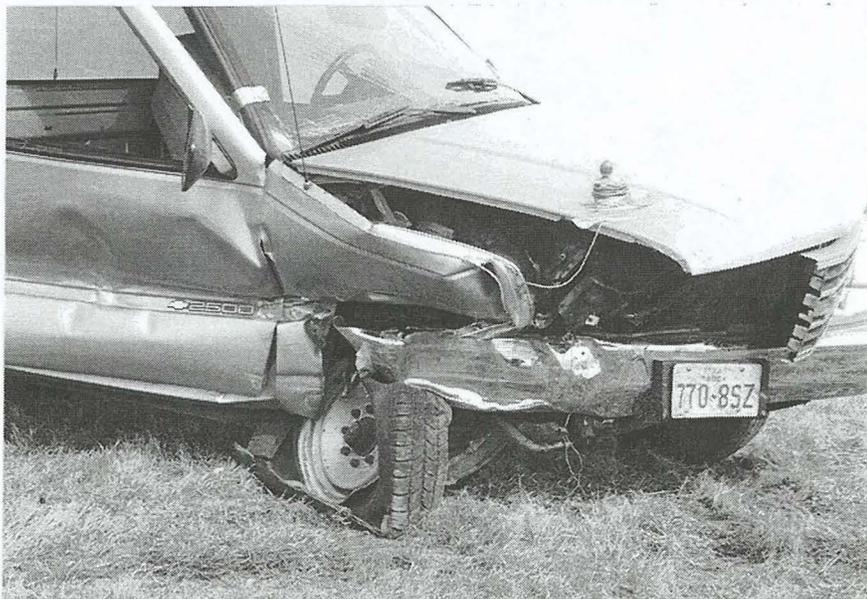
Figure 12. Vehicle after test 472610-4.

Damage to the vehicle is shown in figures 12 and 13. The right side upper and lower A-arms, sway bar, frame, and floorpan were bent. The front bumper, grill, fan, radiator, hood, both front quarter panels, right door, and both right side tires and rims were damaged. The windshield was shattered and right door glass was broken out. Maximum crush to the exterior of the vehicle was 960 mm at the right front corner. The maximum deformation of the occupant compartment was 92 mm in the center front firewall area.

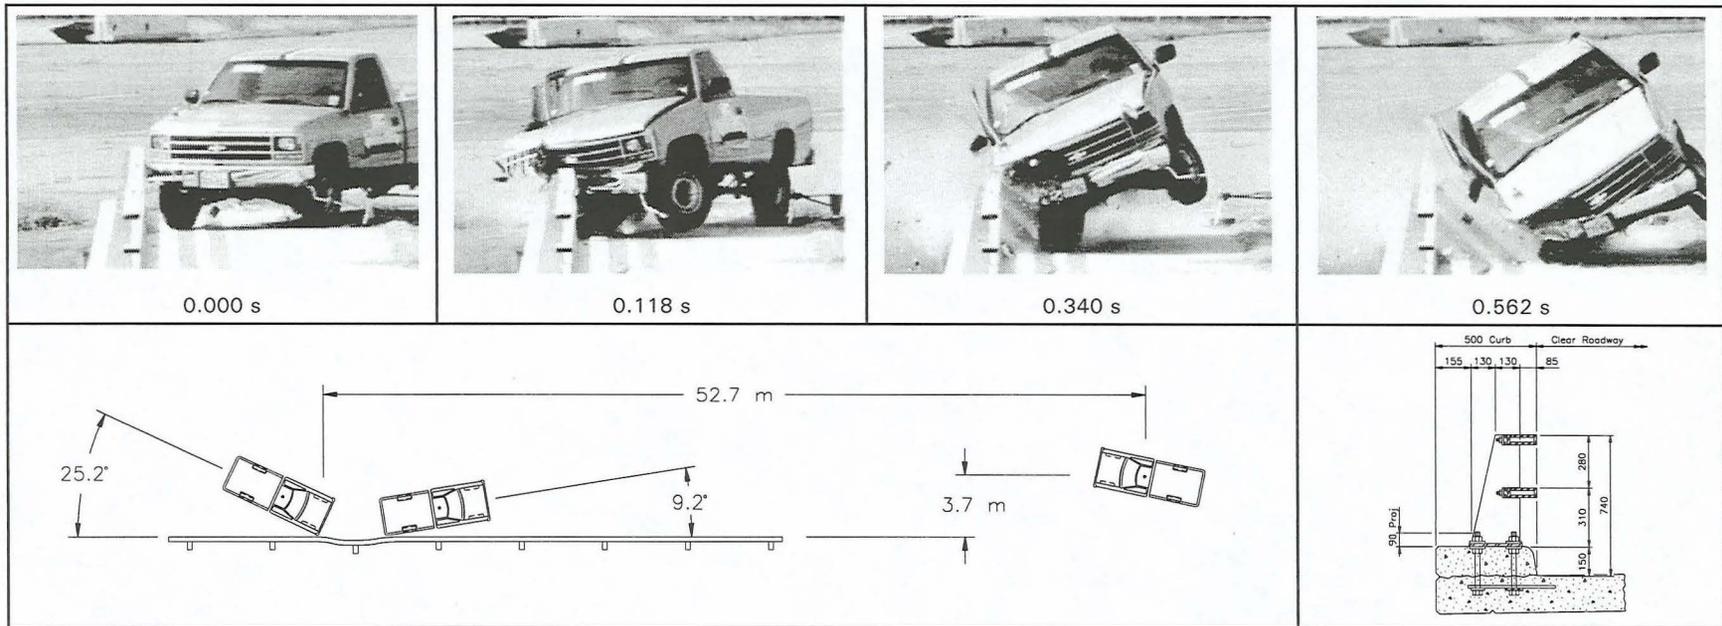
Figure 14. Summary of results for test 472610-4.

Test Agency Texas Transportation Institute
 Test No. 472610-4
 Date 02/12/96
Test Article
 Type Bridge Rail
 Name 740WYBRAIL
 Installation Length (m) 23
 Size and/or dimension
 and material of key Tubular steel railing on
 elements concrete deck and curb
 Soil Type and Condition Concrete bridge deck, dry
Test Vehicle
 Type Production
 Designation 2000P
 Model 1989 Chevrolet 2500
 Mass (kg) Curb 2080
 Test Inertial 2000
 Dummy No dummy
 Gross Static 2000

Speed (km/h) 101.7
 Angle (deg) 25.2
Exit Conditions
 Speed (km/h) 65.5
 Angle (deg) 9.2
Occupant Risk Values
 Impact Velocity (m/s)
 x-direction 7.6
 y-direction 7.7
 THIV (optional)
Ridedown Accelerations (g's)
 x-direction 4.6
 y-direction -12.8
 PHD (optional)
 ASI (optional)
 Max. 0.050-s Average (g's)
 x-direction -9.2
 y-direction -12.1
 z-direction -4.9

Exterior
 VDS 01RFQ5
 CDC 01FREK4
 & 01RYES4
Interior
 OCDI FS0112000
Maximum Exterior
 Vehicle Crush (mm) 960
Max. Occ. Compartment
 Deformation (mm) 92
Post-Impact Behavior
 Max. Roll Angle (deg) -12
 Max. Pitch Angle (deg) -4
 Max. Yaw Angle (deg) -43

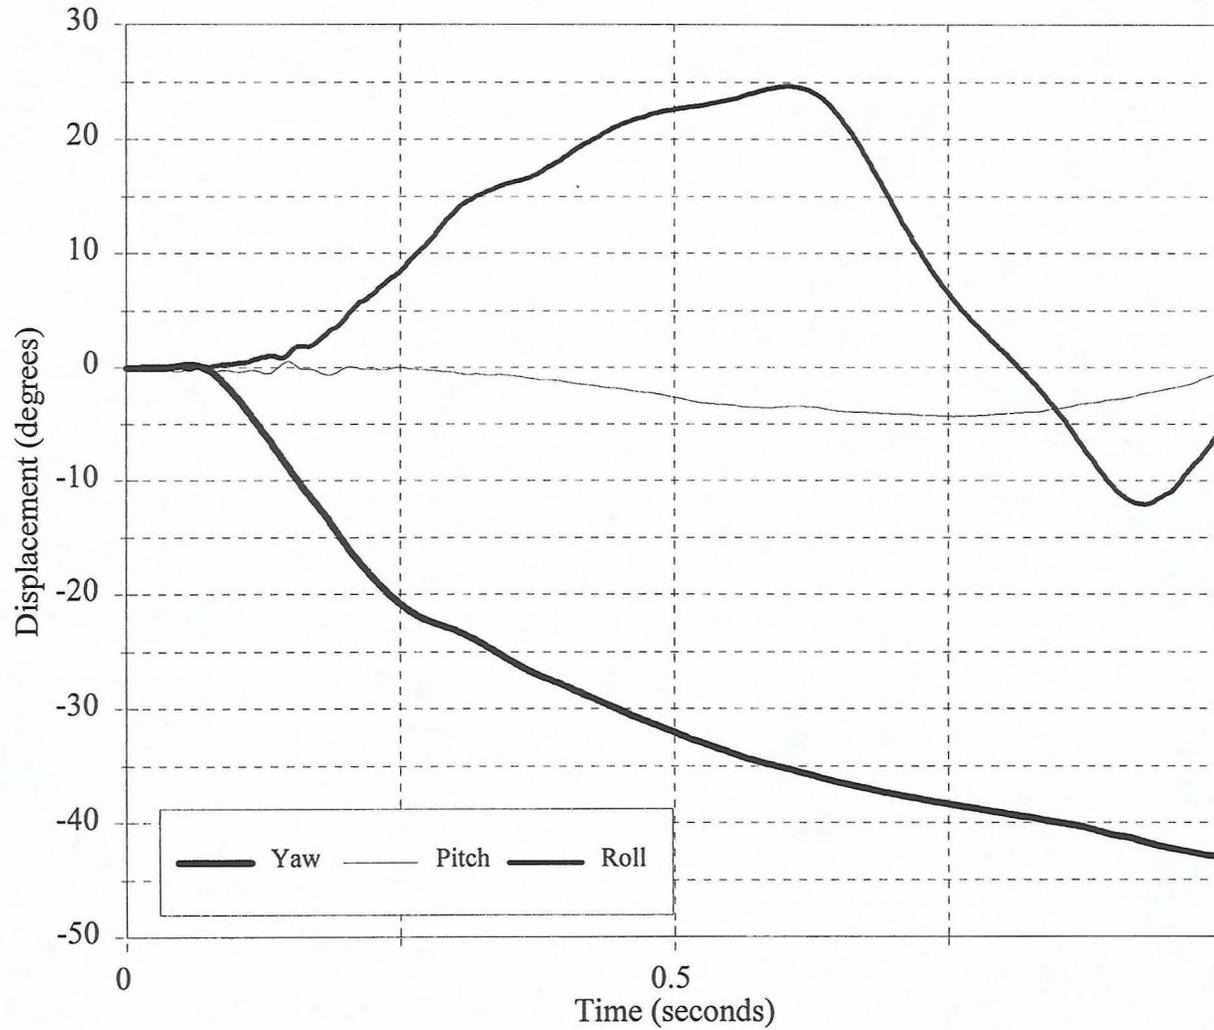
Figure 15. Vehicle angular displacements for test 472610-4.

Axes are vehicle fixed.
Sequence for determining orientation is:

1. Yaw
2. Pitch
3. Roll

The PLOTANGLE program used the digitized data from the yaw, pitch, and roll rate transducers to compute angular displacement in degrees at 0.00067-second intervals and then instructs a plotter to draw a reproducible plot: yaw, pitch, and roll versus time. These

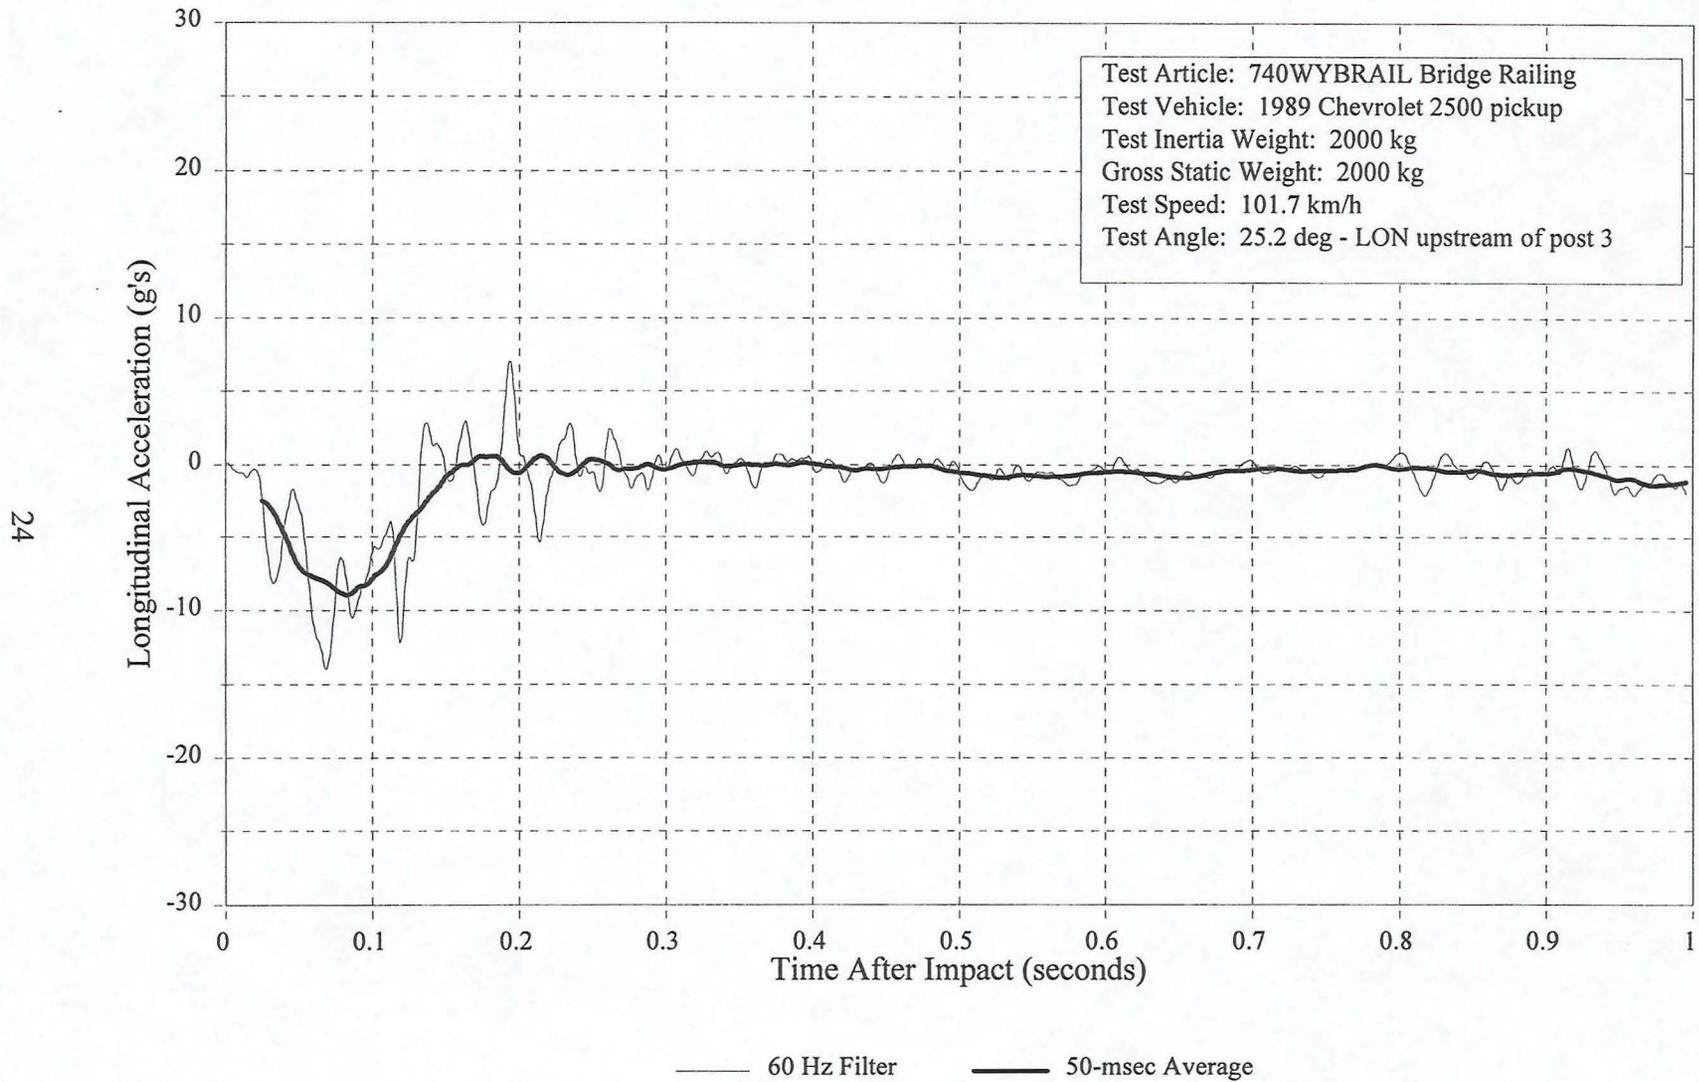
Figure 16. Vehicle longitudinal accelerometer trace for test 472610-4.

Rear accelerometer extrapolated to cg

Due to damage sustained by the vehicle near the location where the accelerometers at the vehicle center of gravity was mounted, it was felt that the data from these accelerometers might be unreliable. Therefore, data from the backup accelerometers located over the rear axle, extrapolated to the center of gravity, were used instead. The occupant risk factors were computed as follows. In the longitudinal direction, the occupant impact velocity was 7.6 m/s at 0.160 second, the highest 0.010-second occupant ridedown acceleration was 4.6 g from 0.188 to 0.198 second, and the maximum 0.050-second average acceleration -9.2 g between 0.055 and 0.105 second. In the lateral direction, the occupant impact velocity was 7.7 m/s at 0.133 second, the highest 0.010-second occupant ridedown acceleration was -12.8 g from 0.180 to 0.190 second, and the maximum 0.050-second average was -12.1 g between 0.054 and 0.104 second. These data and other pertinent information from the test are summarized in figure 14. Vehicle angular displacements are displayed in figure 15. Vehicular accelerations versus time traces from the extrapolated data are presented in figure 16 and 17.

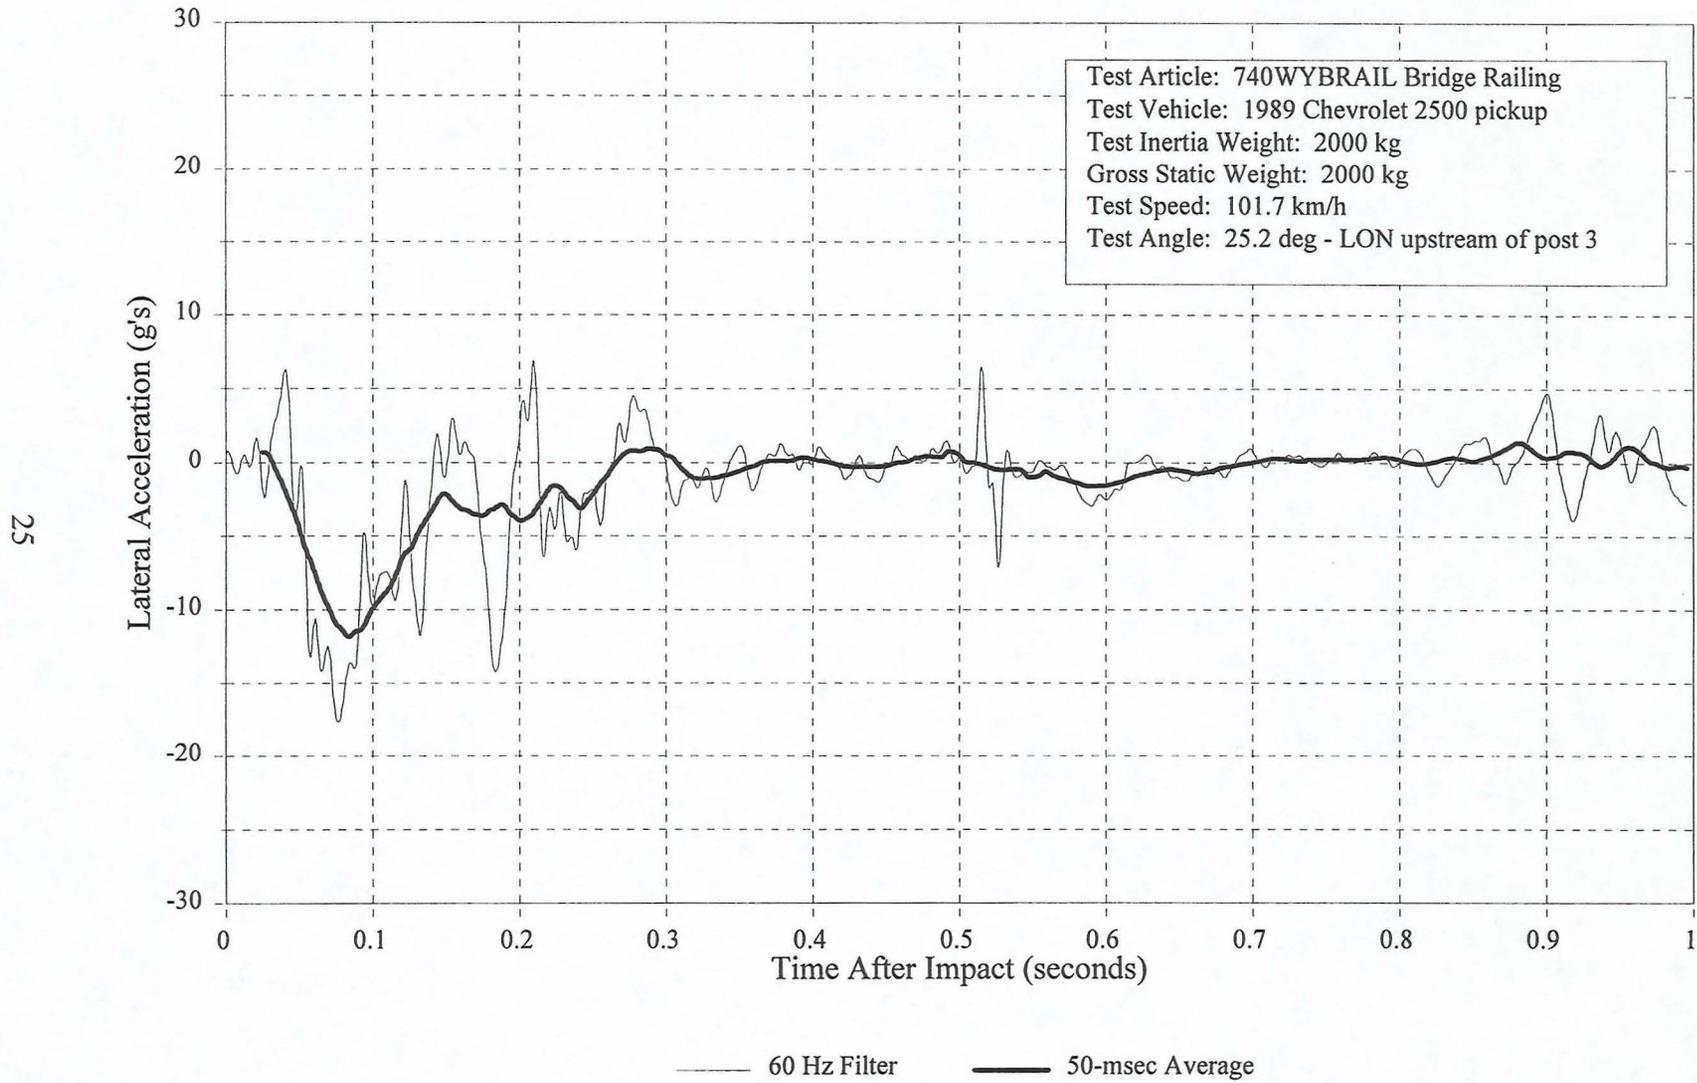
Figure 17. Vehicle lateral accelerometer trace for test 472610-4.

Rear accelerometer extrapolated to cg
