**NCHRP REPORT 350 TEST 3-11 OF
GEORGIA TEMPORARY CONCRETE BARRIERS**

Contract No. T98170
Project No. 404821

Sponsored by
Georgia Department of Transportation

February 2000

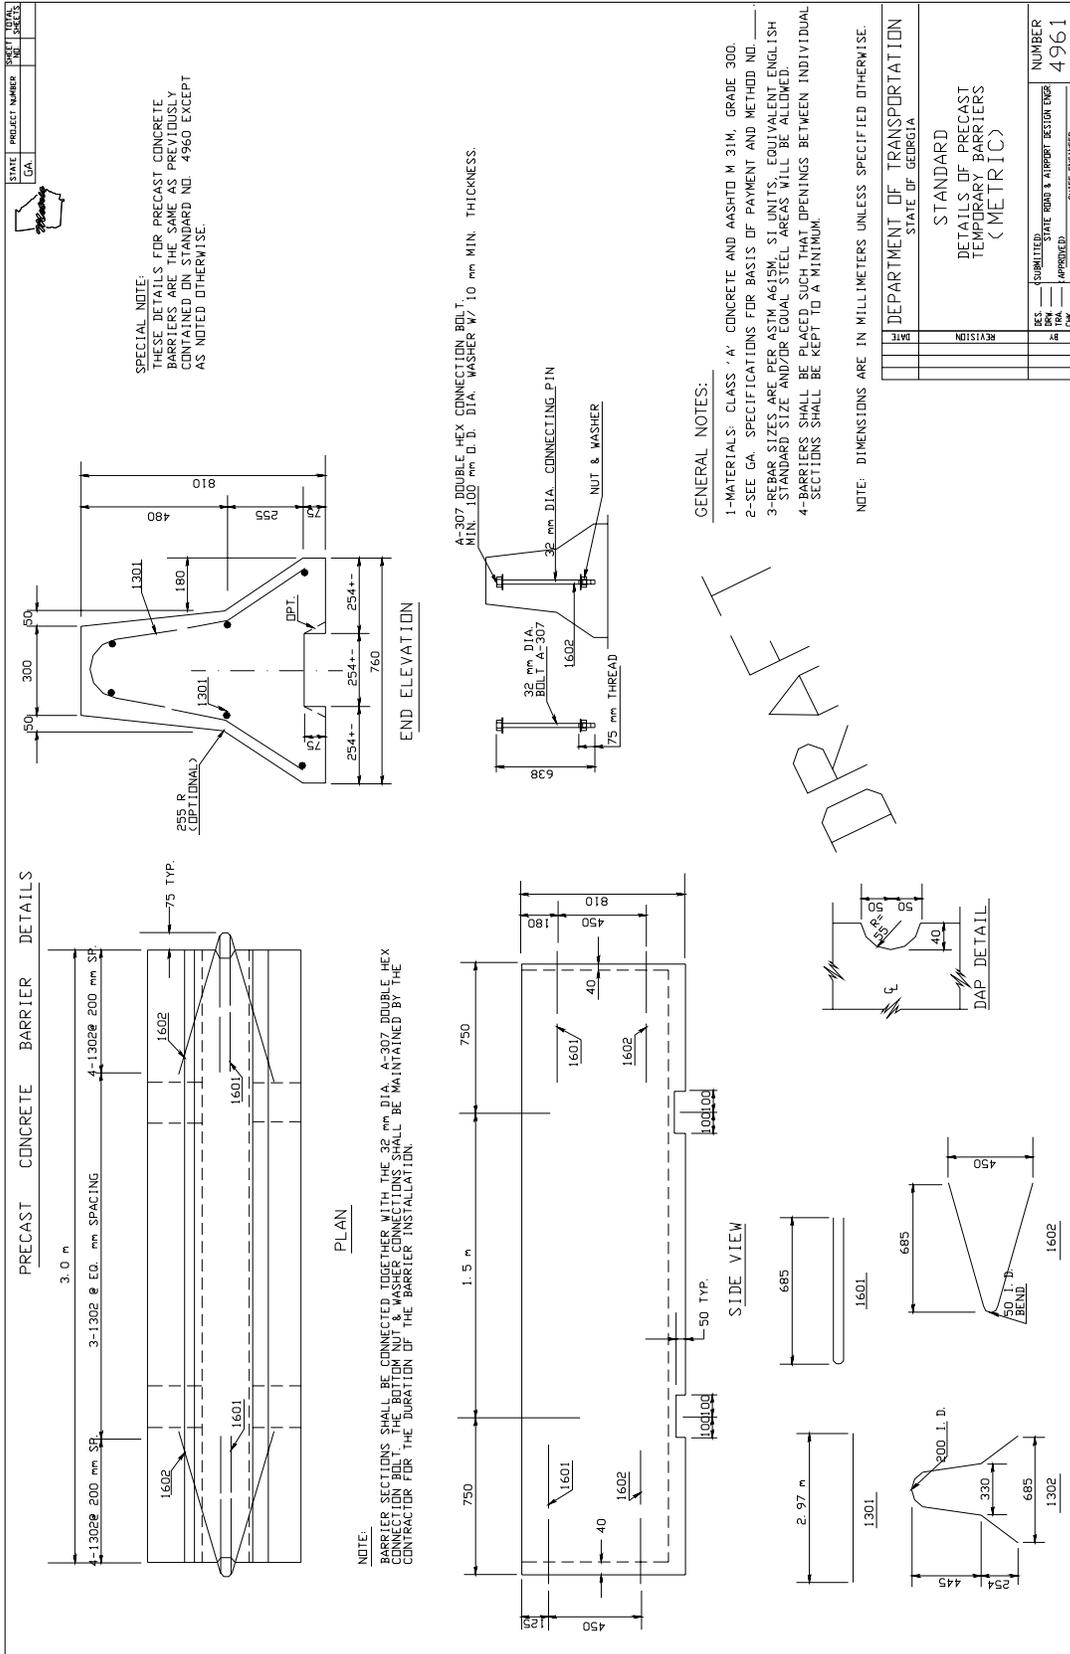
Based on information from the construction drawing, each barrier is 3.0 meters in length and 810 mm in height. The bottom of the barrier is 760 mm wide with a 75 mm by 254 mm wide recess. The recess is located along the centerline of the barrier and runs along the entire length of the barrier. From the bottom of the barrier, upward, the width tapers to 400 mm wide at 330 mm above the base of the barrier. The barrier tapers to 300 mm wide at the top.

Reinforcement in each barrier consists of six longitudinal number 13 Bars with three bars located on each face of the barrier. Eleven V-shaped number 13 Bars are present in each barrier

Figure 1. Details of the Georgia Temporary Barrier with pin and loop connection.

with four bars on each end of the barrier spaced at 200 mm on centers with an end cover of 40 mm. Three bars are evenly spaced in the interior of each barrier. A V-shaped and a U-shaped number 16 connection bar extend 75 mm beyond the ends on each barrier and serve as the connection between the barriers. The barriers are connected by aligning the connection bars and inserting a 638 mm long, 32 mm diameter A-307 double hex connection bolt through the bars. A heavy hex nut and washers were used for each connection bolt.

The Georgia Temporary Concrete Barrier is an 810-mm height Jersey Shape portable concrete barrier (PCB). TTI received a draft construction drawing from Georgia Department of Transportation entitled, "Standard Details of Precast Temporary Barriers (Metric), Number 4961." This drawing provided details for construction of the PCB and information on connecting the barriers and is shown as figure 1 of this report.

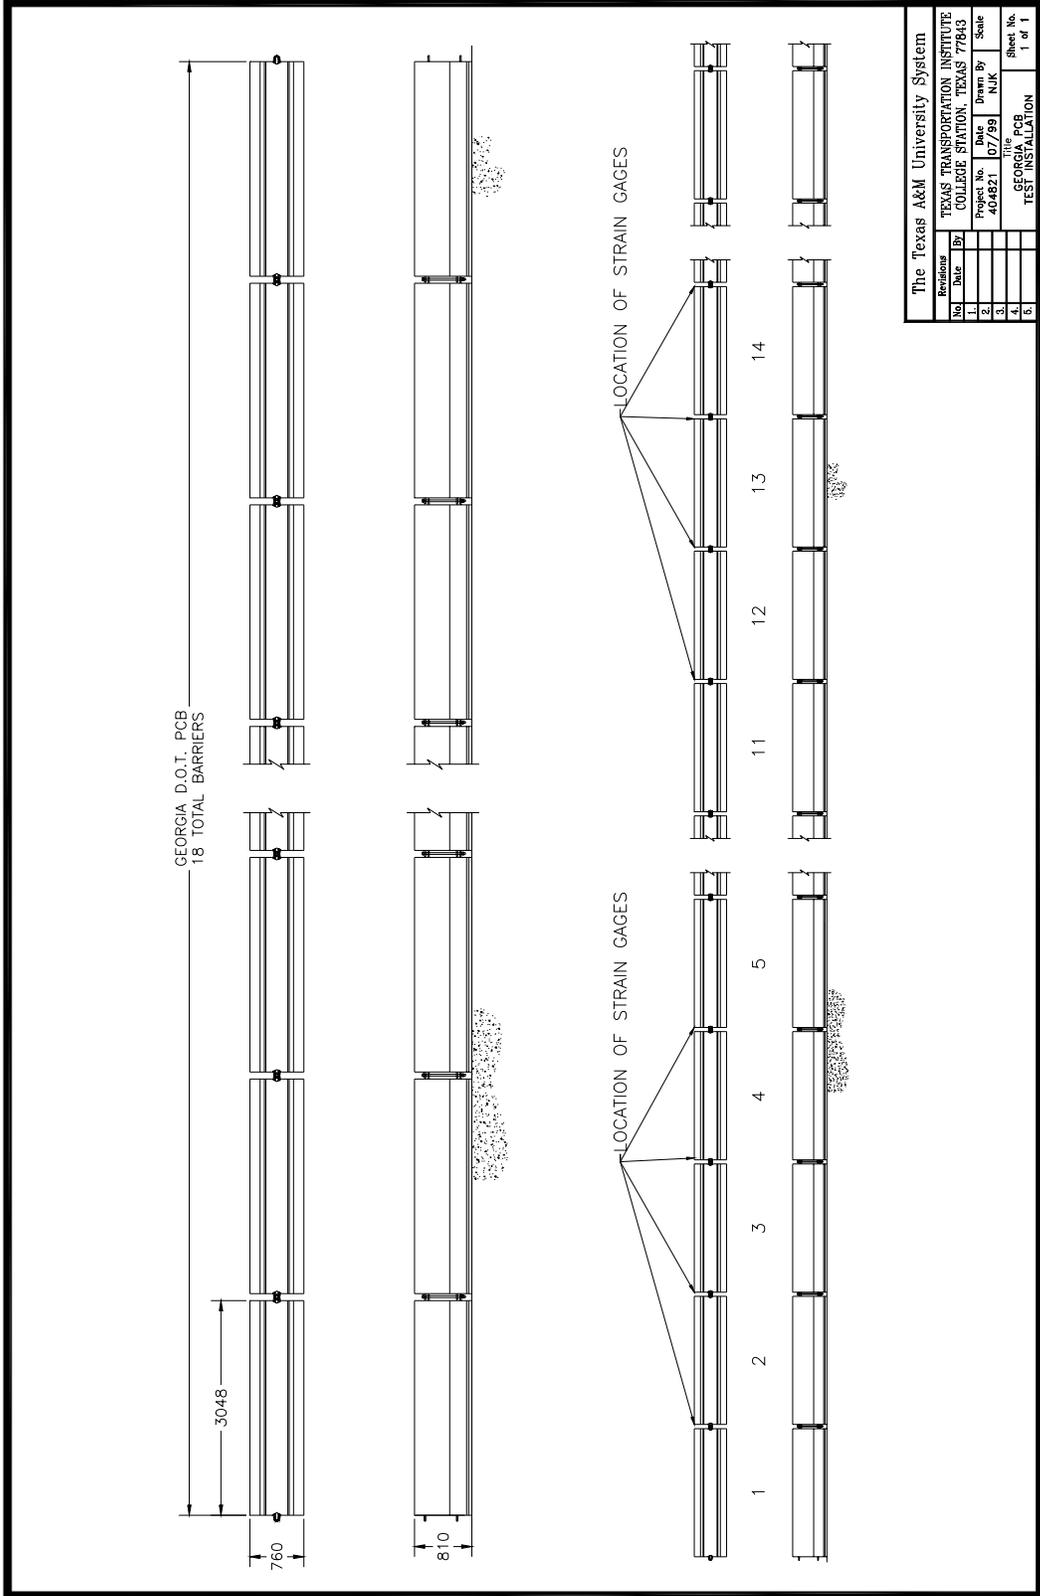
The test installation consisted of 18 barriers connected together for a total test installation length of approximately 55.3 m. This total length includes a joint width of approximately 75-mm at each connection. The barriers were placed on the existing concrete runway located at the TTI test facility. The layout of the barriers is shown in figure 2 and photographs of the completed installation are shown in figure 3.

Figure 2. Layout of test installation.

Identification of each of the instrumented joints was by means of a letter plus (top or bottom). The following describes the location of these joints.

Upstream:

- A – between barriers 1 and 2
- B – between barriers 2 and 3
- C – between barriers 3 and 4
- D – between barriers 4 and 5

Downstream:

- E – between barriers 11 and 12
- F – between barriers 12 and 13
- G – between barriers 13 and 14
- H – between barriers 14 and 15

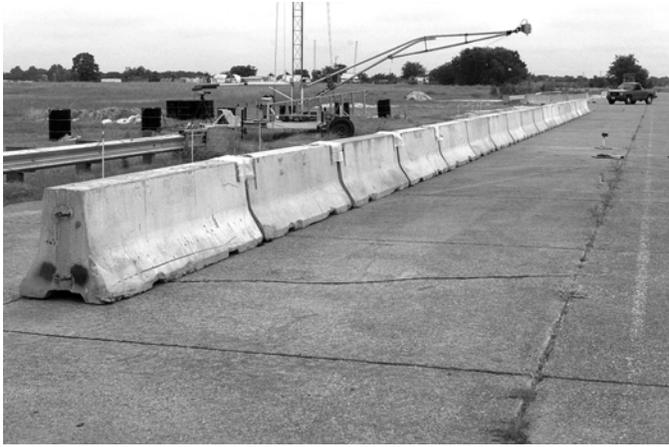
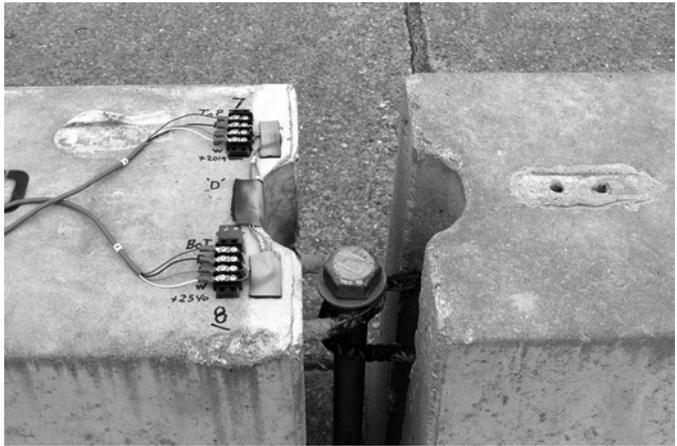
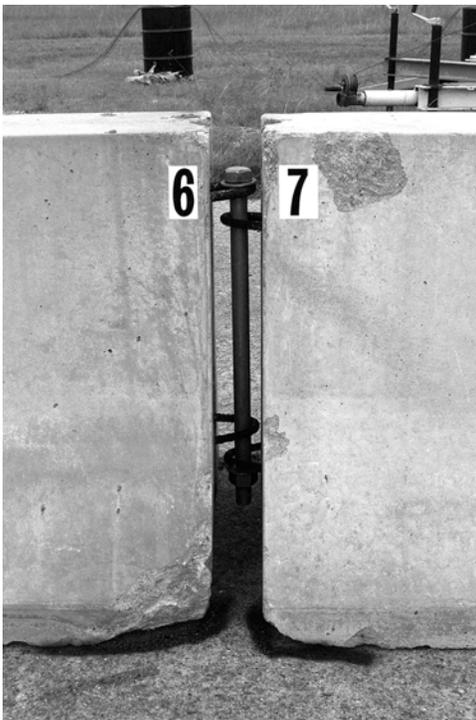
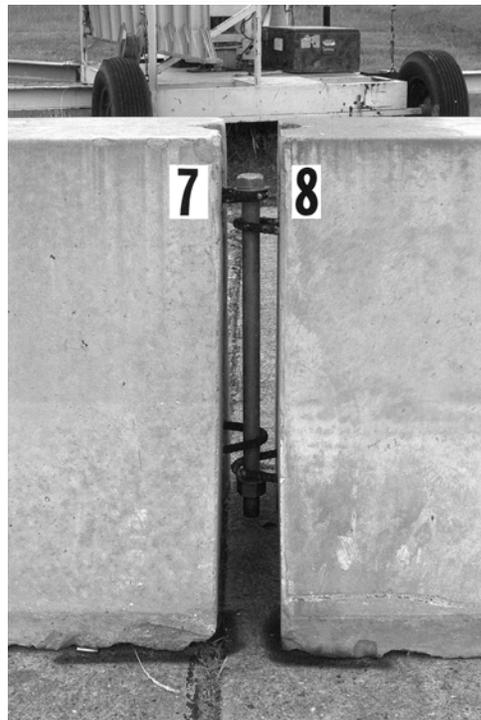
Figure 3. Georgia Temporary Concrete Barrier prior to testing.

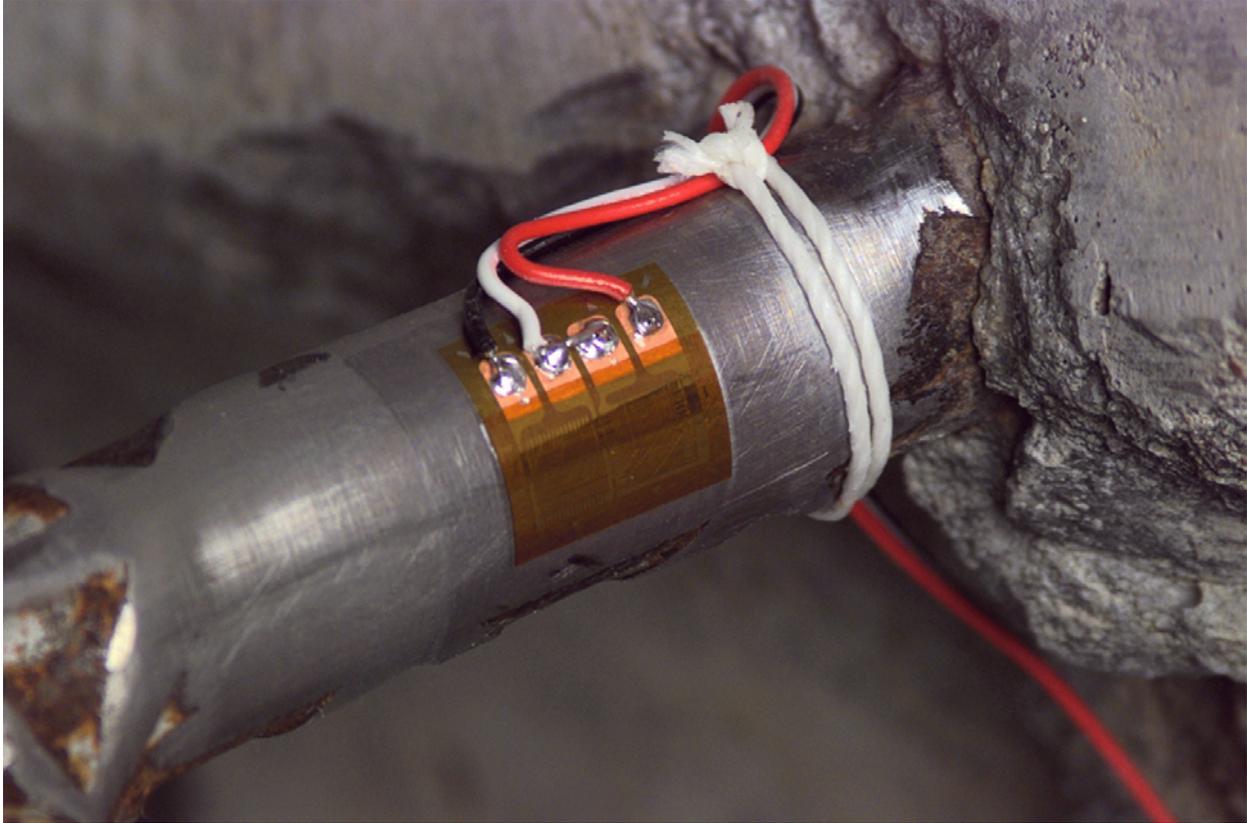
Precision metal-foil strain gages, from Micro-Measurements, designed for stress analysis applications, were used on the #16 rebar connection loops. In order to provide proper adhesive bonding of the gages to the steel, the rebar was ground smooth on the top and bottom of each instrumented loop, within 25-50 mm from the concrete. This reduced the average diameter of the bars from 16 mm to about 14 mm. This reduction in area was not a concern for these joints due to the location being a significant distance away from the impact area. A photograph of an installed gage is shown in figure 4. After gage bonding, the gages on each loop were wired and the lead wires were added, and terminated at the top of the barrier into a screw terminal strip. The gages and lead wires were then sealed with epoxy and mastic tape for weatherproofing.

Figure 4. Typical strain gage installation used in test 404821-1.

Strain gages were located on the connecting “loop” bars for barriers 2, 4, 12, and 14. A total of 8 joints was instrumented. These strain gages were used to measure the tensile strains in the connecting bars during impact.

In addition to the usual *NCHRP Report 350* instrumentation, strains in the steel connecting loops of the barriers were measured at eight connections (four at the upstream end and four at the downstream end of the installation) to obtain data that would be helpful in determining the length of barrier involved during the collision. A strain gage rosette was installed on the top loop and another on the bottom loop of each the eight pin and loop connections designated in figure 2. This resulted in 16 channels of data that were digitized and recorded on computer disk during the impact.

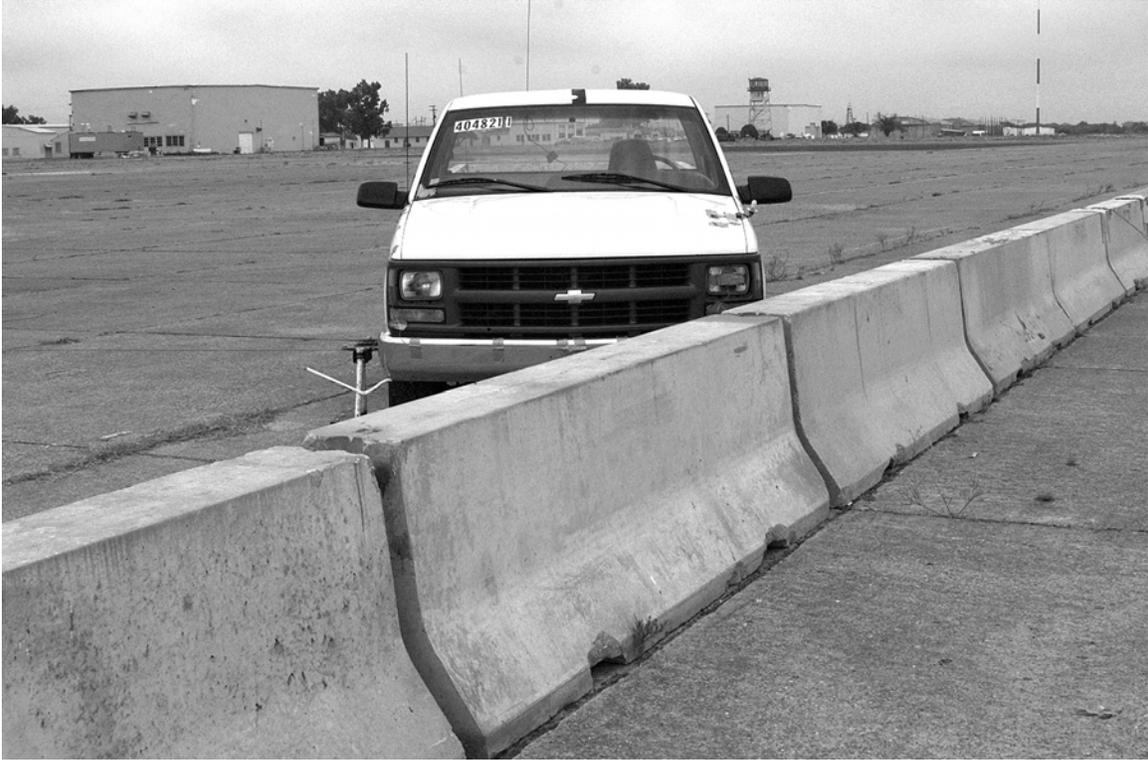
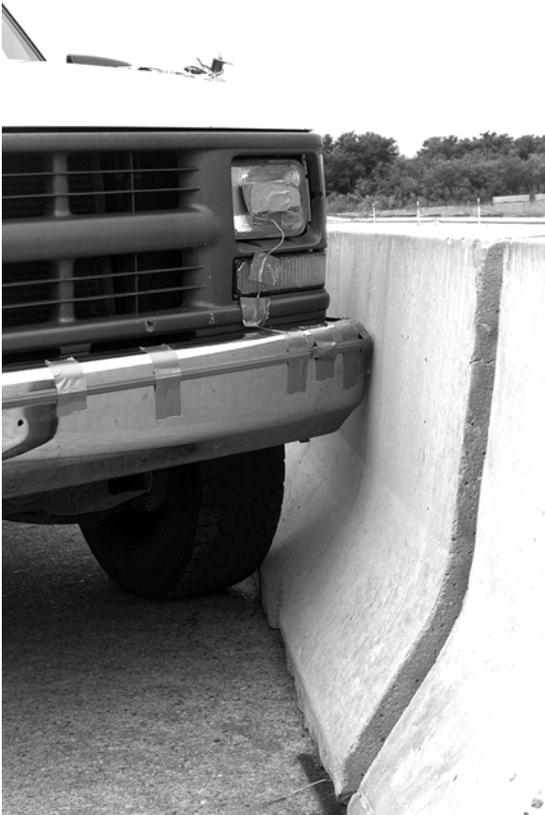
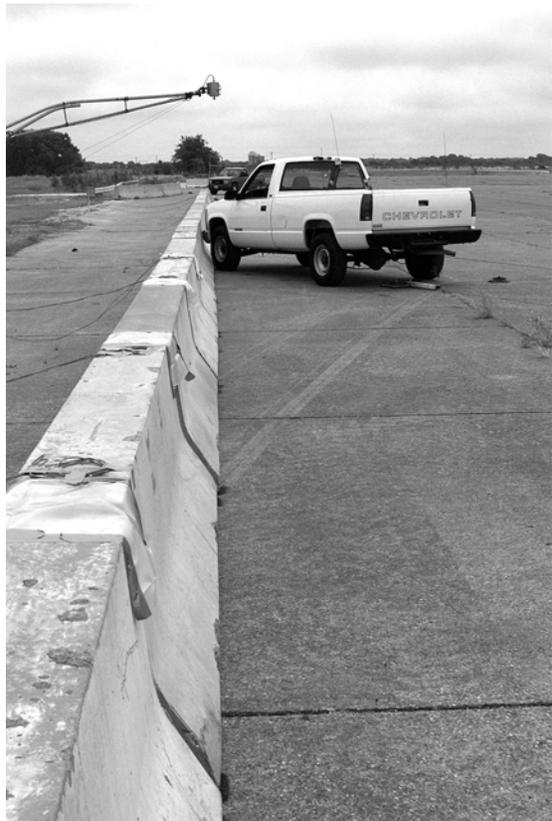
Figure 5. Vehicle/installation geometrics for test 404821-1.

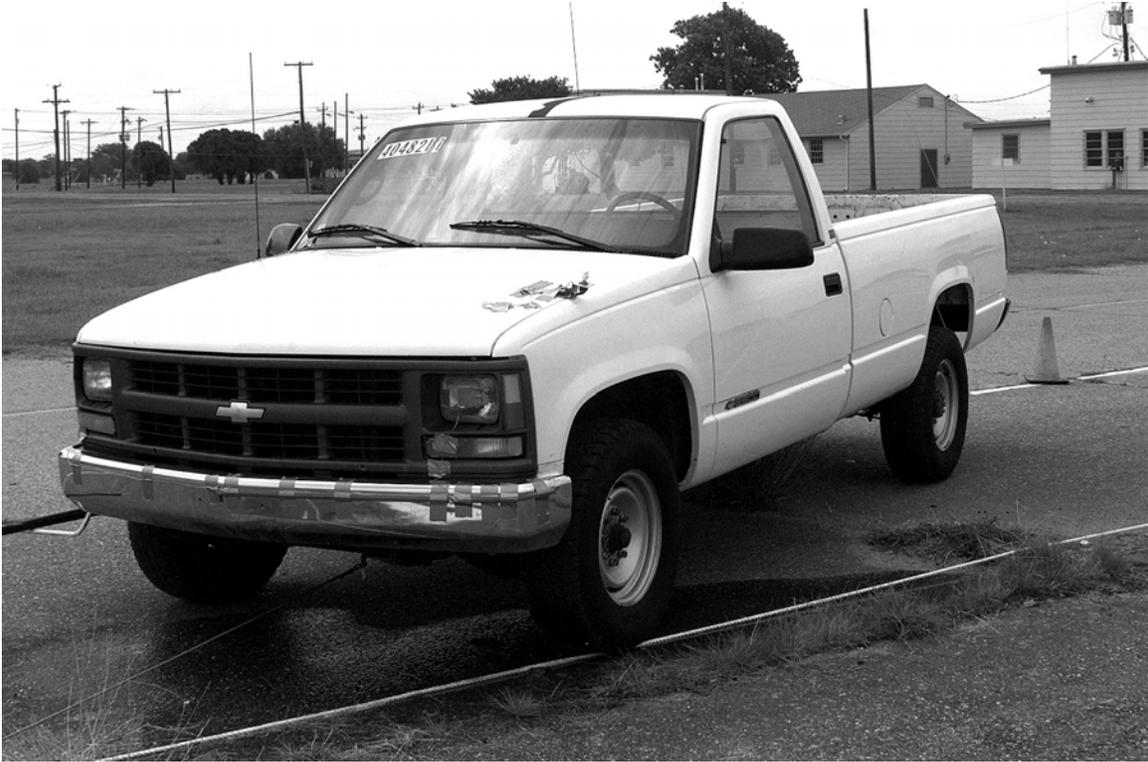
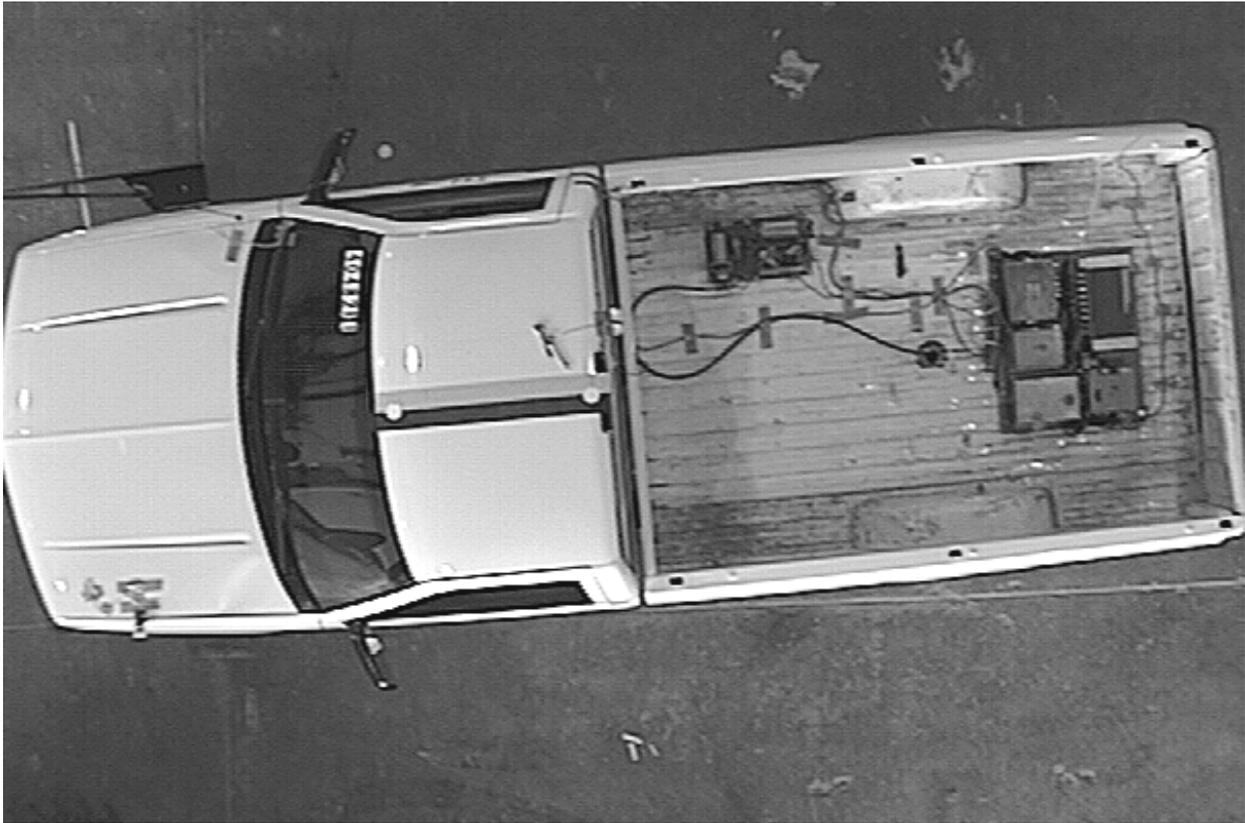
A 1996 Chevrolet 2500 pickup truck, shown in figures 5 and 6, was used for the crash test. Test inertia weight of the vehicle was 2000 kg, and its gross static weight was 2000 kg. The height to the lower edge of the vehicle front bumper was 430 mm and to the upper edge of the front bumper was 650 mm. Additional dimensions and information on the vehicle are given in appendix B, figure 14. The vehicle was directed into the installation using the cable reverse tow and guidance system, and was released to be free-wheeling and unrestrained just prior to impact.

Figure 6. Vehicle before test 404821-1.

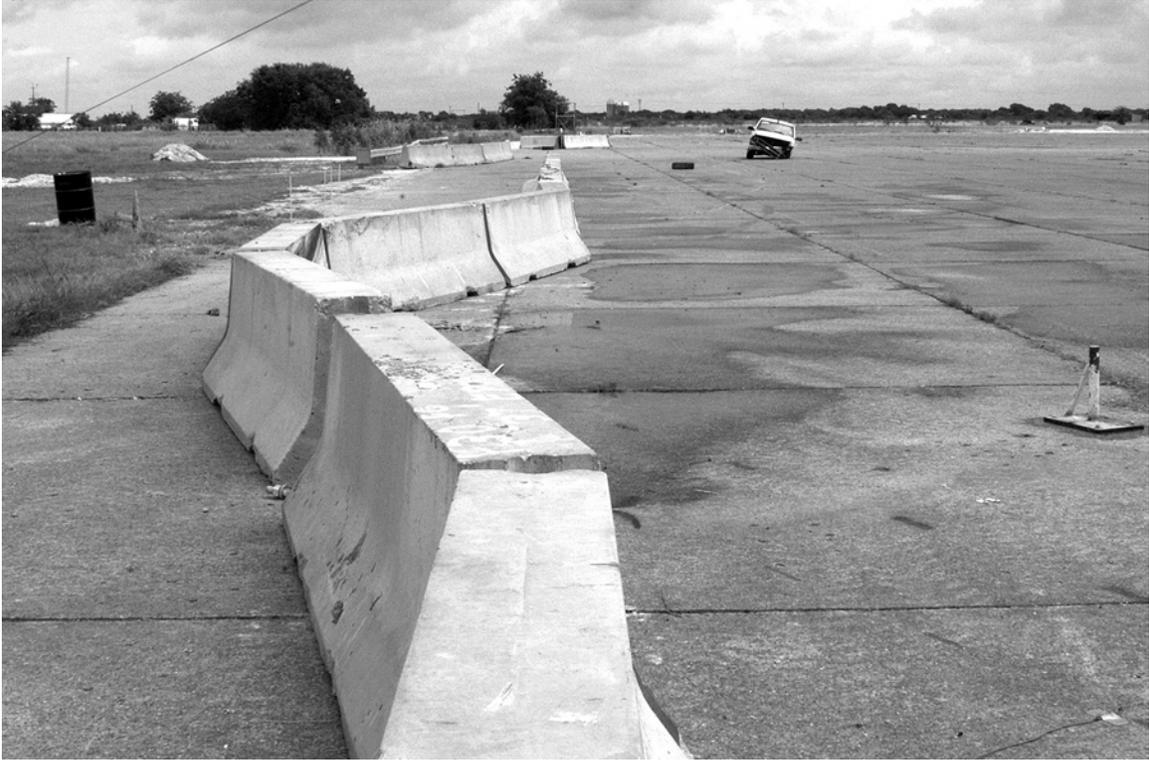
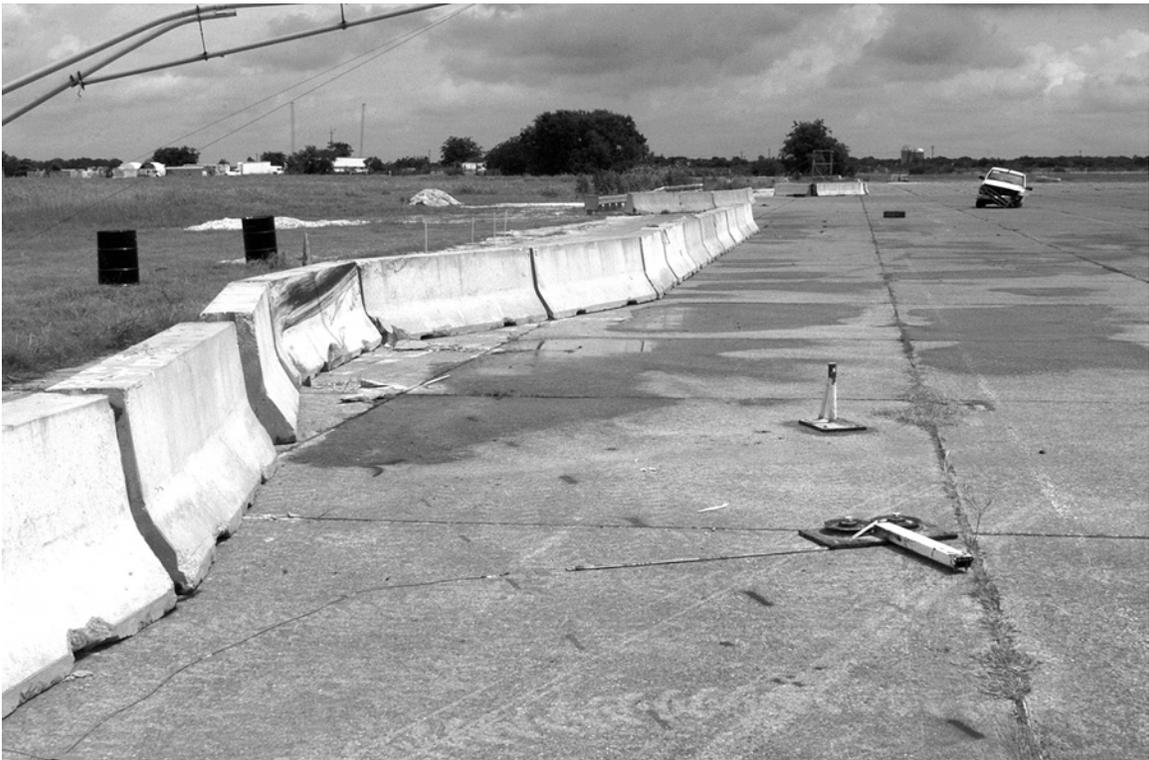
Figure 7. Vehicle trajectory path after test 404821-1.

As can be seen in figures 7 through 10, the Georgia Temporary Concrete Barrier installation pulled apart at the connection of segments 6 and 7. The pin was deformed and the lower loop on segment 6 ruptured. At the connection of 7 and 8, the pin was deformed and pulled out of the upper loop on segment 7. The pins at the connections of 8 and 9, 9 and 10, and 10 and 11 were slightly deformed and the pin pulled out of the top loop of segment 11. Tire marks marred the face of segments 6 through 8 and the concrete was spalled at the lower edges near the pavement and along the edges at the joints. Segment 1 moved slightly on the end connected to segment 2 and segments 2 through 11 moved as shown in table 1. Maximum lateral movement of the barriers was 1.88 m at the connection of segments 8 and 9. The total length of contact of the vehicle with the barriers was 4.32 m.

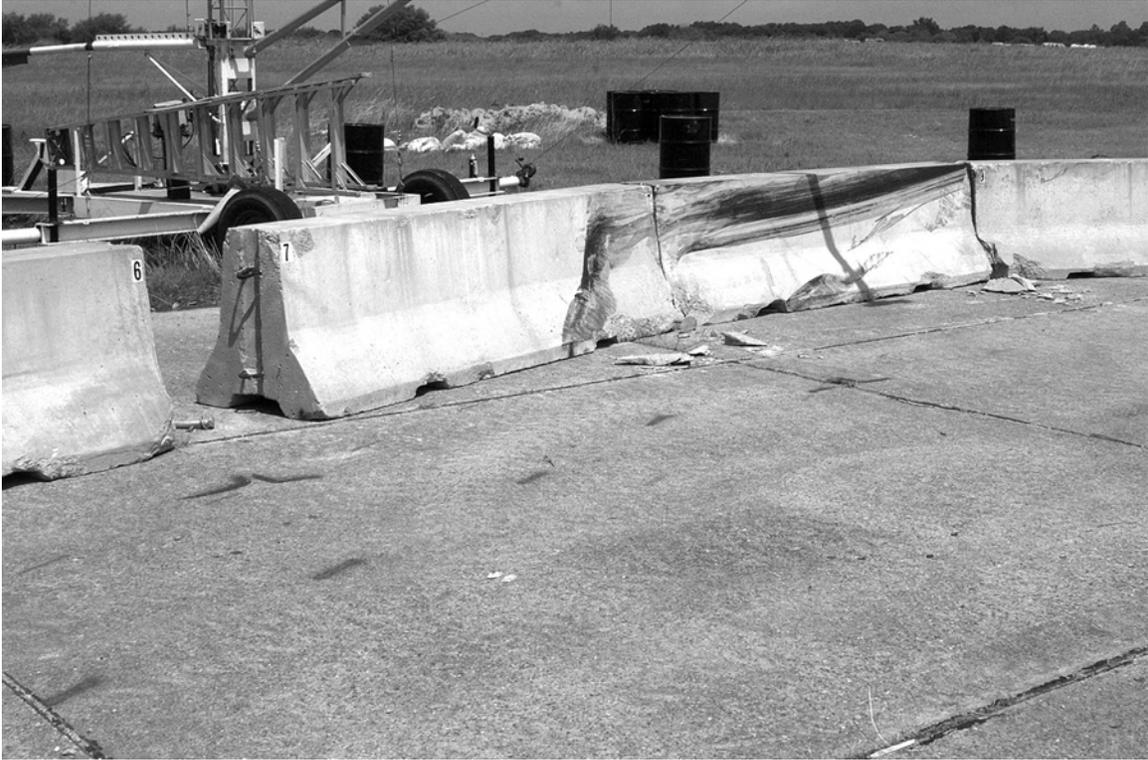
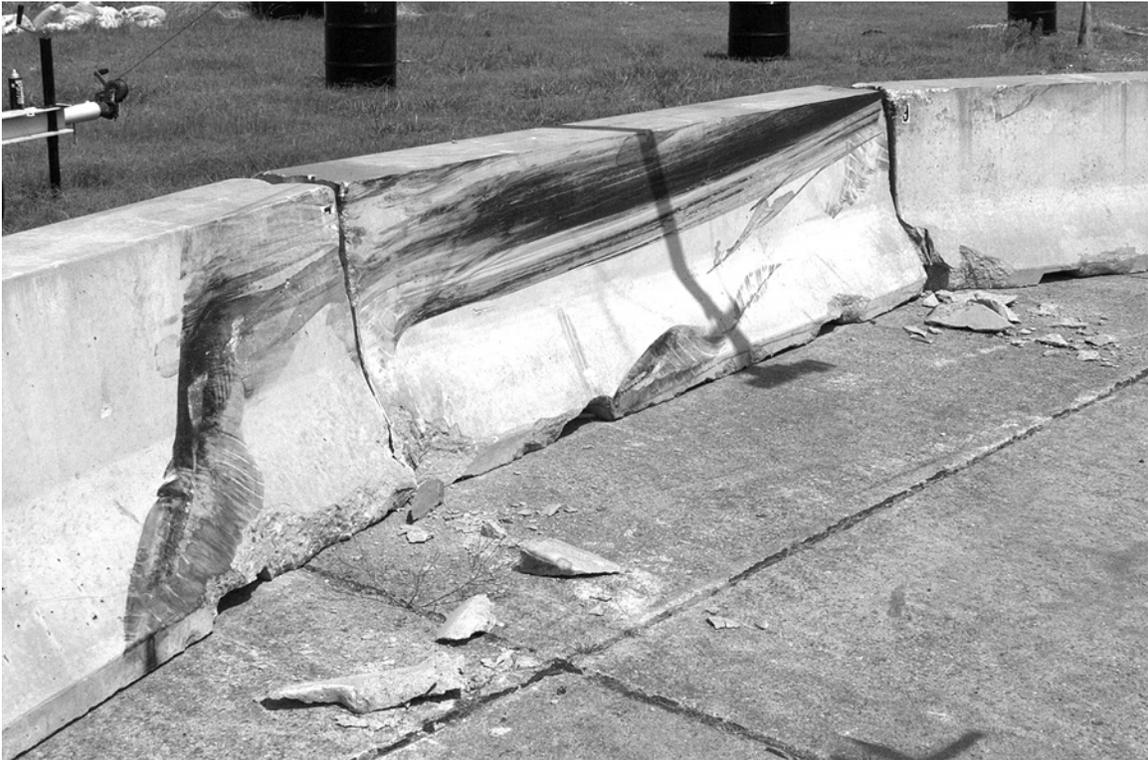
Figure 8. Installation after test 404821-1.

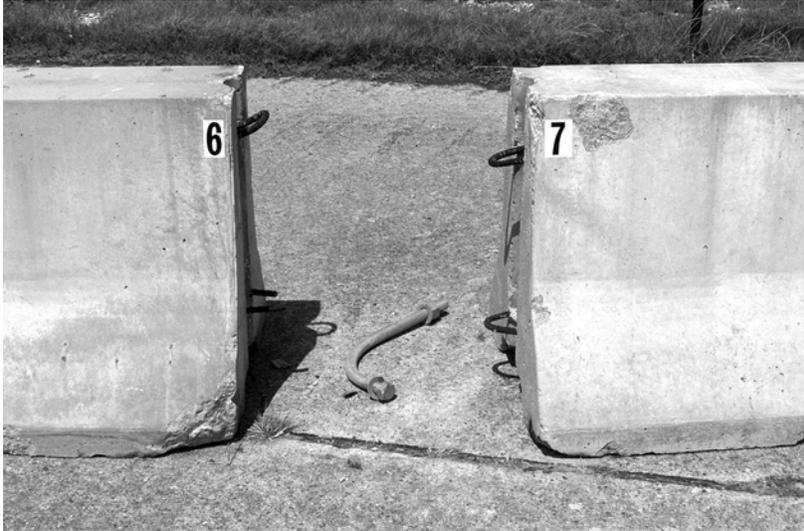
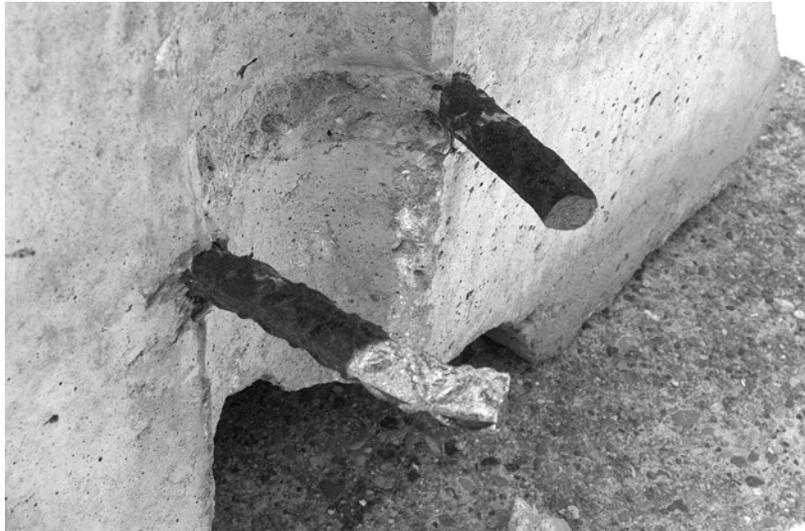
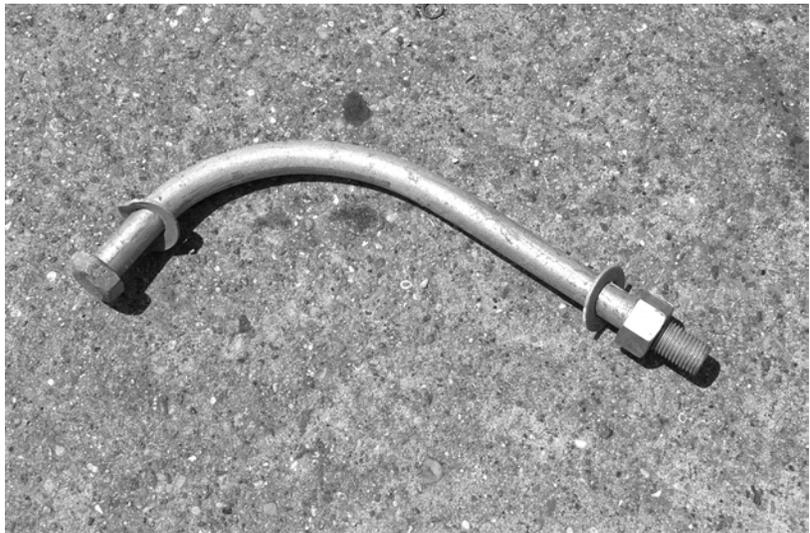
Figure 9. Damage at connection of segments 6 and 7.

The Georgia Temporary Concrete Barrier contained and redirected the 2000 kg pickup truck. The connection at segments 6 and 7 ruptured; however, impact occurred at 1.2 m upstream of the connection at segments 7 and 8, therefore the vehicle did not penetrate the installation. The vehicle did not underride or override the installation. Maximum movement of the barrier was 1.88 m.

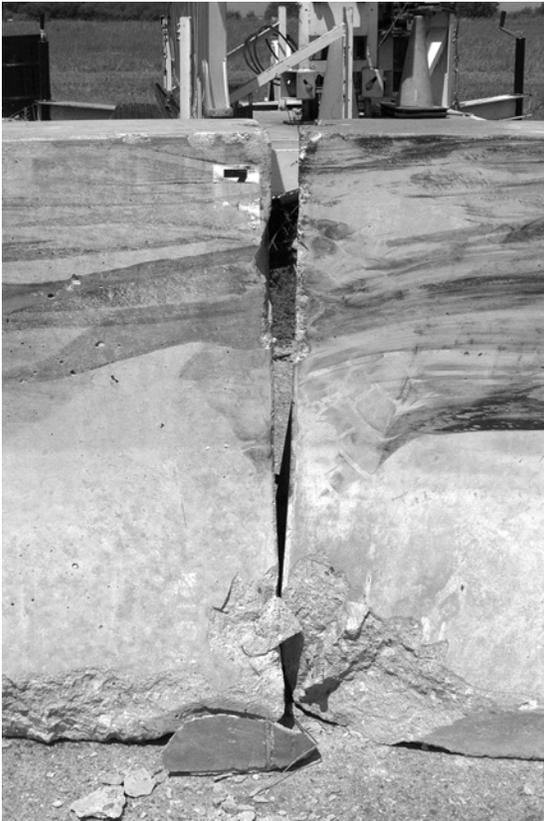
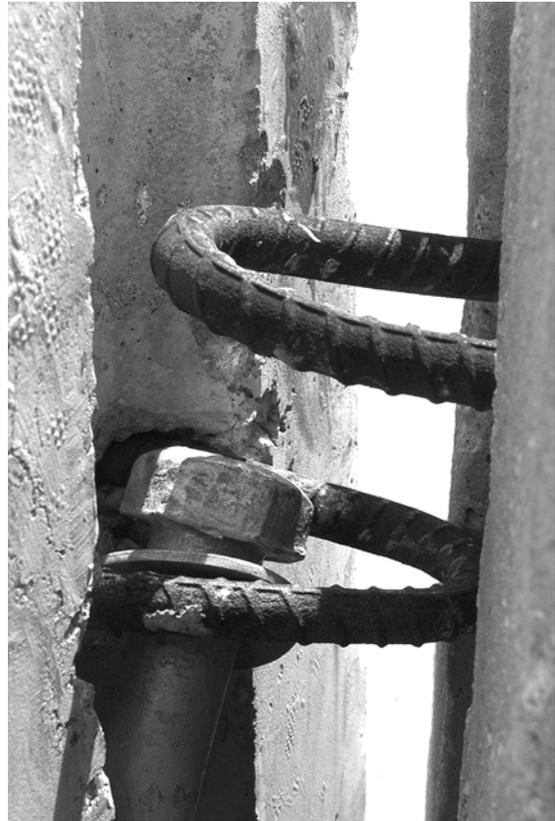
Figure 10. Damage at connection of segments 7 and 8.

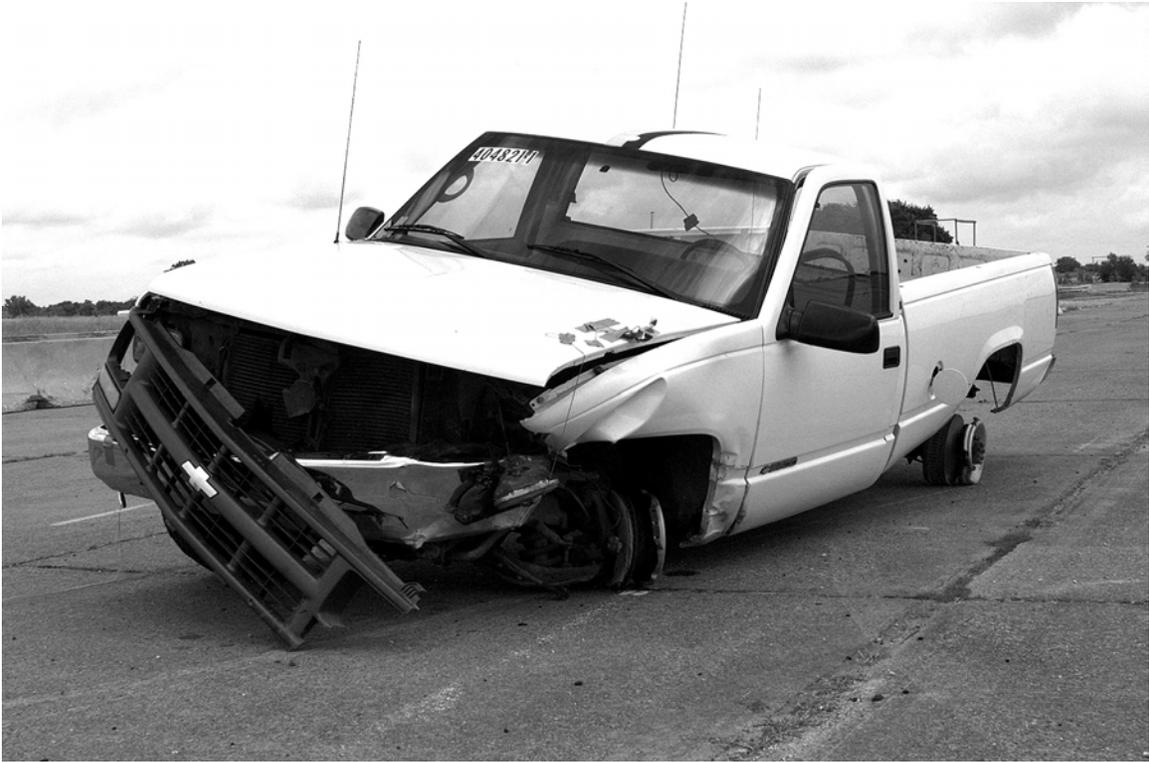
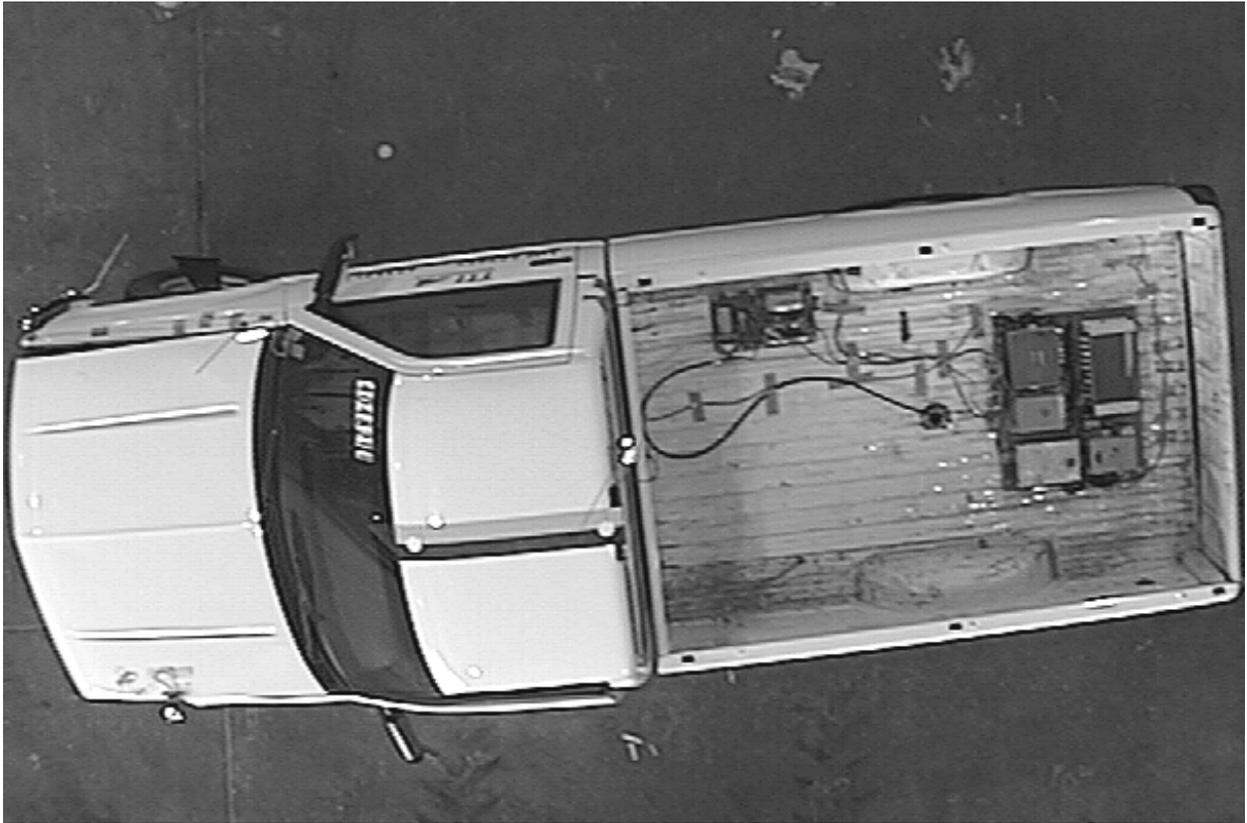
Damage sustained by the vehicle is shown in figure 11. Structural damage to the left frame rail, left upper and lower A-arm, and left outer tie rod occurred. The outer sections of the wheel rims on the left side front and rear wheels separated at the welds. The front bumper, grill,

Figure 11. Vehicle after test 404821-1.

left front headlight, left front quarter panel, left door and left rear bed also were damaged. Maximum exterior crush to the vehicle was 350 mm to the front left side at bumper height. The floor pan was deformed with maximum occupant compartment deformation of 42 mm (3 percent reduction of space) on the left side of the floor pan/firewall area. The interior of the vehicle is shown in figure 12. Exterior vehicle crush and occupant compartment measurements are shown in appendix B, tables 3 and 4.

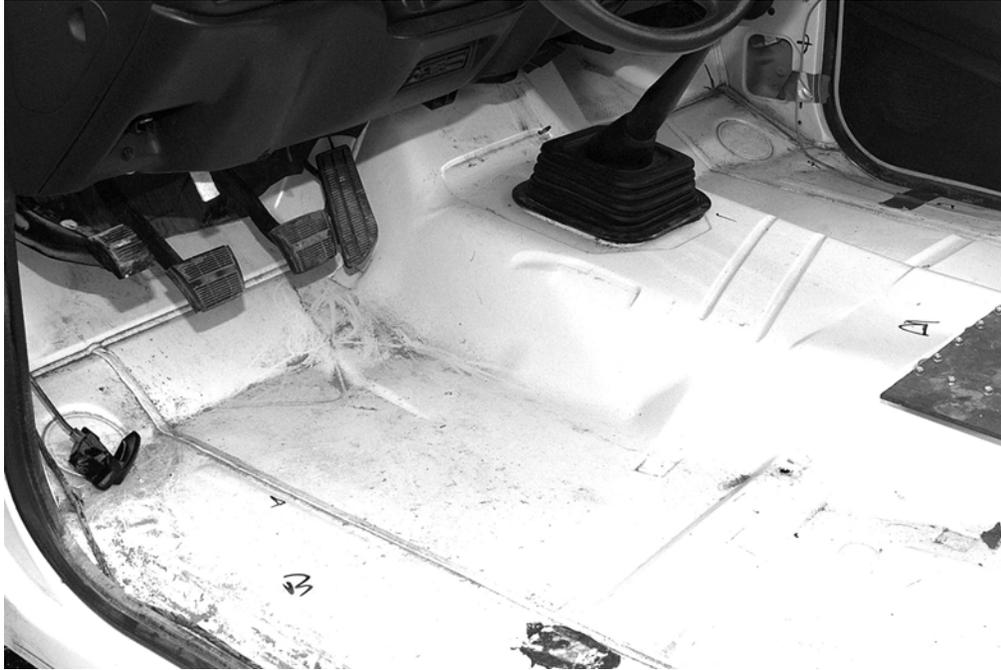
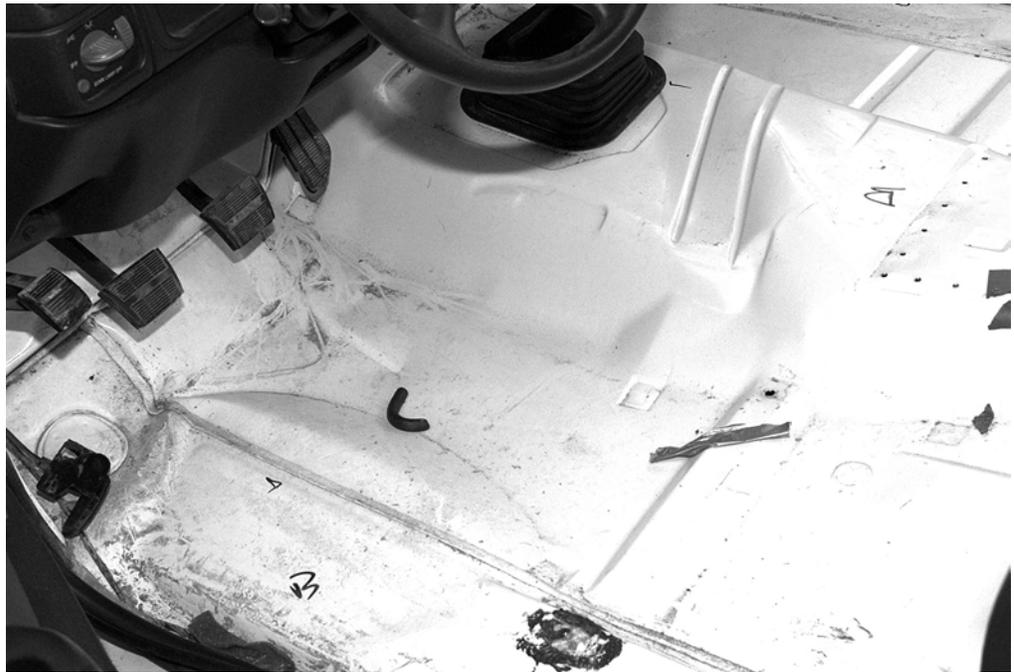
Figure 12. Interior of vehicle for test 404821-1.

The detached pin and segments did not penetrate nor show potential for penetrating the occupant compartment, not to present undue hazard to others in the area. Maximum occupant compartment deformation was 42 mm (3 percent reduction of space) in the firewall/floor pan area and was judged to not cause serious injury.
