**NCHRP REPORT 350 TEST 3-11 OF
GEORGIA TEMPORARY CONCRETE BARRIERS**

Contract No. T98170
Project No. 404821

Sponsored by
Georgia Department of Transportation

February 2000

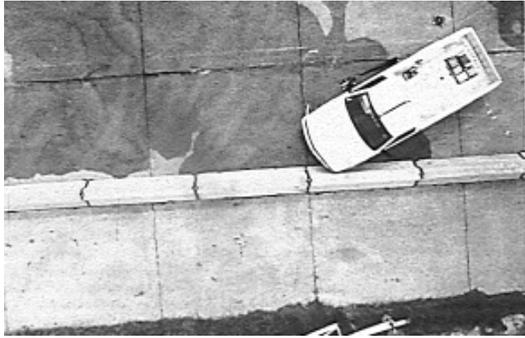
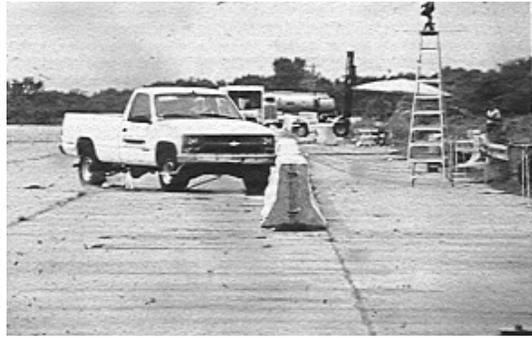
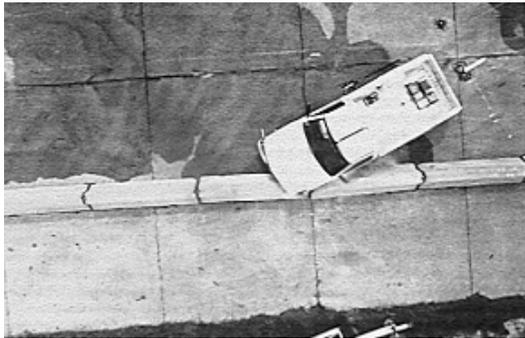
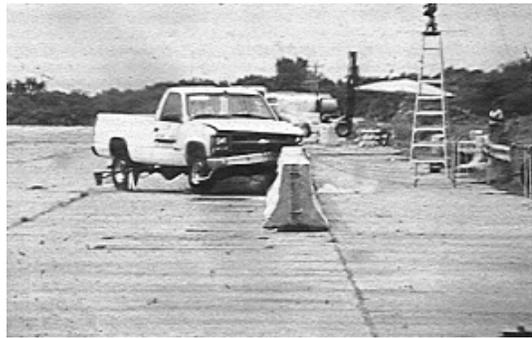
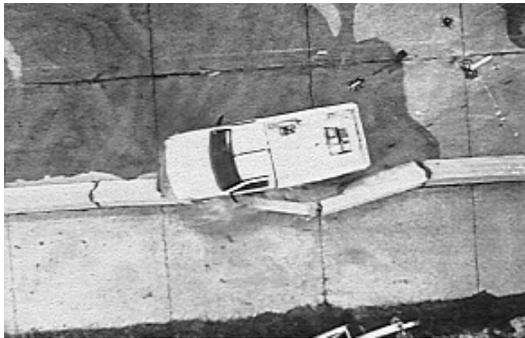
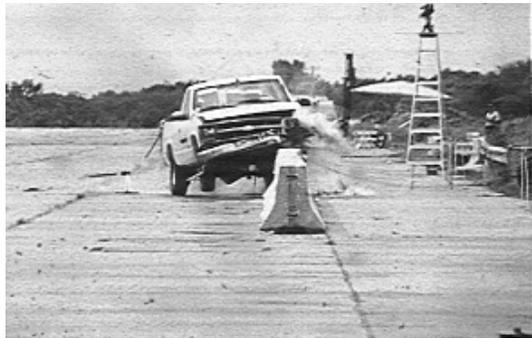
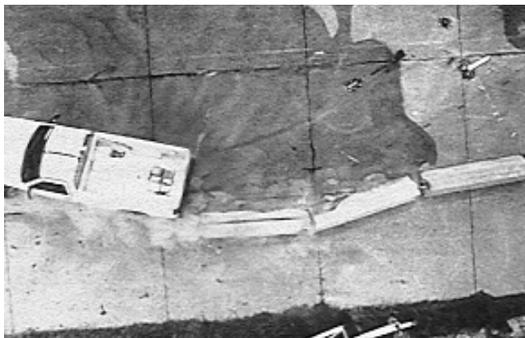
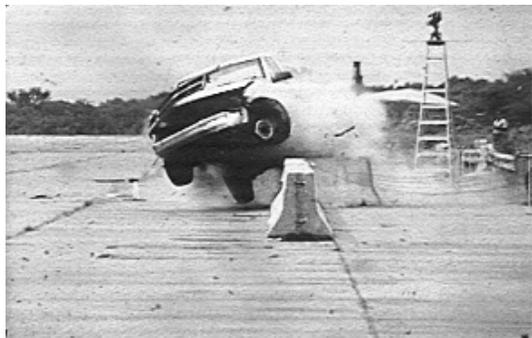
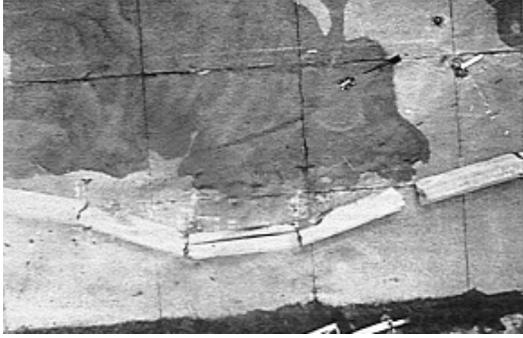
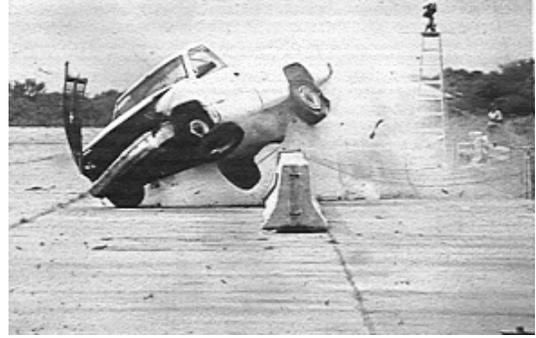
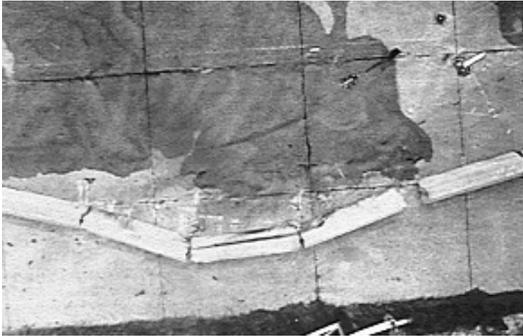
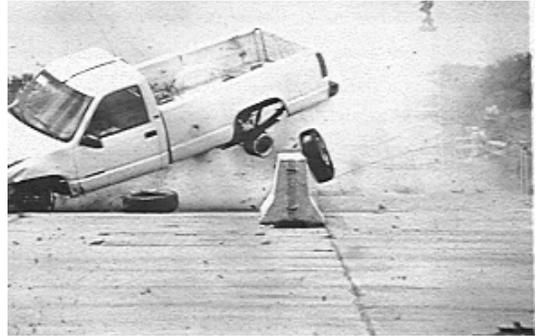
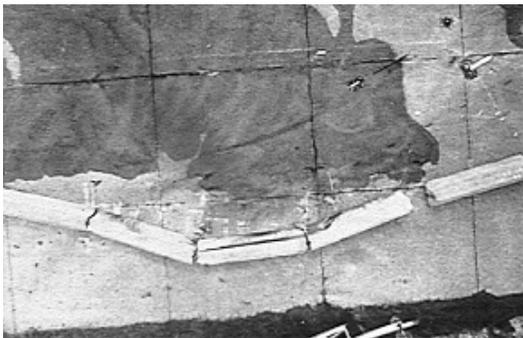
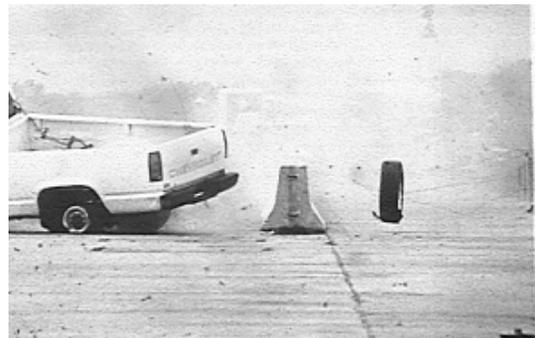
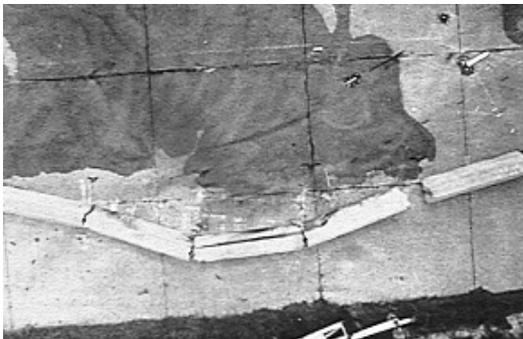
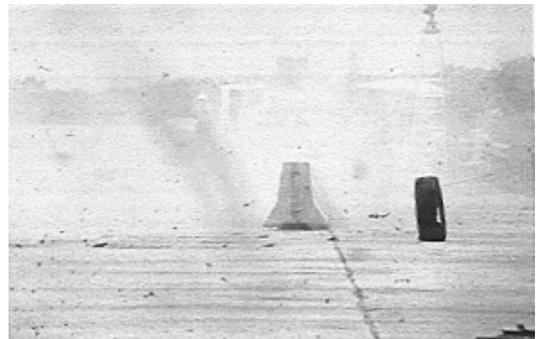
Figure 15. Sequential photographs for test 404821-1 (overhead and frontal views).

At 0.990 s the outer rim of the left rear wheel separated from the inner rim section. By 1.793 s all four wheels returned to the ground. Brakes on the vehicle were applied at 2.46 s. The vehicle yawed clockwise and subsequently came to rest 73.2 m down from impact and 9.1 m toward traffic lanes. Sequential photographs of the test period are shown in appendix C, figures 15 and 16.

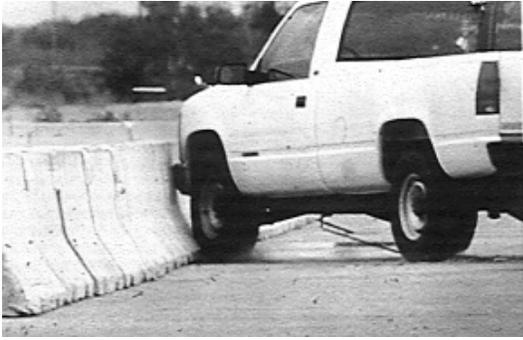
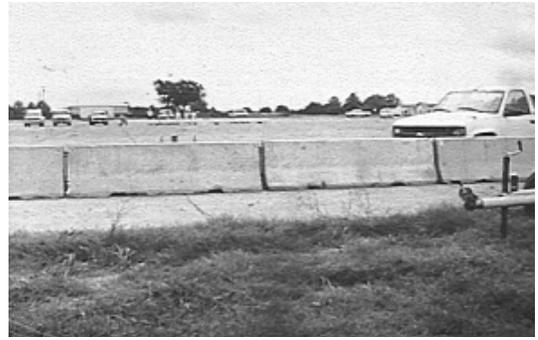
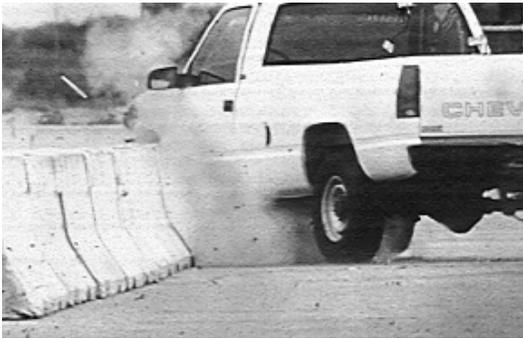
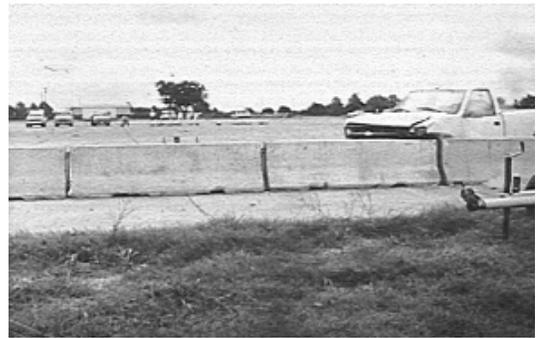
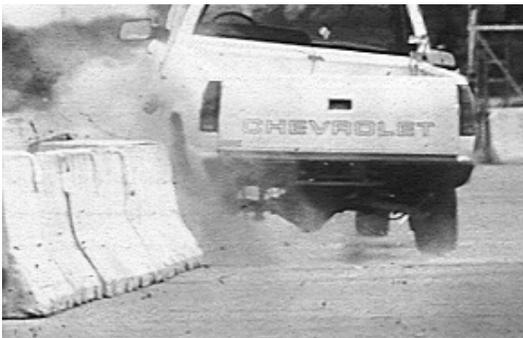
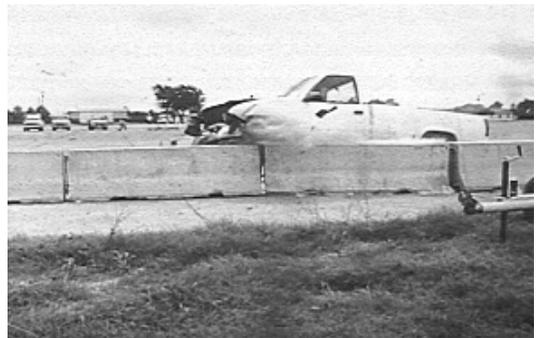
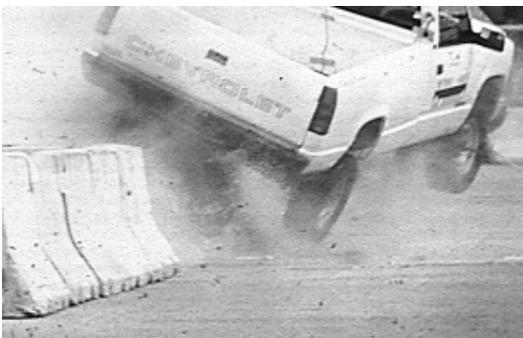
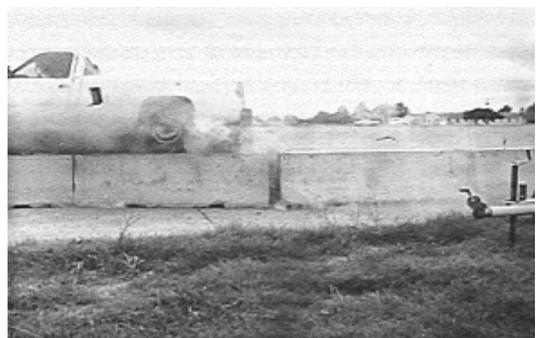
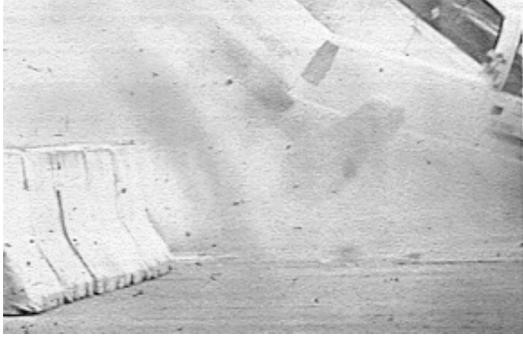
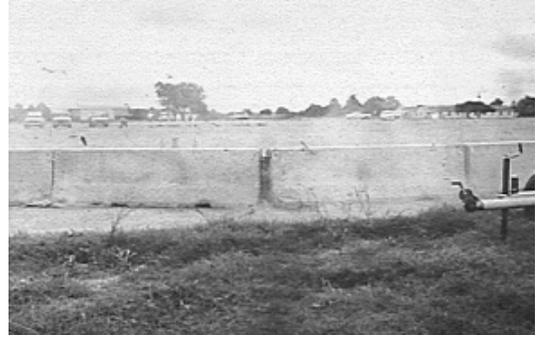
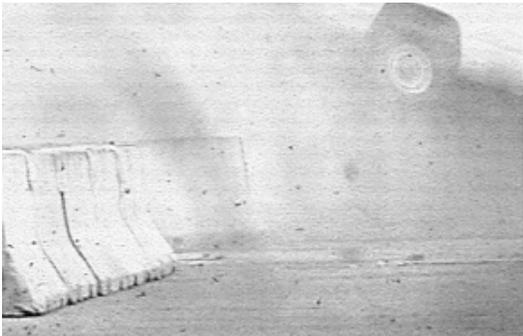
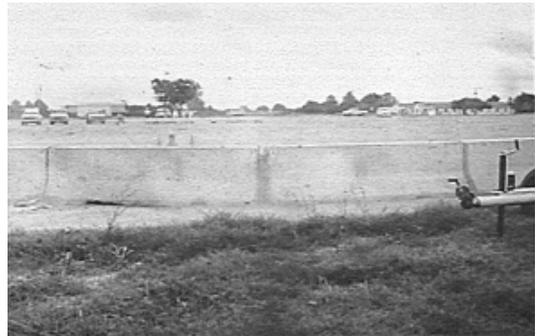
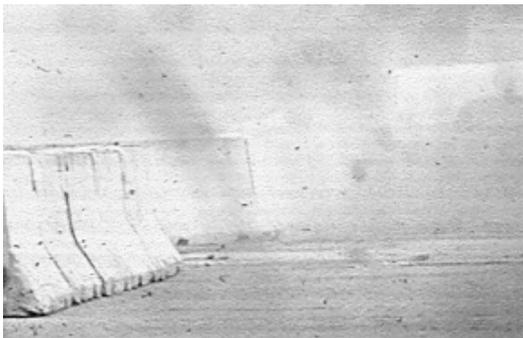
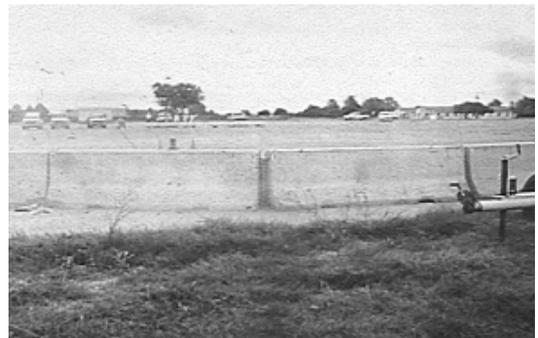
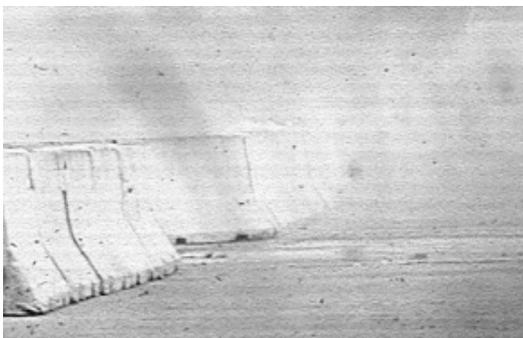
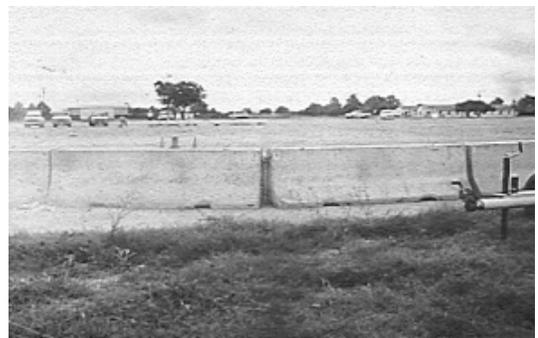
Figure 16. Sequential photographs for test 404821-1 (rear views).

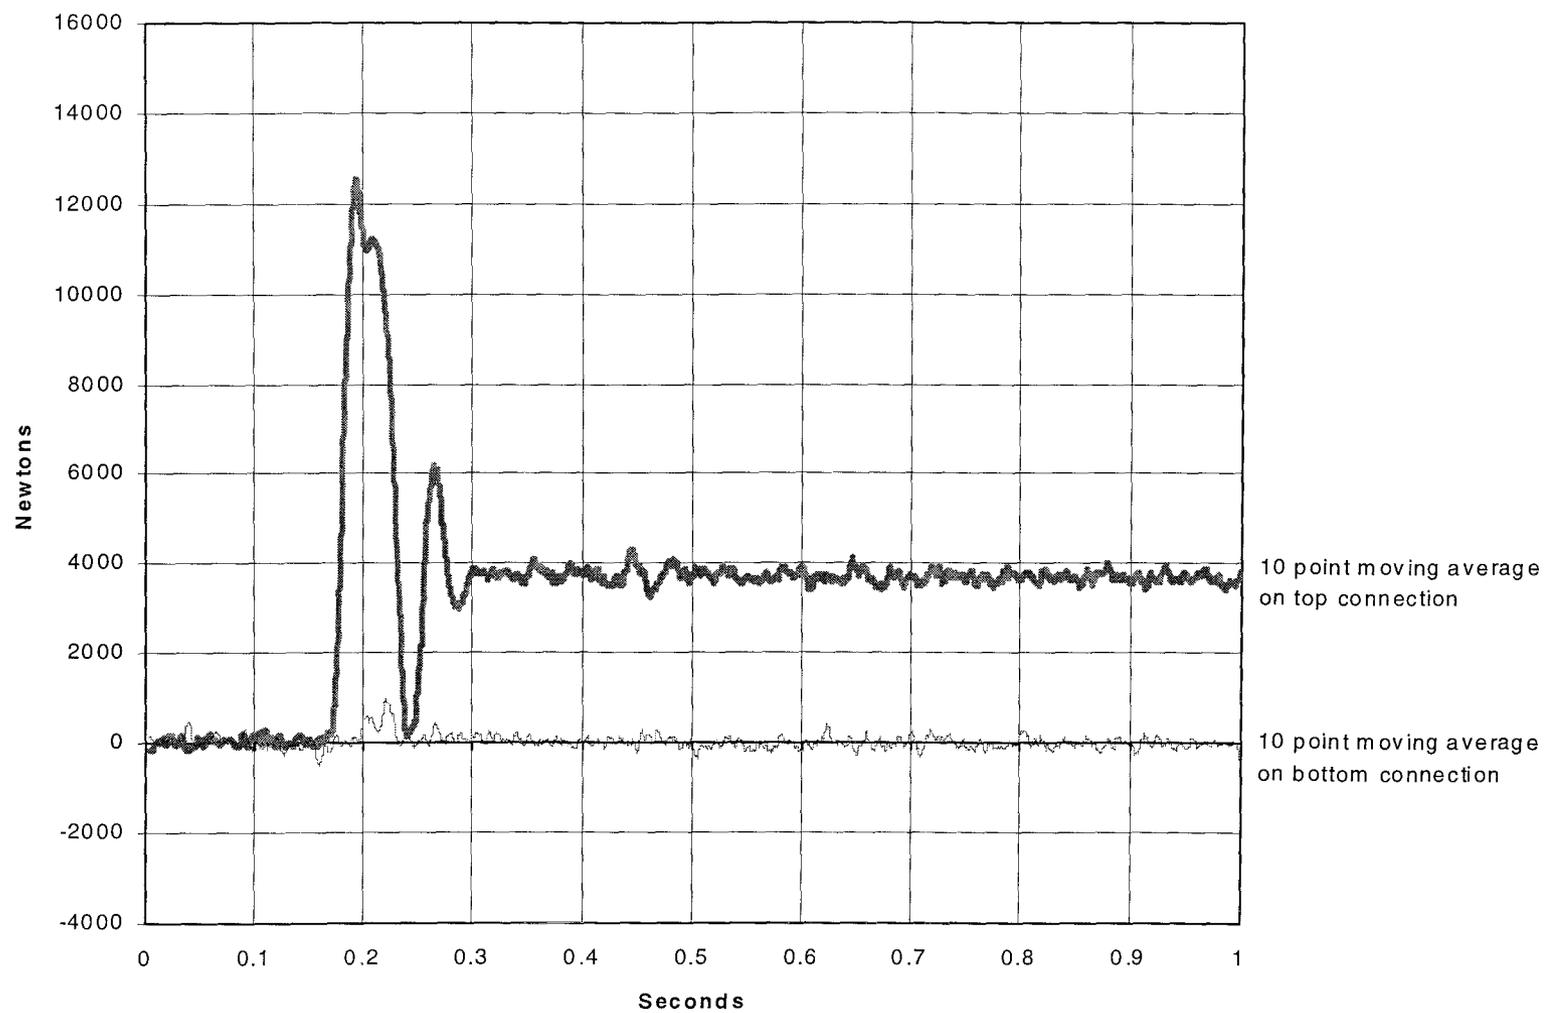
404821-1 Connection at Segments 1 and 2

Figure 17. Force experienced at connection of segments 1 and 2.

Graphs of forces computed from the readings made during the test are shown in appendix D, figures 17 through 24. As seen in these graphs, the top loops experienced most of the strain during the collision period. Maximum force experienced on the top loops on the upstream end was 42296 N at 0.120 s at the connection of segments 4 and 5 while only a maximum of 12868 N at 0.193 s occurred in the top loops at the connection of segments 1 and 2. On the top loops on the end downstream of impact a maximum force of 53754 N at 0.312 s occurred at the connection of segments 11 and 12 and a maximum of 18179 N at 0.364 s occurred at the connection of segments 14 and 15.

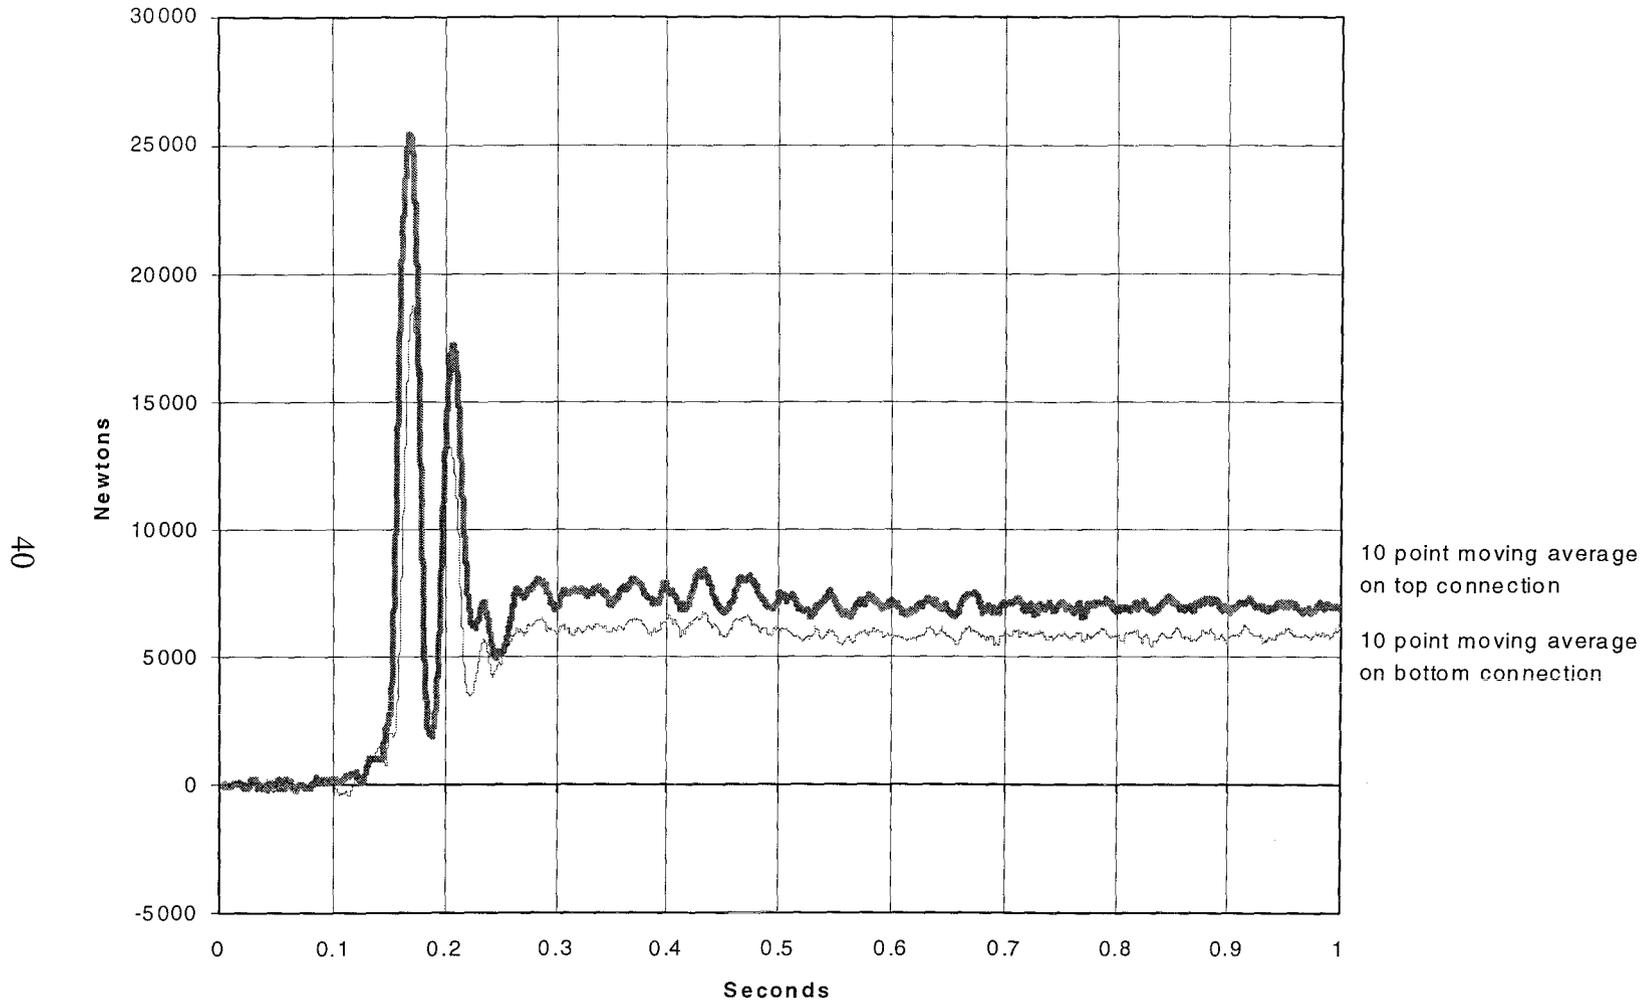
404821-1 Connection at Segments 2 and 3

Figure 18. Force experienced at connection of segments 2 and 3.

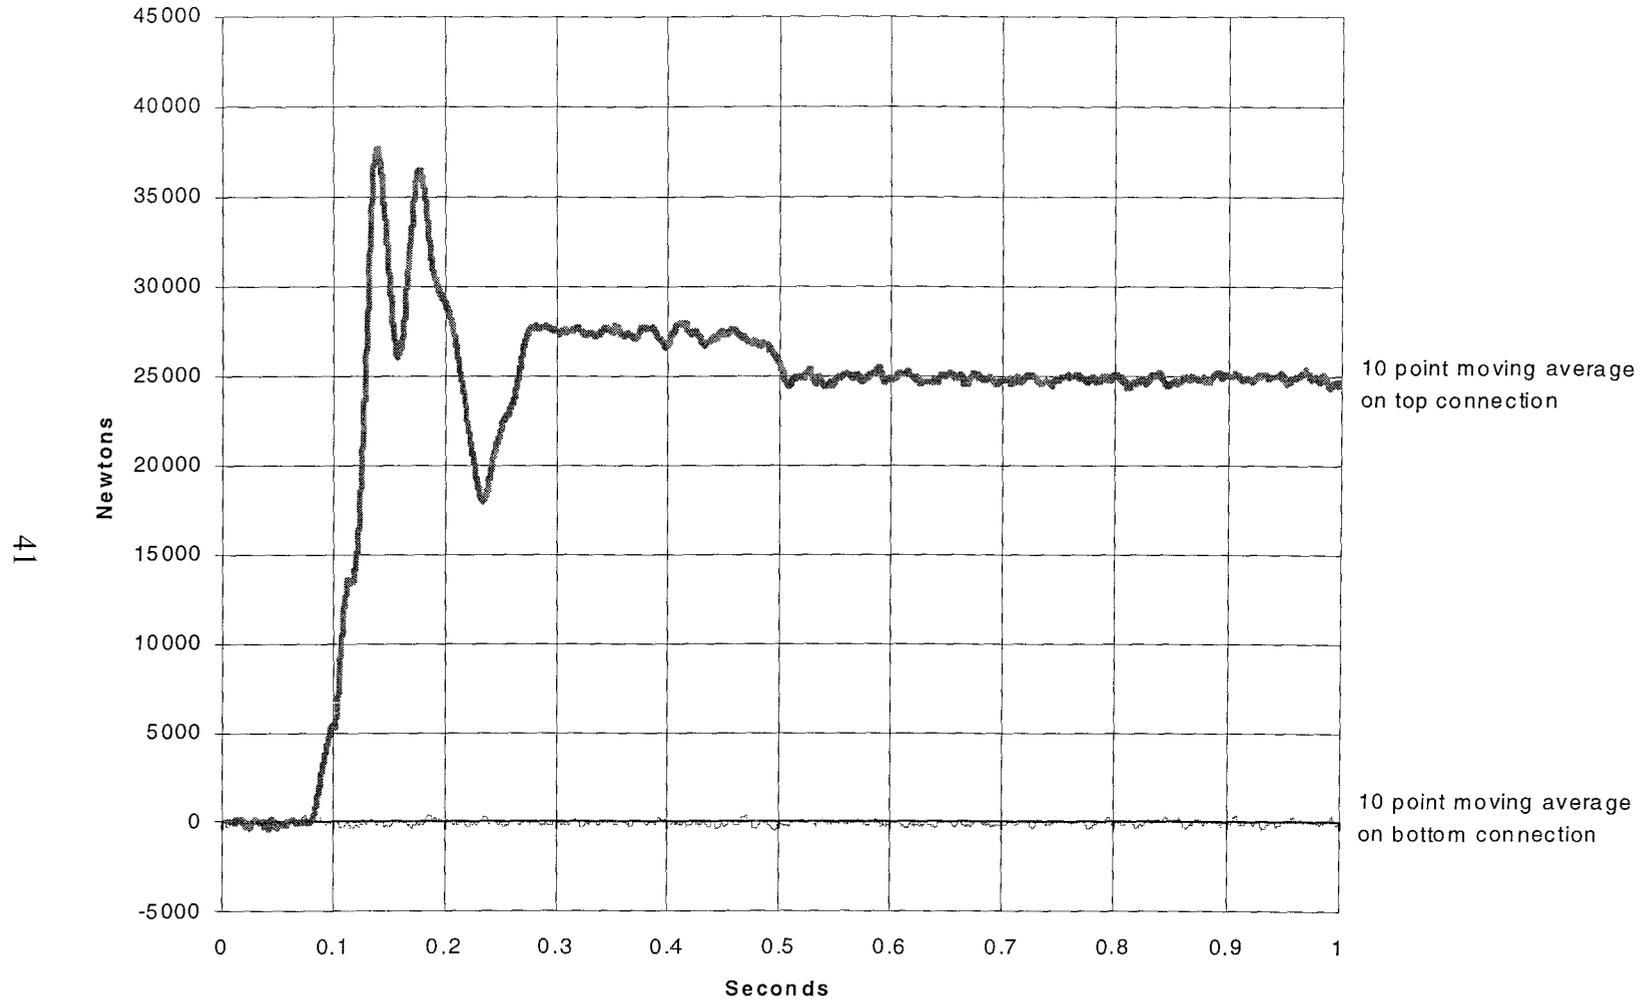
404821-1 Connection at Segments 3 and 4

Figure 19. Force experienced at connection of segments 3 and 4.

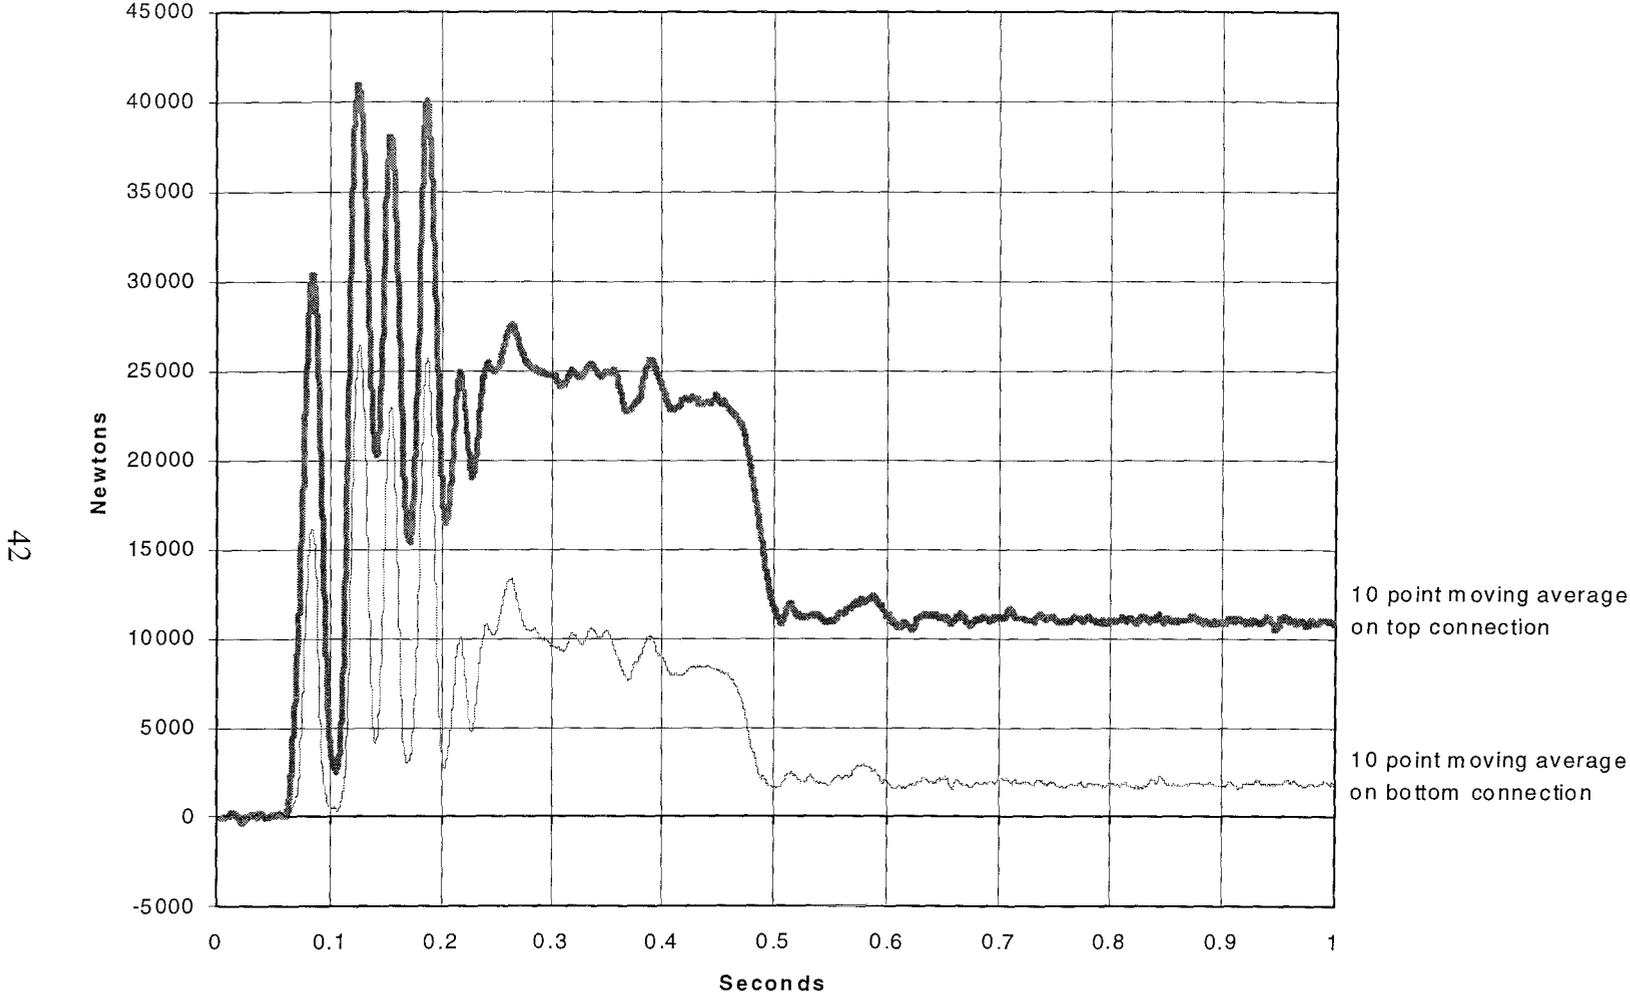
404821-1 Connection at Segments 4 and 5

Figure 20. Force experienced at connection of segments 4 and 5.

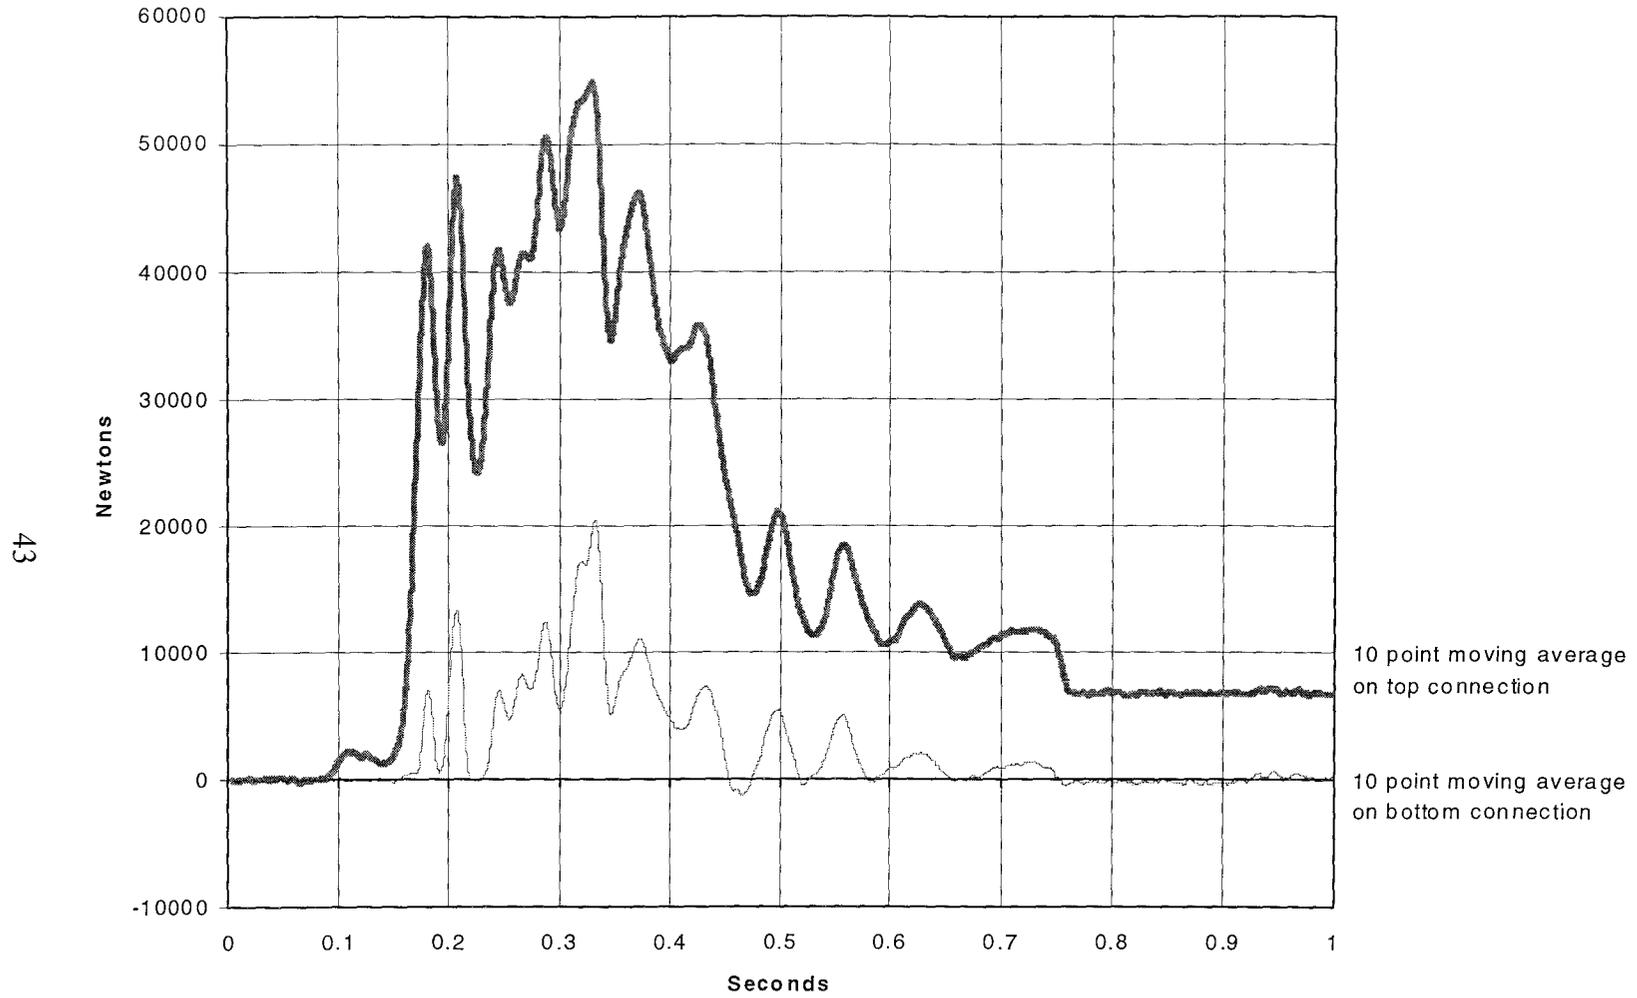
404821-1 Connection at Segments 11 and 12

Figure 21. Force experienced at connection of segments 11 and 12.

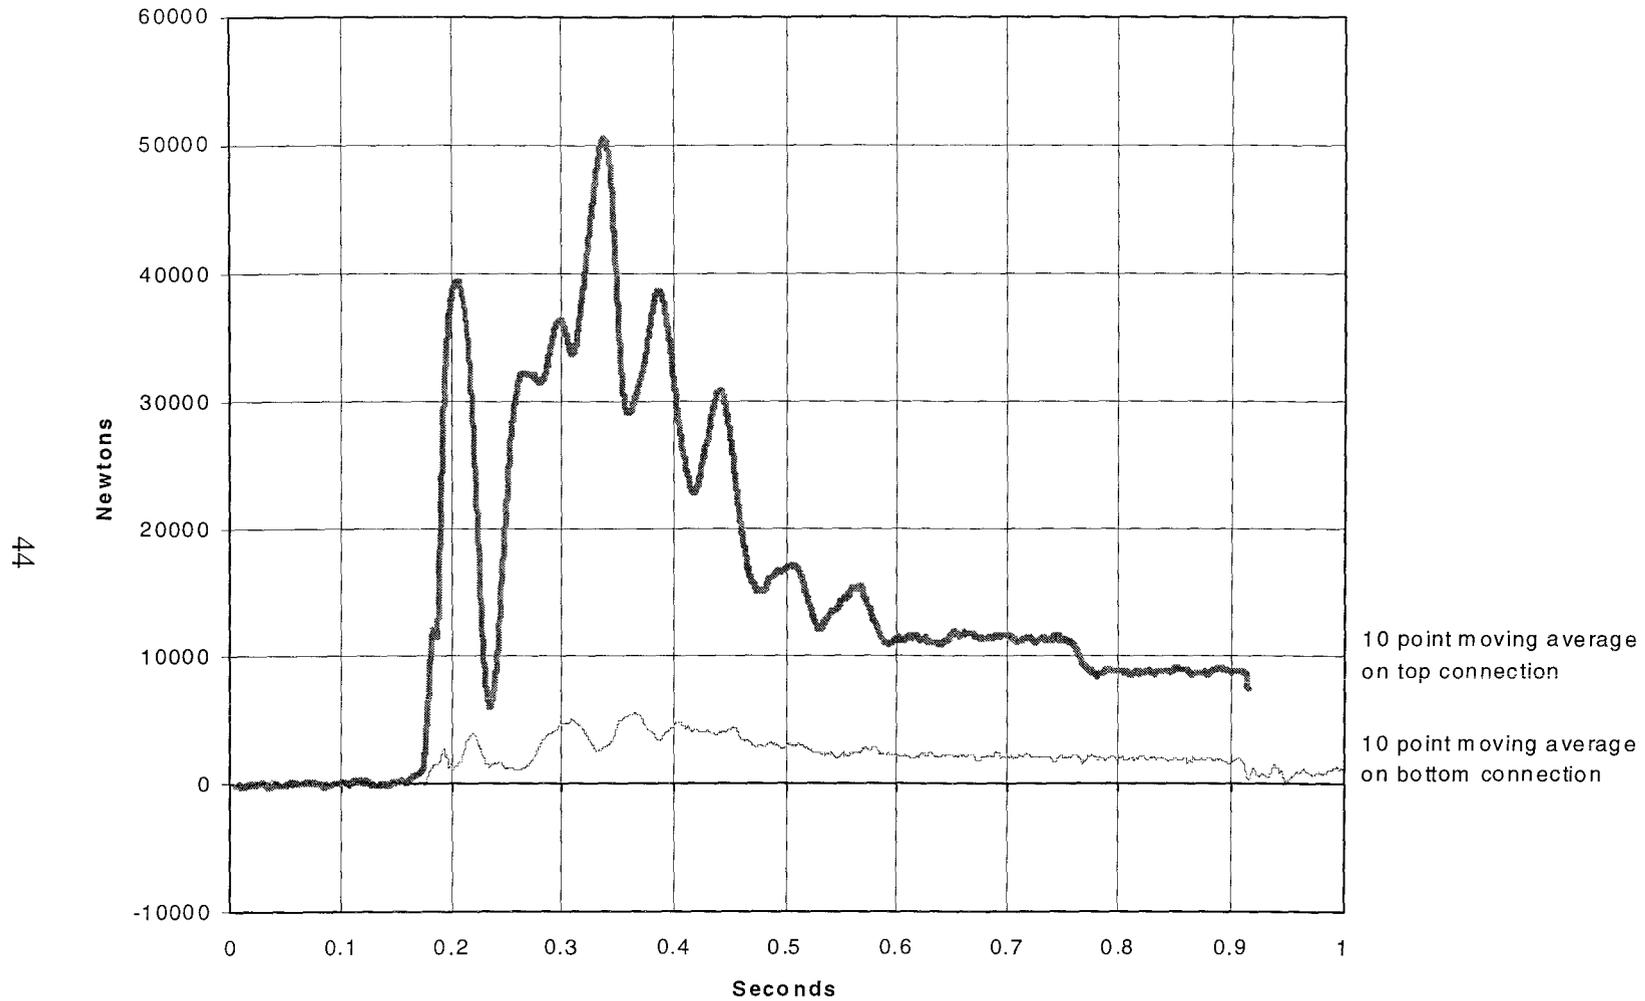
404821-1 Connection at Segments 12 and 13

Figure 22. Force experienced at connection of segments 12 and 13.

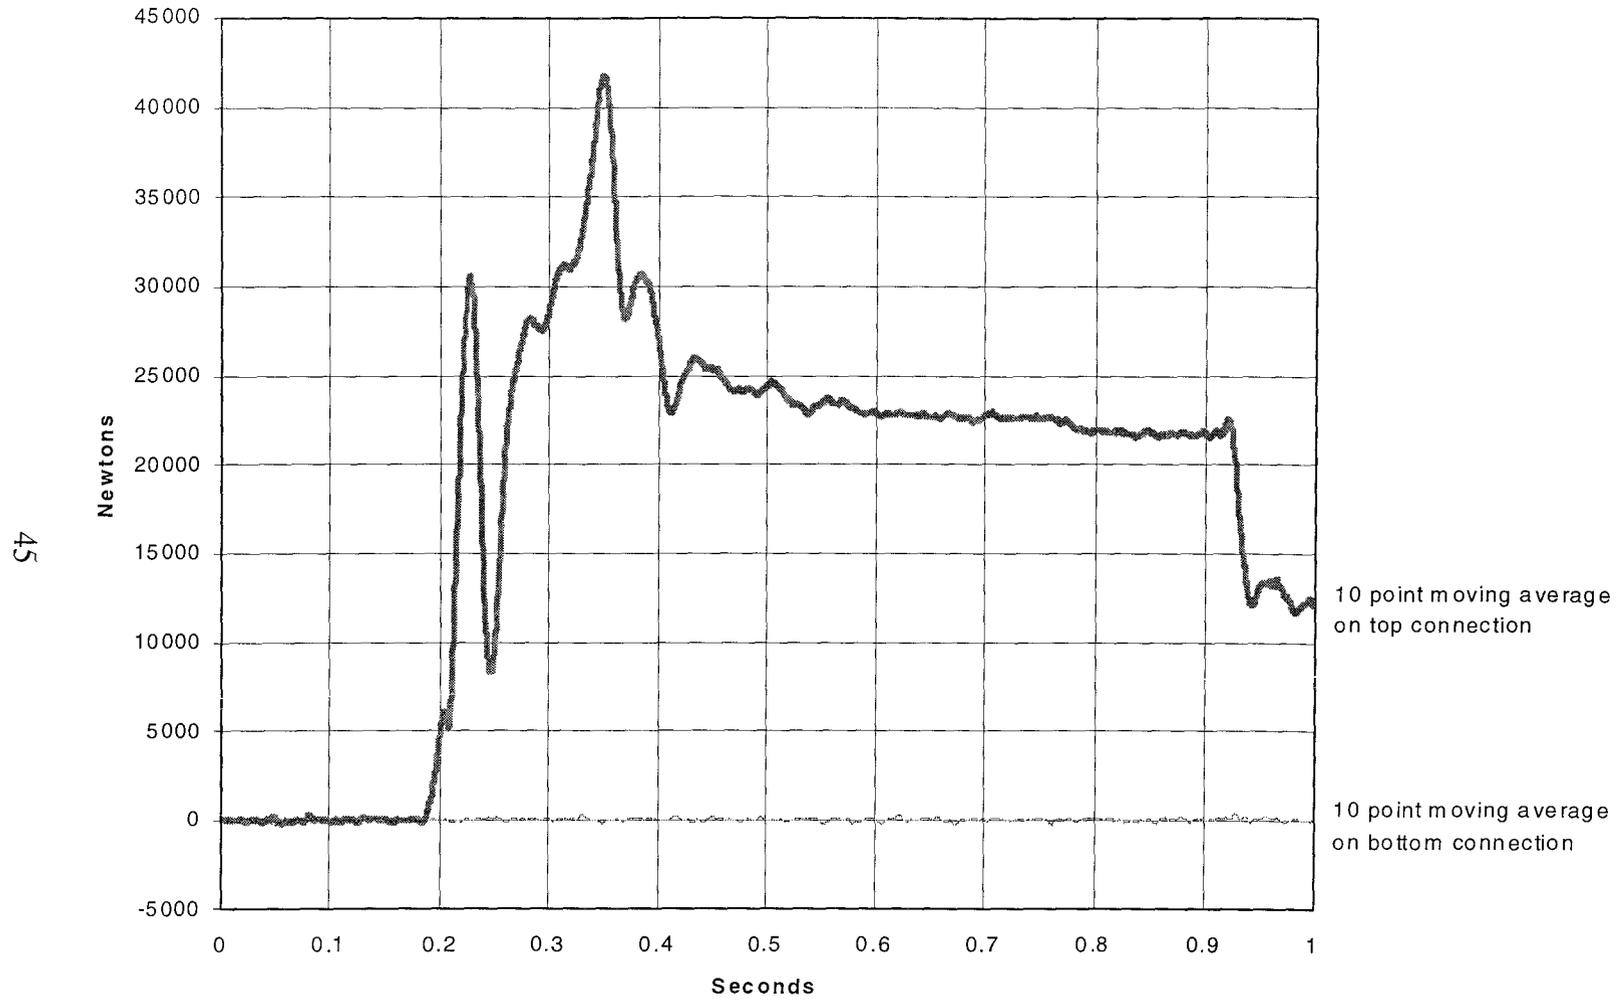
404821-1 Connection at Segments 13 and 14

Figure 23. Force experienced at connection of segments 13 and 14.

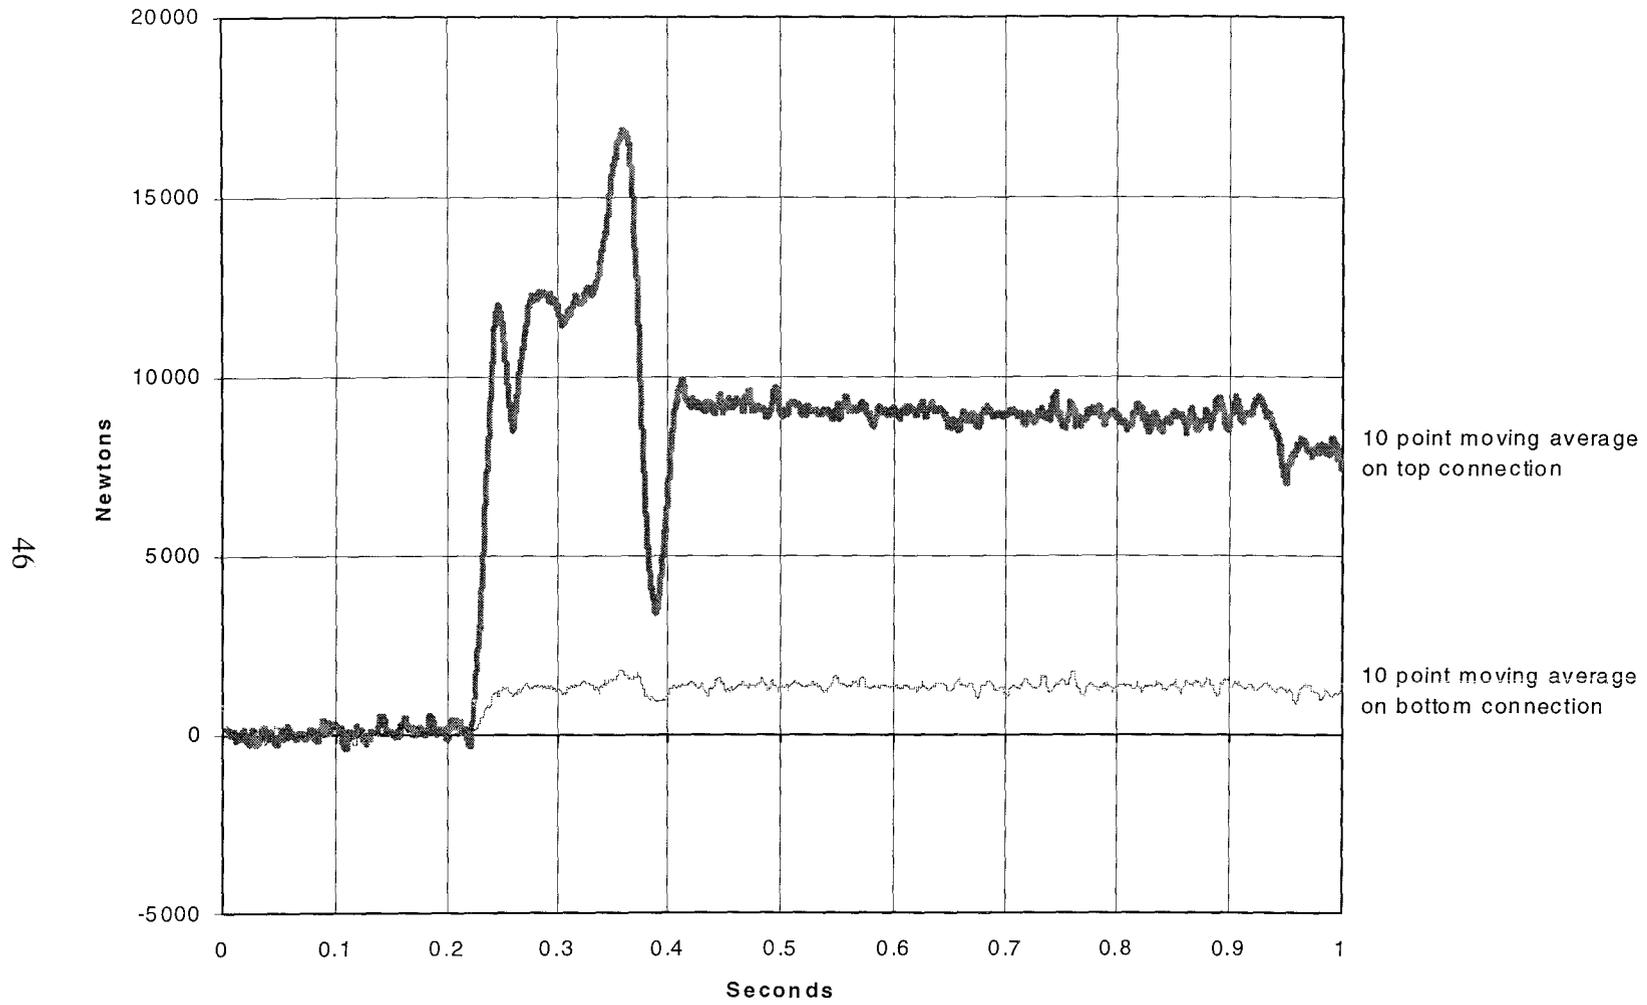
404821-1 Connection at Segments 14 and 15

Figure 24. Force experienced at connection of segments 14 and 15.

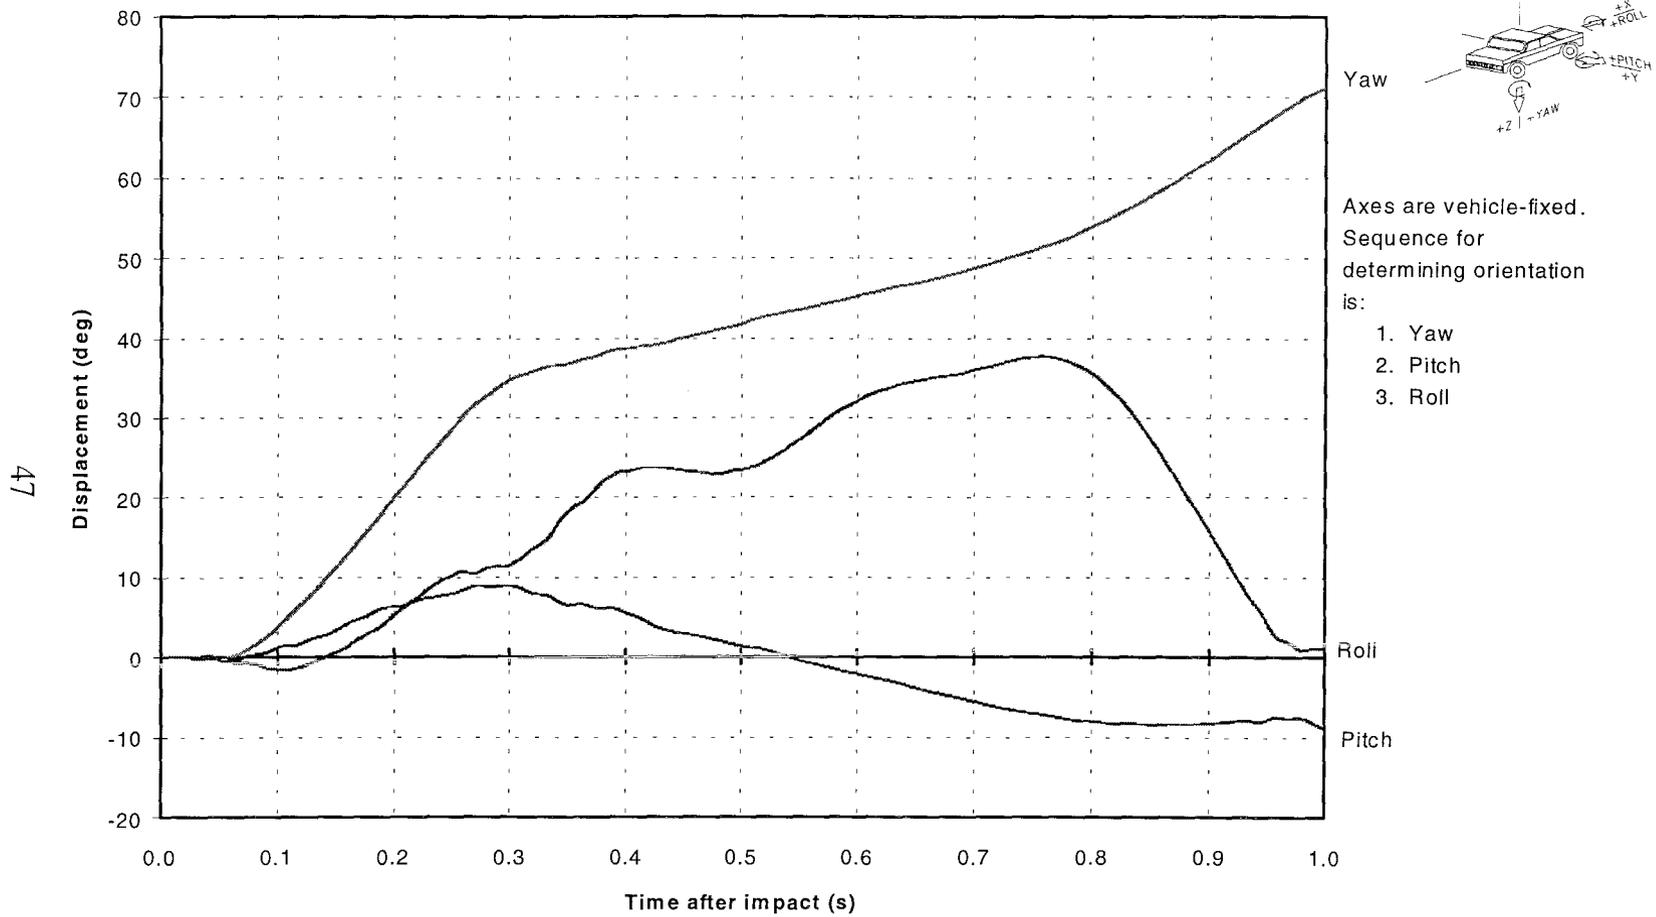
Figure 25. Vehicular angular displacements for test 404821-1.

Data from the tri-axial accelerometer, located at the vehicle center of gravity, were digitized to compute occupant impact velocity and ridedown accelerations. The occupant impact velocity and ridedown accelerations in the longitudinal axis only are required from these data for evaluation of criterion L of *NCHRP Report 350*. In the longitudinal direction, occupant impact velocity was 6.5 m/s at 0.172 s, maximum 0.010-s ridedown acceleration was -5.9 g's from 0.328 to 0.338 s, and the maximum 0.050-s average was -6.8 g's between 0.047 and 0.097 s. In the lateral direction, the occupant impact velocity was 5.9 m/s at 0.110 s, the highest 0.010-s occupant ridedown acceleration was 7.4 g's from 0.113 to 0.123 s, and the maximum 0.050-s average was 9.1 g's between 0.036 and 0.086 s. These data and other information pertinent to the test are presented in figure 13. Vehicle angular displacements and accelerations versus time traces are shown in appendix E, figures 25 through 28.

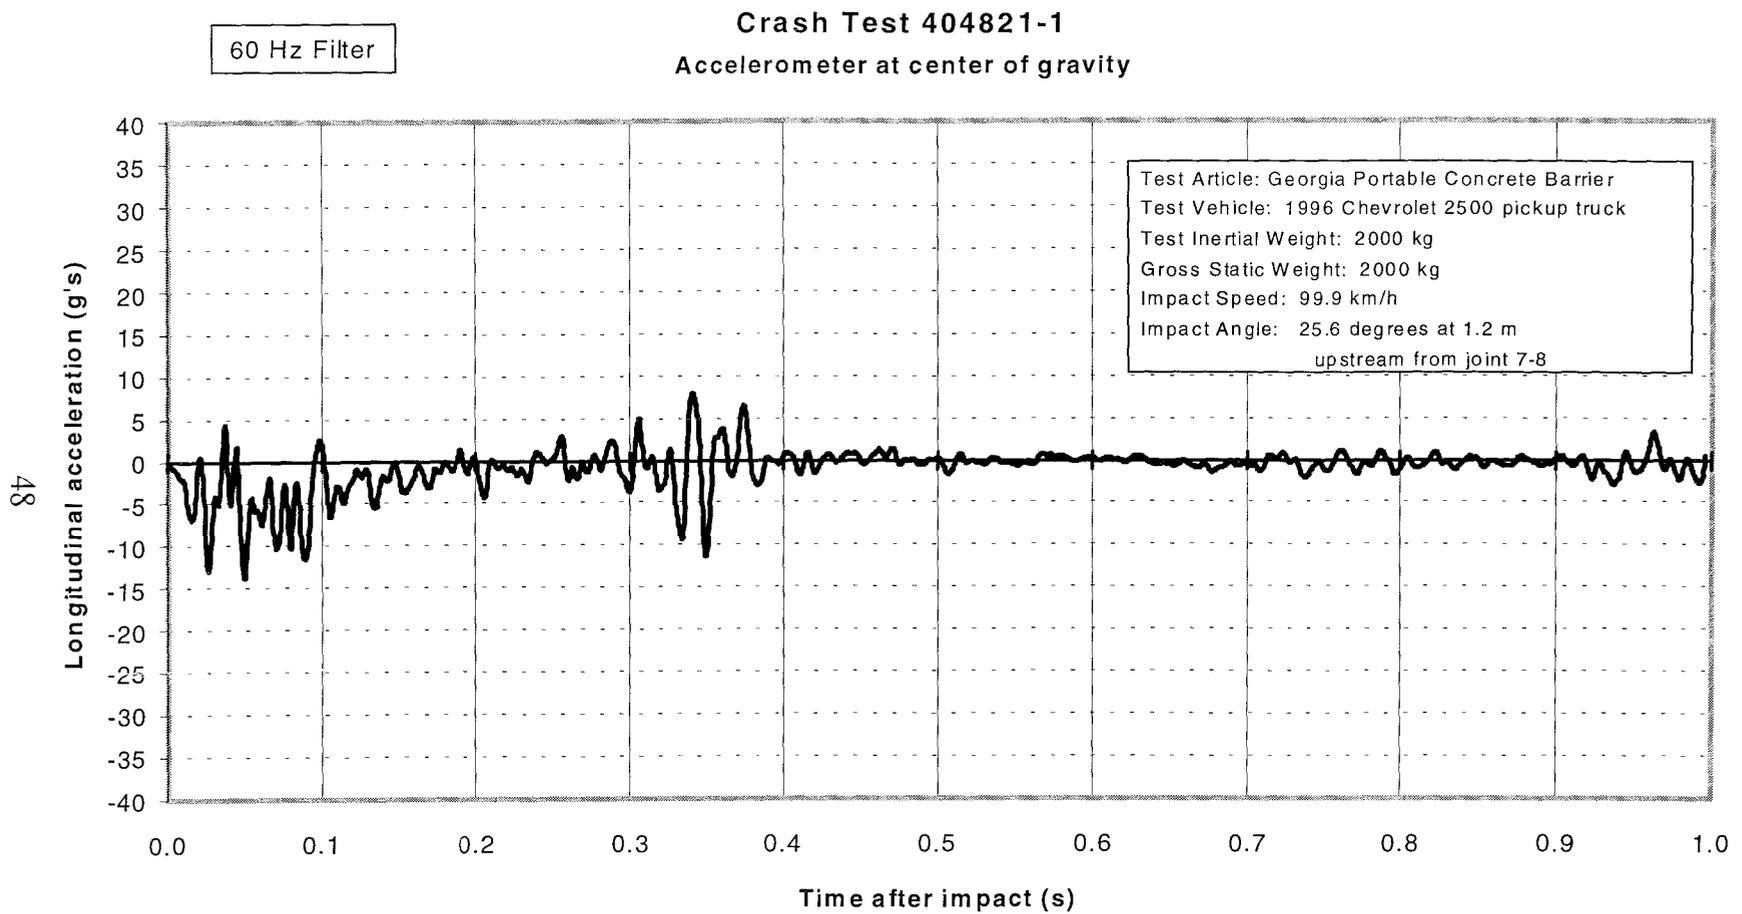
Figure 26. Vehicle longitudinal accelerometer trace for test 404821-1 (accelerometer located at center of gravity).
