**NCHRP REPORT 350 TEST 3-11 OF
GEORGIA TEMPORARY CONCRETE BARRIERS**

Contract No. T98170
Project No. 404821

Sponsored by
Georgia Department of Transportation

February 2000

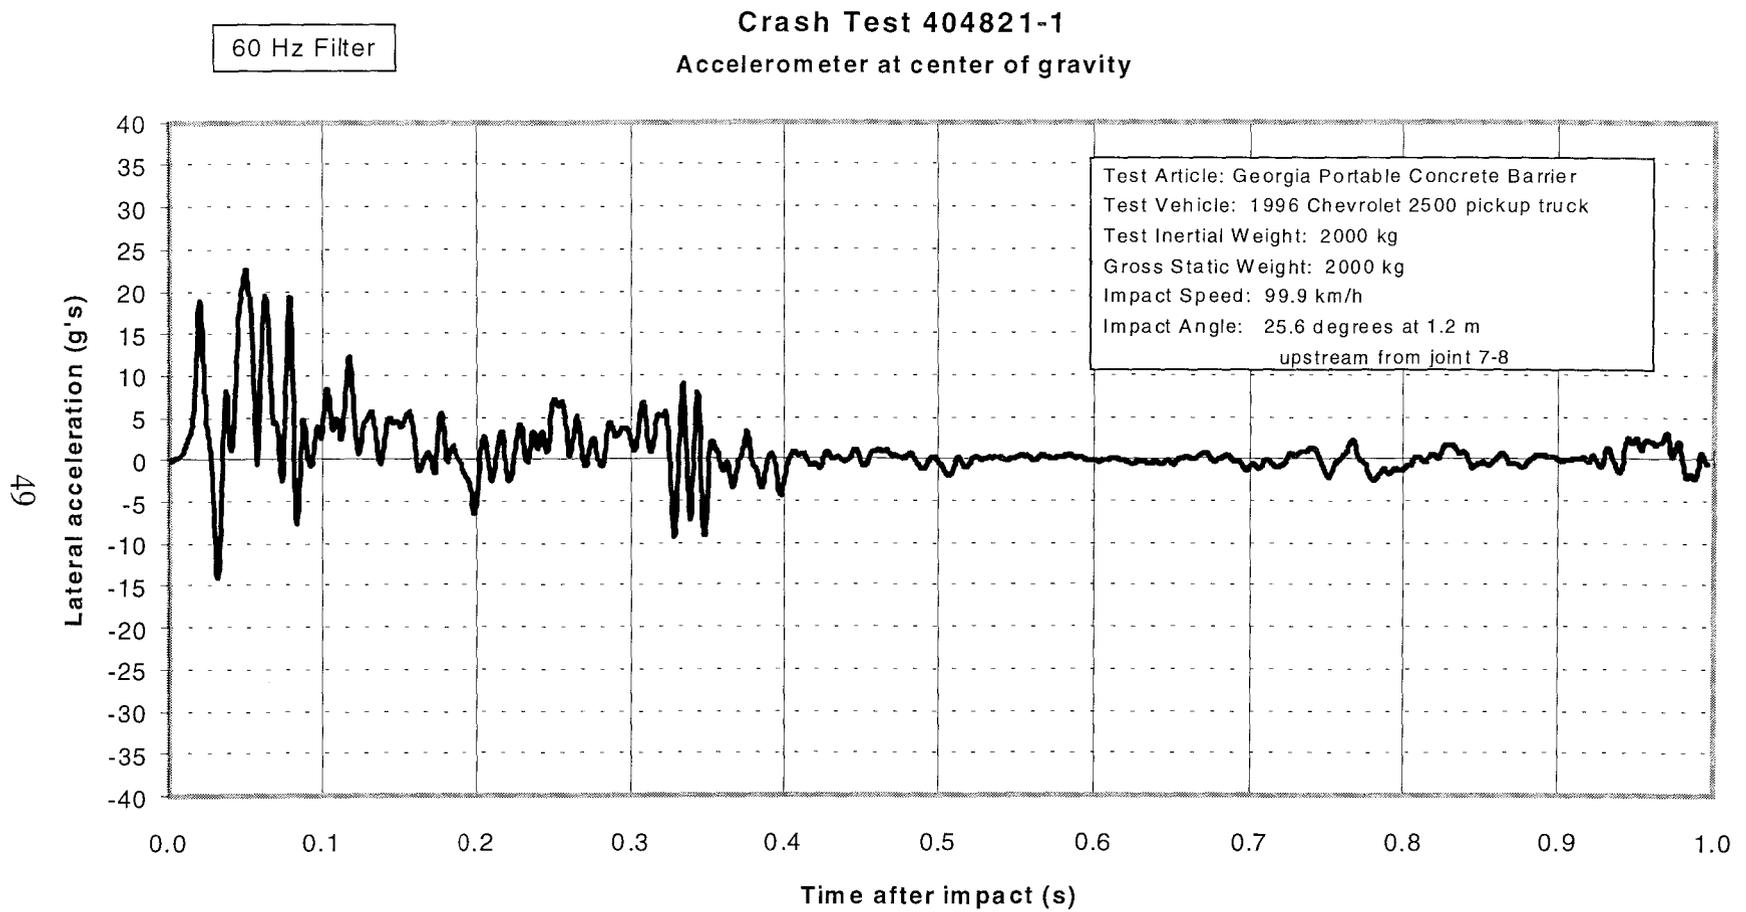
Figure 27. Vehicle lateral accelerometer trace for test 404821-1 (accelerometer located at center of gravity).

Data from the tri-axial accelerometer, located at the vehicle center of gravity, were digitized to compute occupant impact velocity and ridedown accelerations. The occupant impact velocity and ridedown accelerations in the longitudinal axis only are required from these data for evaluation of criterion L of *NCHRP Report 350*. In the longitudinal direction, occupant impact velocity was 6.5 m/s at 0.172 s, maximum 0.010-s ridedown acceleration was -5.9 g's from 0.328 to 0.338 s, and the maximum 0.050-s average was -6.8 g's between 0.047 and 0.097 s. In the lateral direction, the occupant impact velocity was 5.9 m/s at 0.110 s, the highest 0.010-s occupant ridedown acceleration was 7.4 g's from 0.113 to 0.123 s, and the maximum 0.050-s average was 9.1 g's between 0.036 and 0.086 s. These data and other information pertinent to the test are presented in figure 13. Vehicle angular displacements and accelerations versus time traces are shown in appendix E, figures 25 through 28.

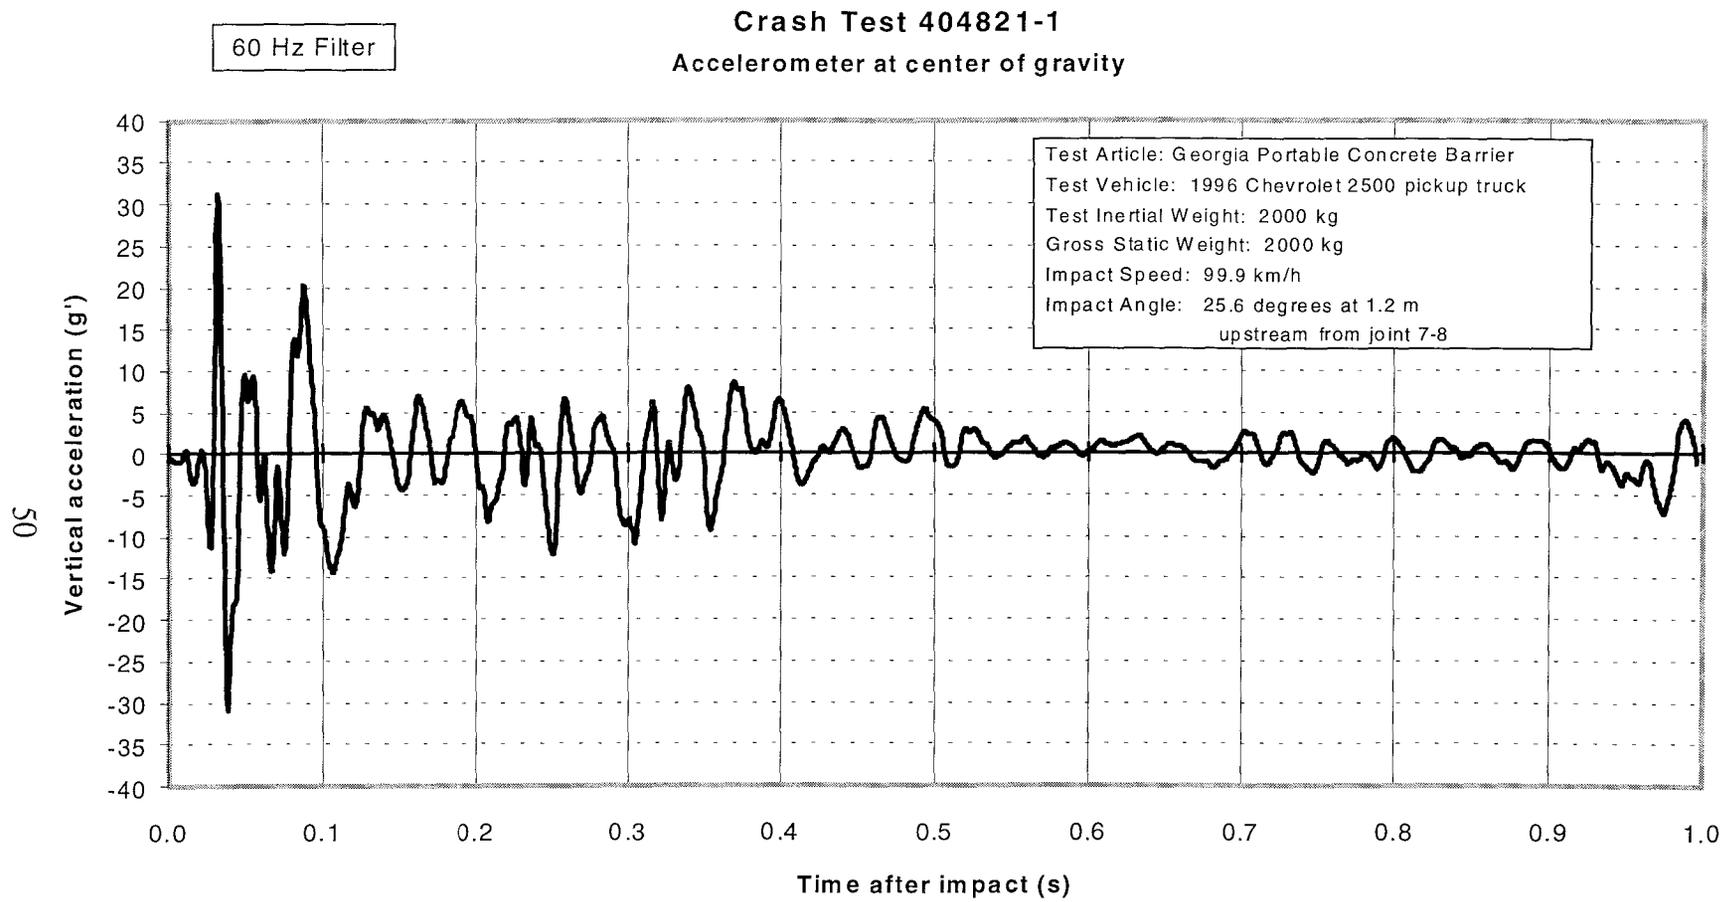
Figure 28. Vehicle vertical accelerometer trace for test 404821-1 (accelerometer located at center of gravity).
