**NCHRP REPORT 350 TEST 3-11 OF THE
NEW YORK DOT PORTABLE CONCRETE BARRIER
WITH I-BEAM CONNECTION (RETEST)**

Contract No. DTFH61-97-C-00064
Project No. 473220-14

July 2001

**TEXAS TRANSPORTATION INSTITUTE
THE TEXAS A & M UNIVERSITY SYSTEM
COLLEGE STATION, TEXAS 77843**

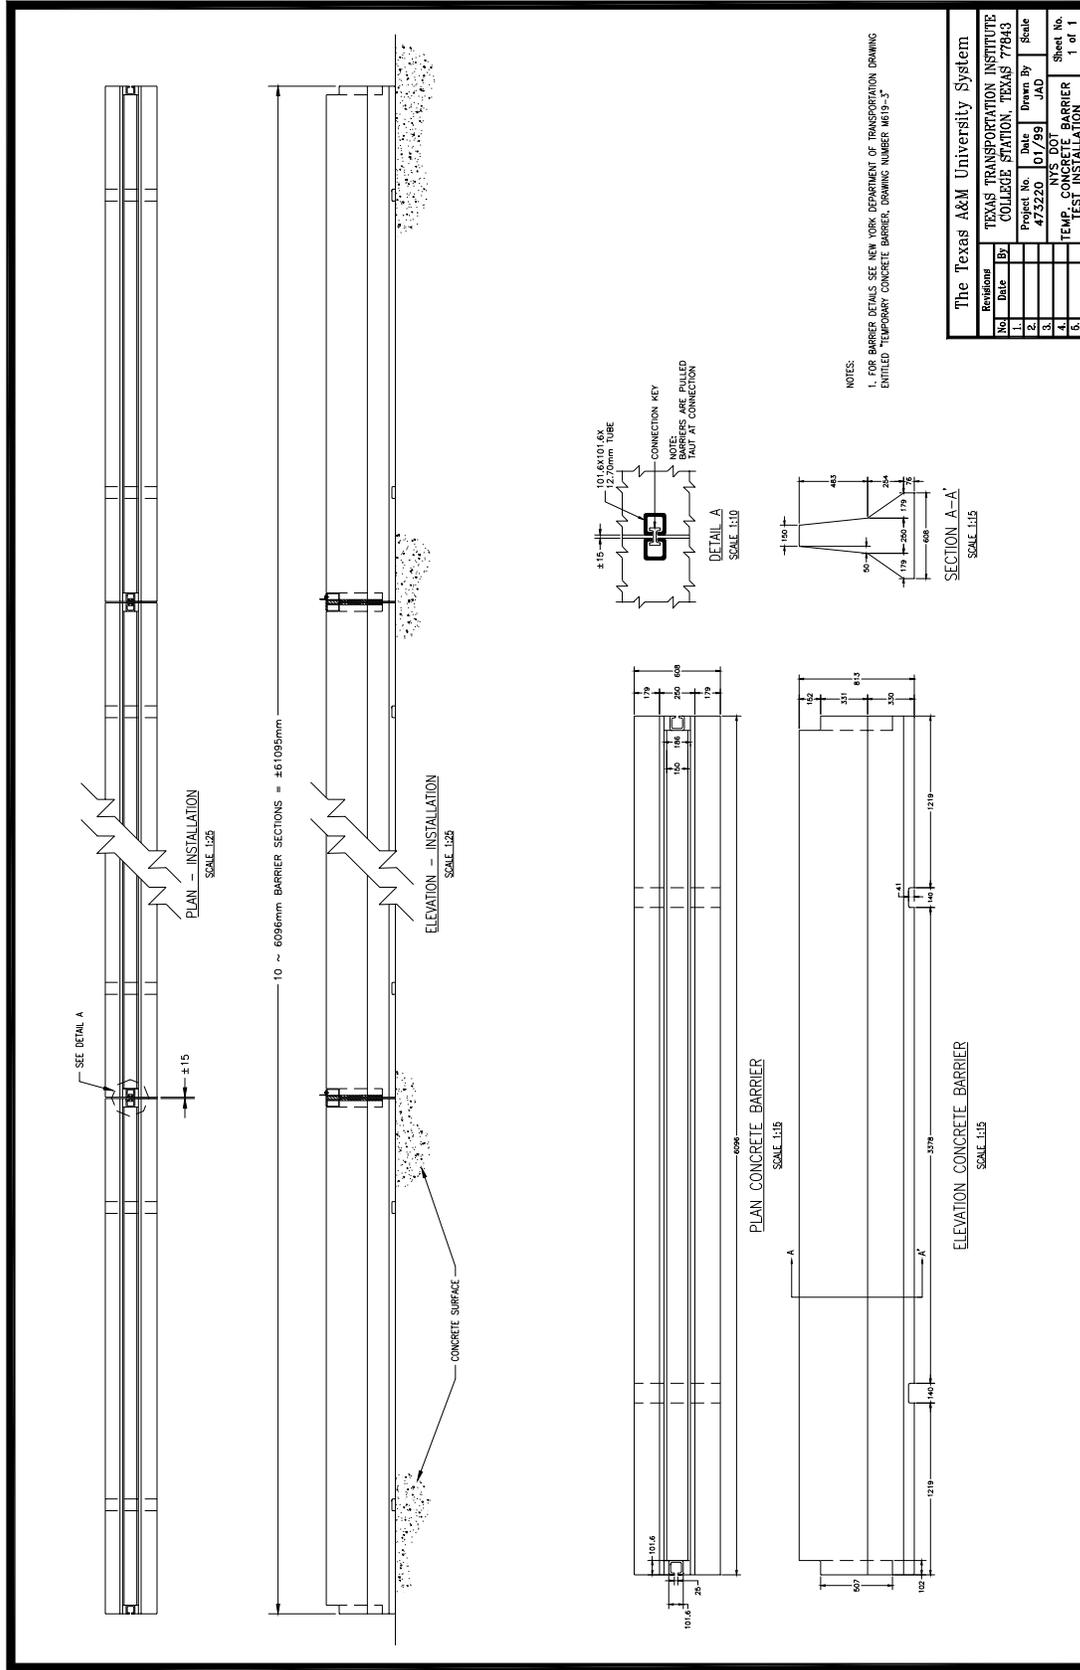
Figure 2. Layout and connection of NYDOT PCB installation prior to testing.

The test installation consisted of ten barrier sections connected together using the steel connection keys for a total test installation length of approximately 61.0 m. The barrier sections were placed on an existing concrete runway located at the TTI test facility. At the request of the Federal Highway Administration, all longitudinal slack was removed from the joints as the barrier segments were placed. The layout of the test installation is shown in figure 2. Photographs of the completed test installation are shown in figures 3 and 4.

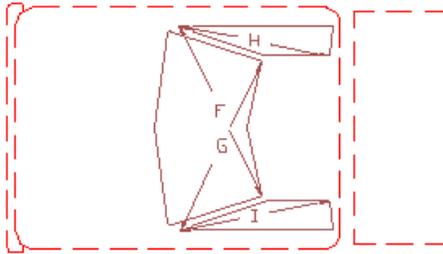
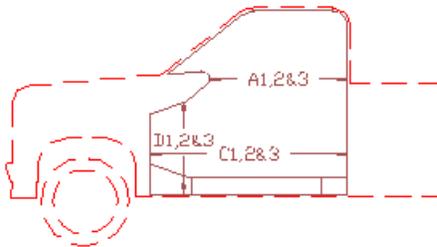
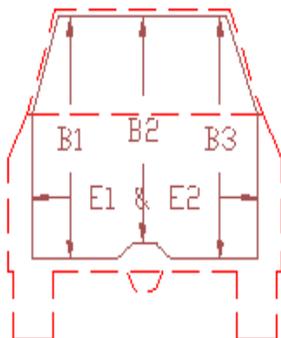
Occupant Compartment Deformation

Results: No detached elements, fragments, or other debris was present to penetrate, or to show potential for penetrating the occupant compartment, or to present a hazard to others in the area. Maximum occupant compartment deformation was only 60 mm in the center floor pan area. *(pass)*

BEFORE	AFTER
A1	866	842
A2	873	862
A3	907	907
B1	1082	1082
B2	1095	1035
B3	1066	1066
C1	1370	1338
C2	1248	1242
C3	1372	1372
D1	320	318
D2	162	140
D3	307	307
E1	1586	1603
E2	1592	1602
F	1460	1460
G	1460	1460
H	1000	1000
I	1000	1000
J	1522	1512
