**NCHRP REPORT 350 EVALUATION OF THE
T501 BRIDGE RAIL WITH SOUNDWALL**

Report No. 408460-F
Project No. 120-xxA1004

Sponsored by
Texas Department of Transportation

January 2001

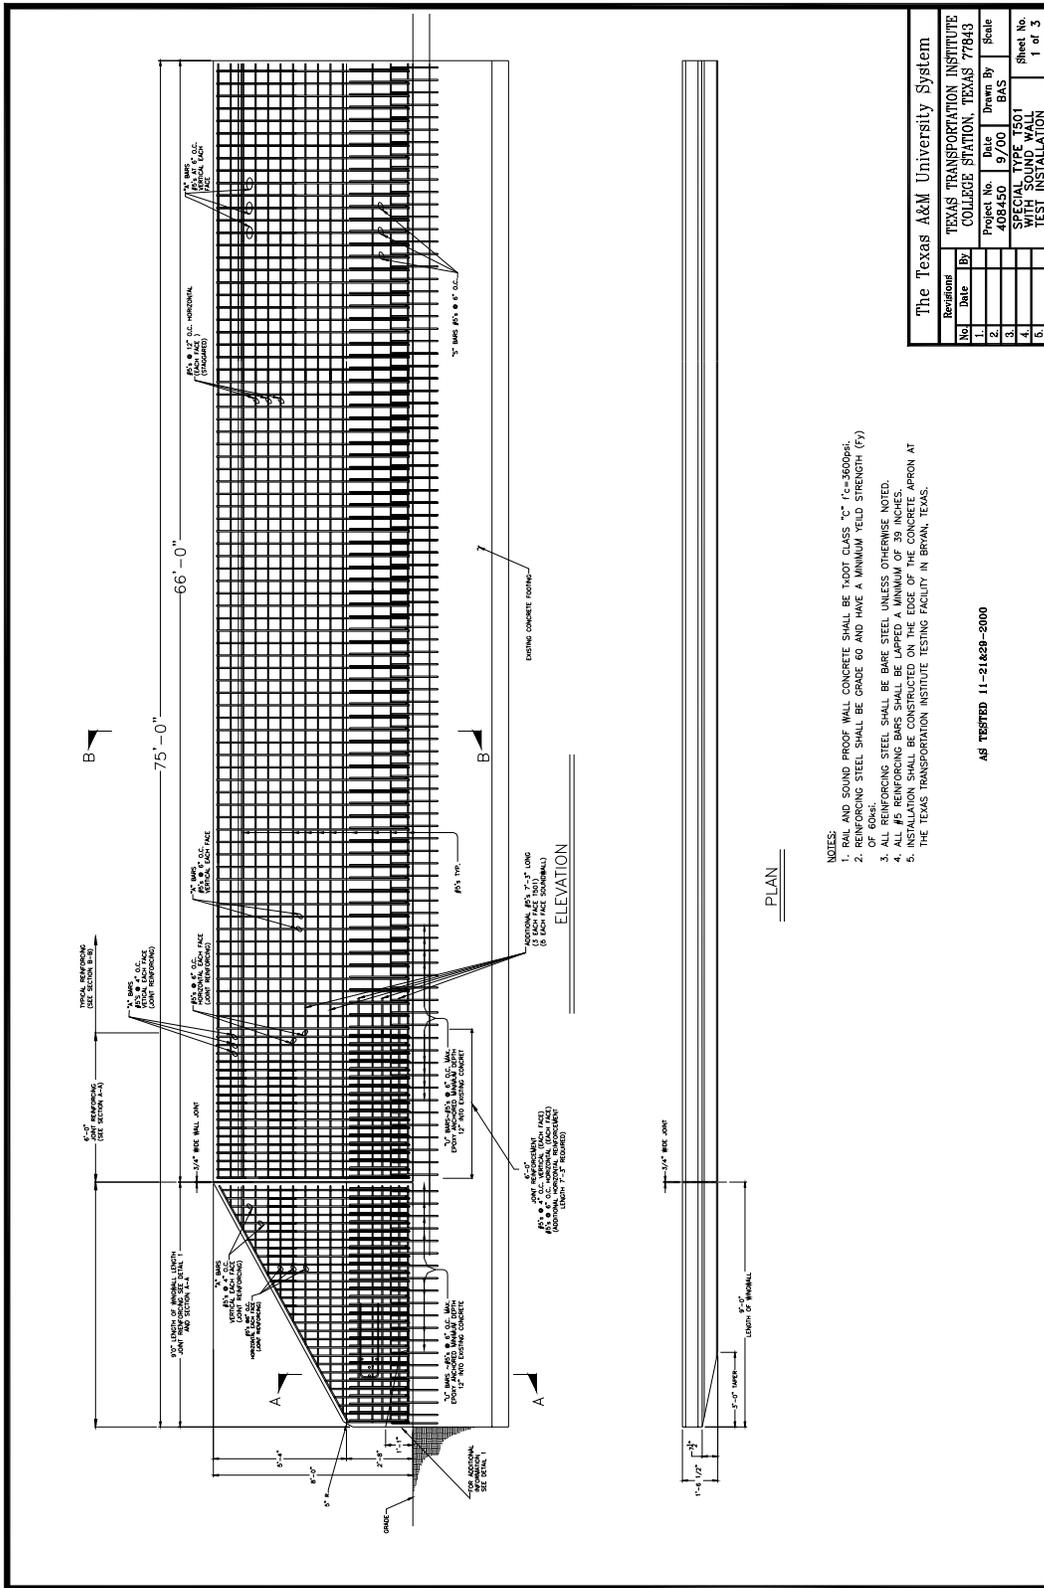
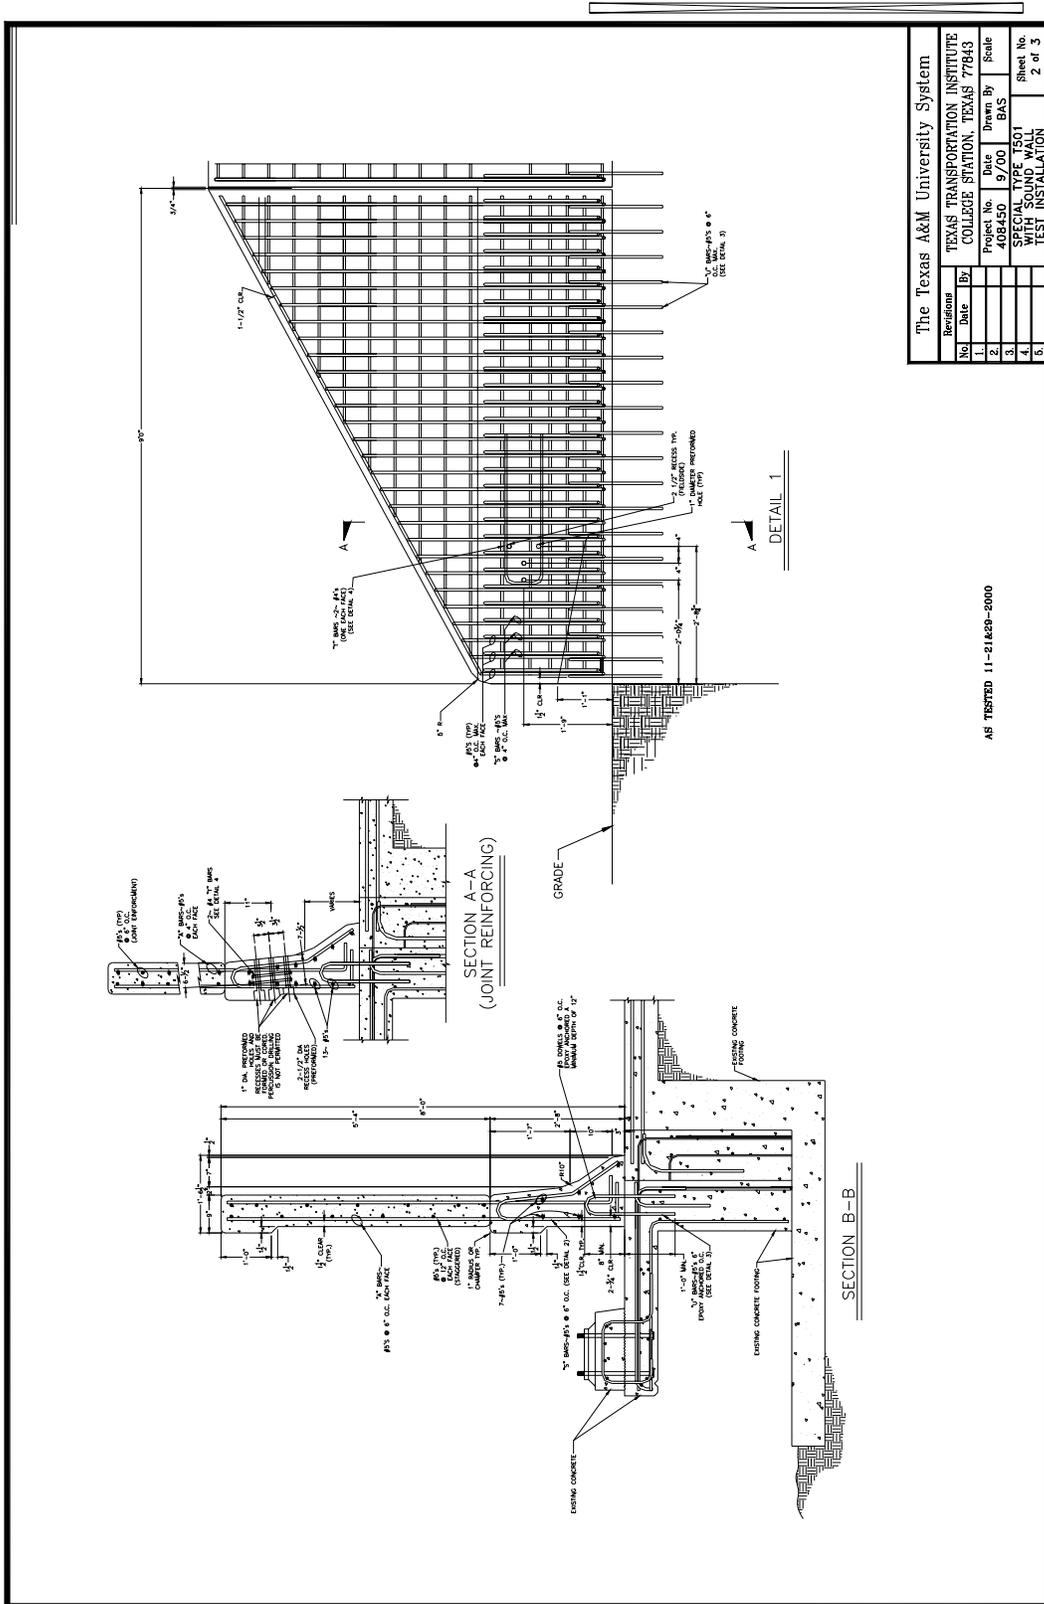
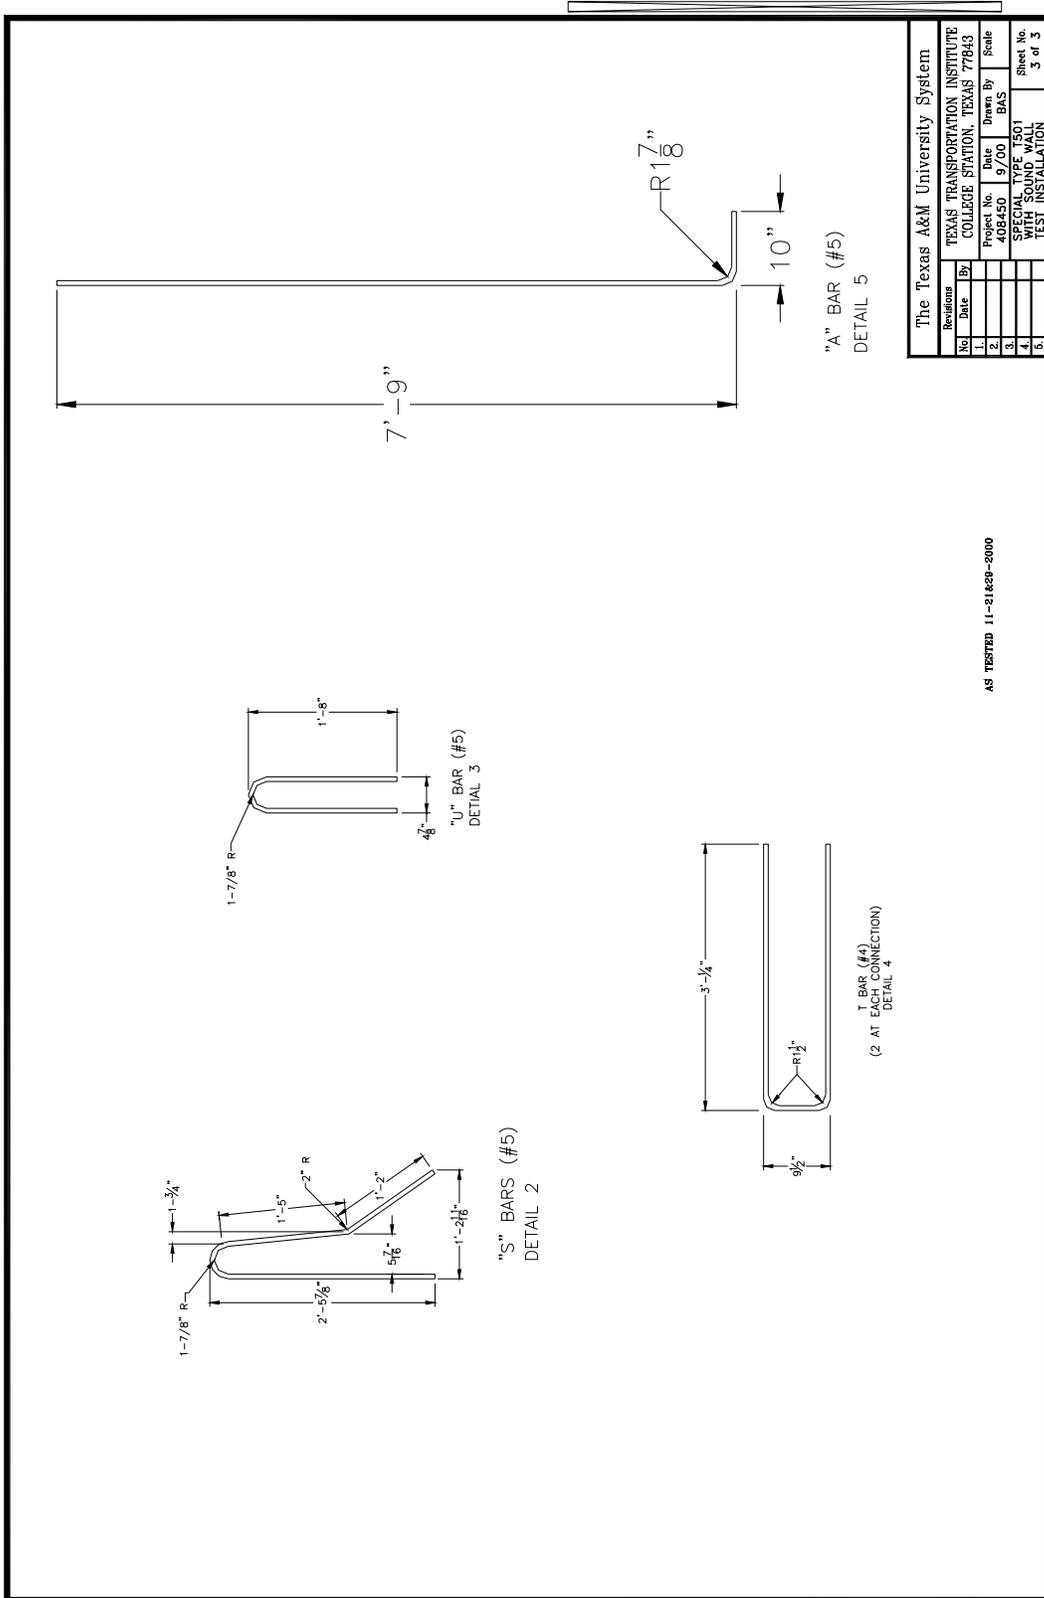
Figure 1. Details of the T501 Bridge Rail with Soundwall.

For this project, 66 ft (20.1 m) of T501 bridge rail with 5 ft-4 in (1.6 m) of cast-in-place concrete soundwall was constructed. The total height of the barrier was 8.0 ft (2.4 m). In addition, an additional 9.0 ft (2.7 m) of wall that tapered to the standard T501 height of 32 in. (813 mm) was constructed. A construction joint approximately $\frac{3}{4}$ in. (19 mm) wide was located between the standard 8-ft (2.4 m) tall section and the point of taper. The total length of the installation was 75 ft (22.9 m). For design and ease of construction, the width of the soundwall was $7\frac{1}{2}$ in. (190 mm) with two layers of reinforcing steel. The standard T501 bridge rail was modified by increasing the overall width of the section by $1\frac{1}{2}$ in. (38 mm) to support the $7\frac{1}{2}$ in. (190 mm) wide soundwall. The total base width of the T501 section was 1 ft- $6\frac{1}{2}$ in. (0.47 m).

The soundwall was anchored to an existing concrete footing at the TTI Proving Ground using #5 “U” shaped bars located approximately 6 in. (152 mm) apart. These bars were epoxy anchored into an existing footing.

Researchers at TTI performed engineering calculations on the 8.0 ft (2.4 m) barrier in accordance with the latest 1998 American Association of State Highway Transportation Officials (AASHTO) LRFD Bridge Design Specifications. These calculations and drawings were submitted to TxDOT for review on August 17, 2000. The details as shown on the drawings provided in this report were approved by TxDOT for construction on September 15, 2000. Additional details are provided on the drawings shown as Figure 1. Photographs of the installations as tested are shown in Figures 2 and 3.

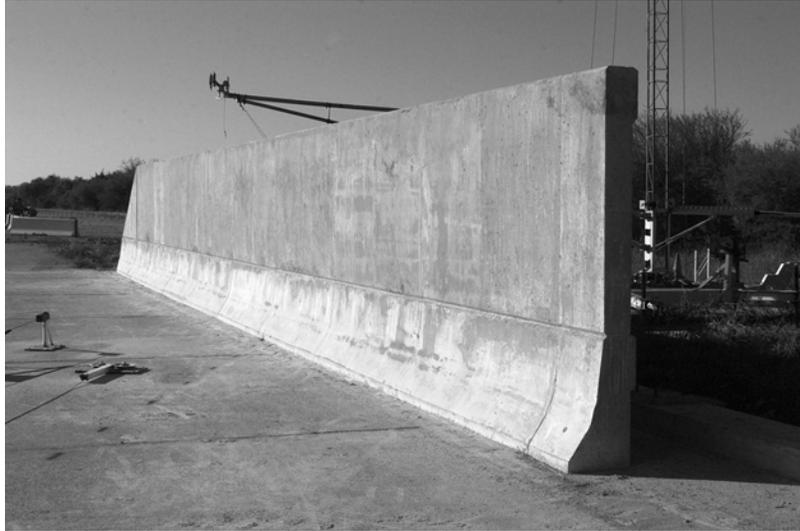
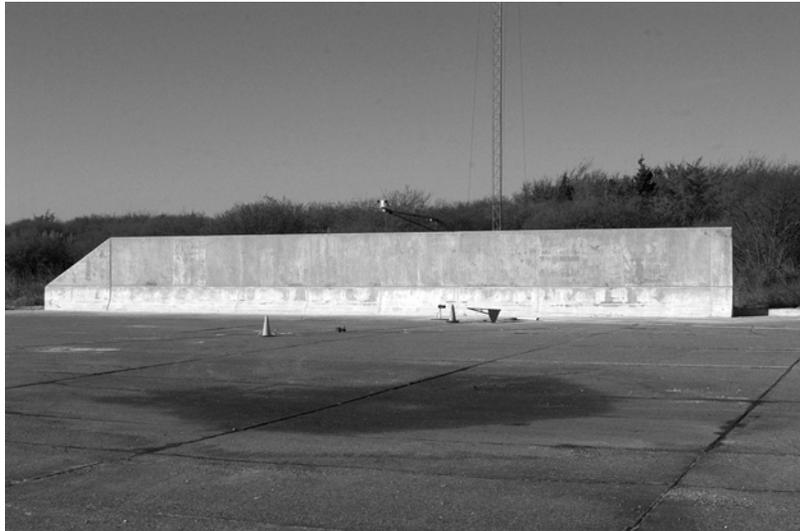
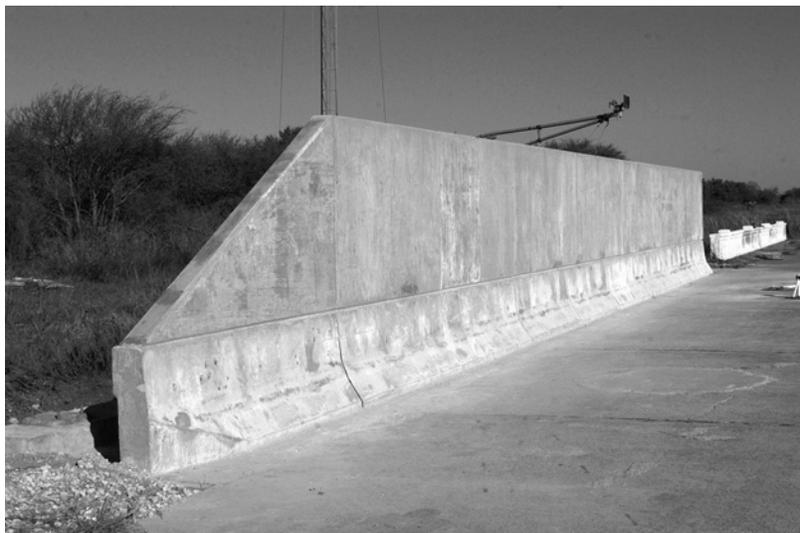
Figure 2. T501 Bridge Rail with Soundwall before Test 408460-1.

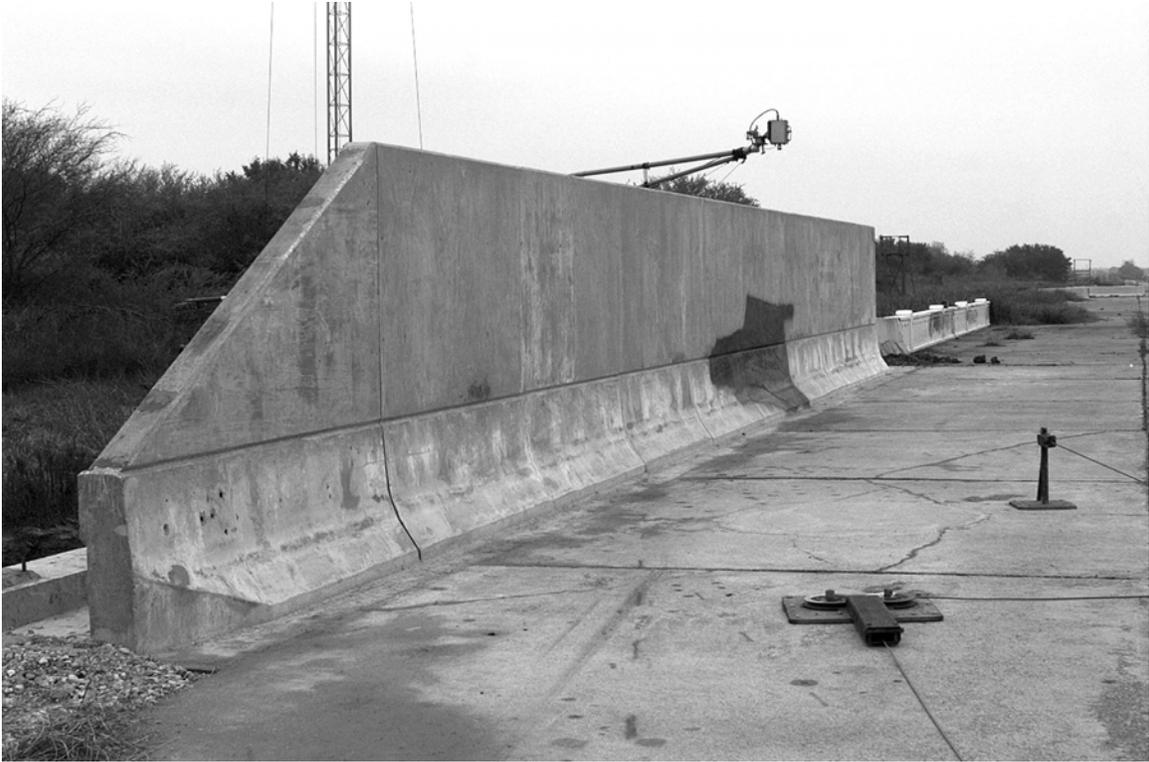
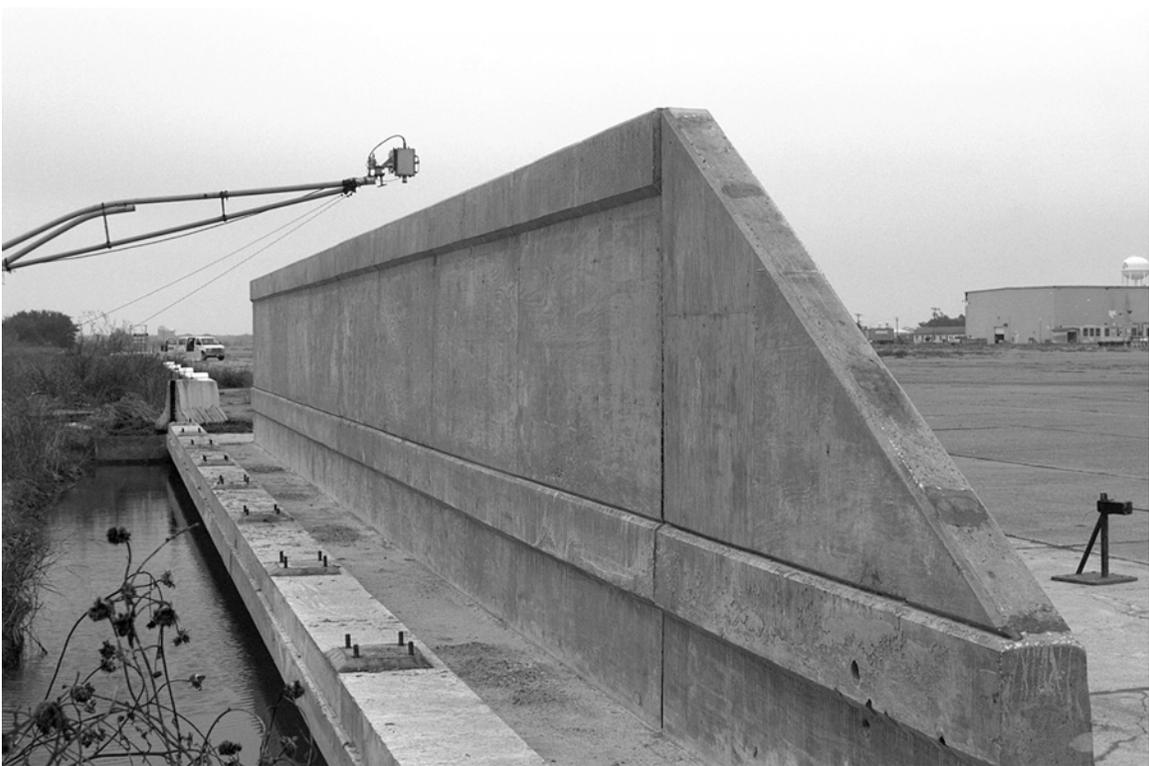
Figure 3. T501 Bridge Rail with Soundwall before Test 408460-2.

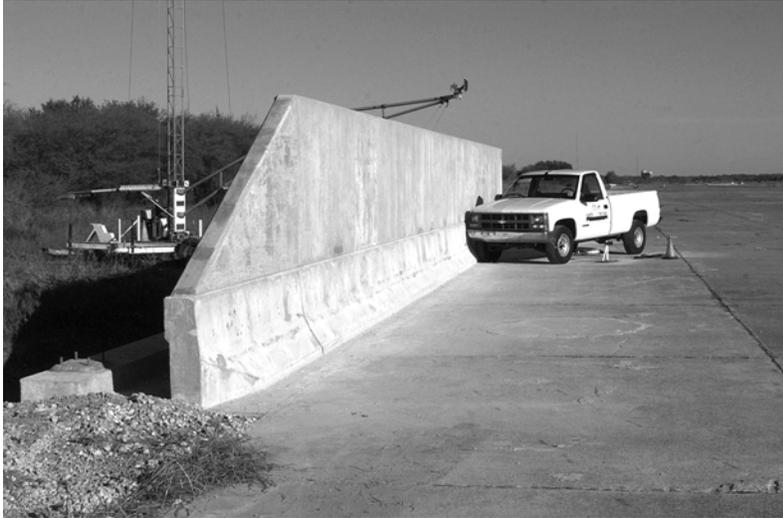
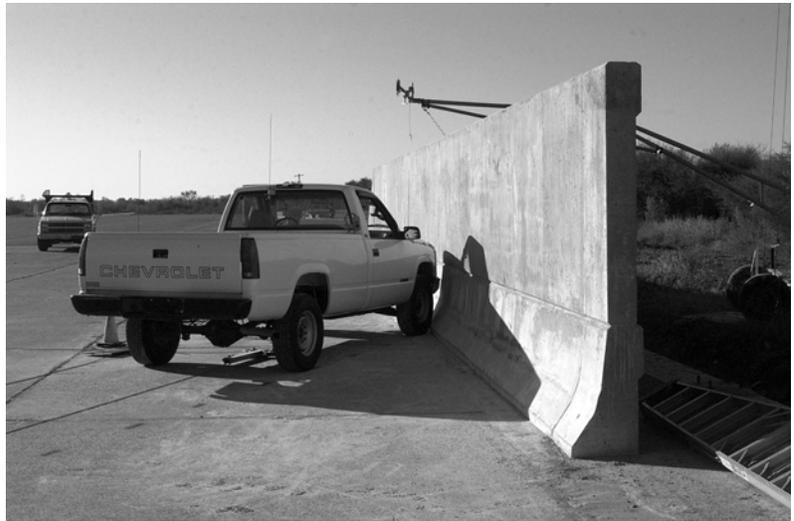
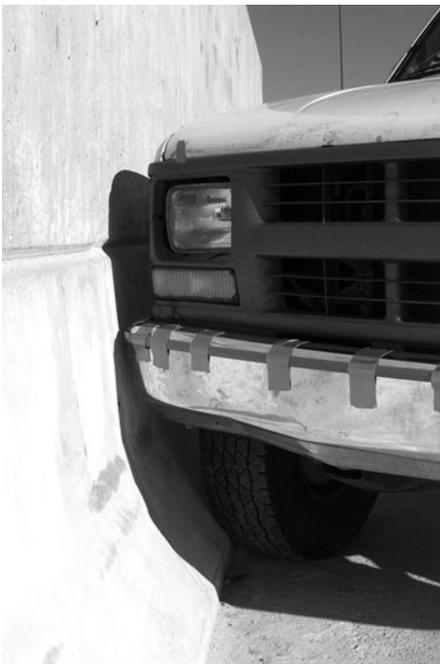
Figure 4. Vehicle/Installation Geometrics for Test 408460-1.

A 1996 Chevrolet 2500 pickup, shown in Figures 4 and 5, was used for the crash test. Test inertia weight of the vehicle was 4,405 lb (2000 kg), and its gross static weight was 4,405 lb (2000 kg). The height to the lower edge of the vehicle bumper was 17.5 in. (445 mm), and it was 26.2 in. (665 mm) to the upper edge of the bumper. Additional dimensions and information on the vehicle are given in Appendix B, Figure 18. The vehicle was directed into the installation using the cable reverse tow and guidance system, and was released to be free-wheeling and unrestrained just prior to impact.

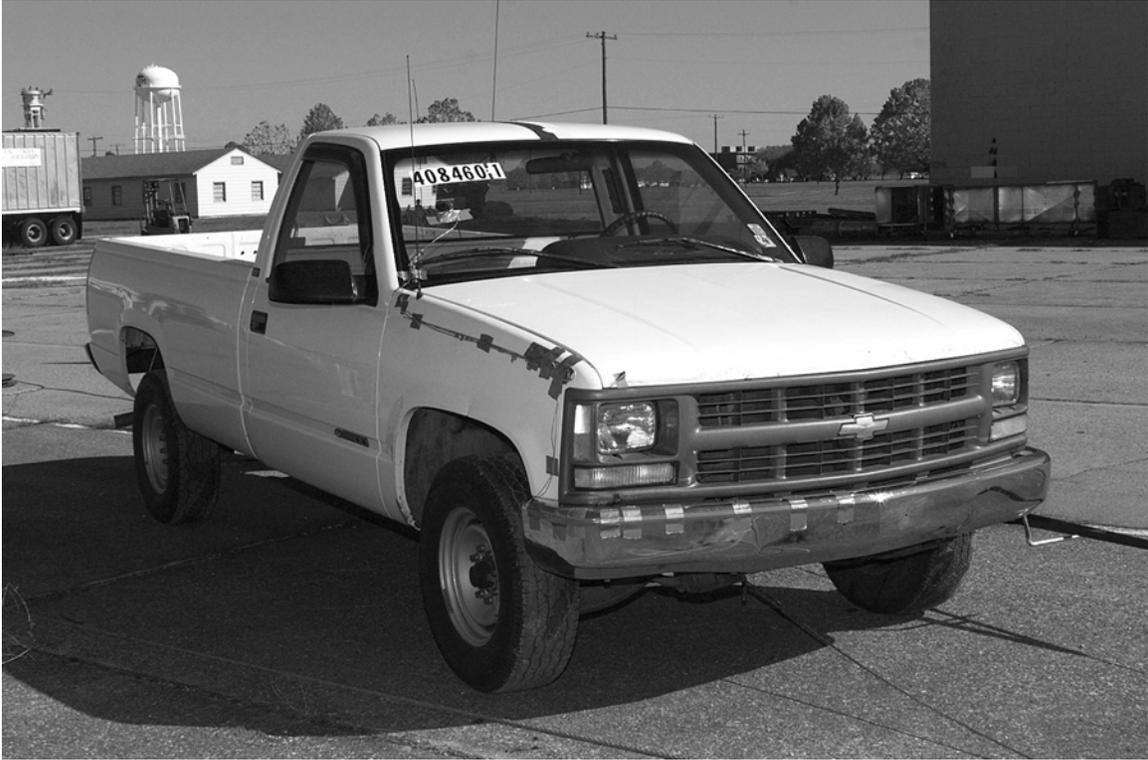
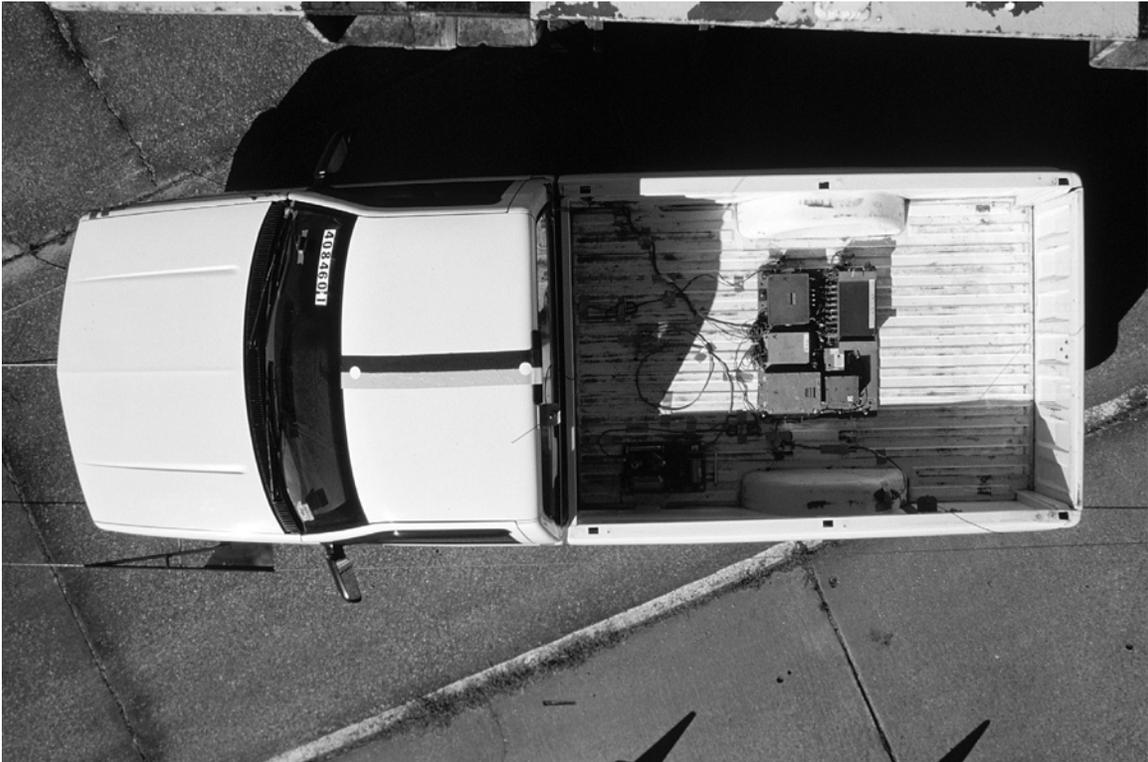
Figure 5. Vehicle before Test 408460-1.

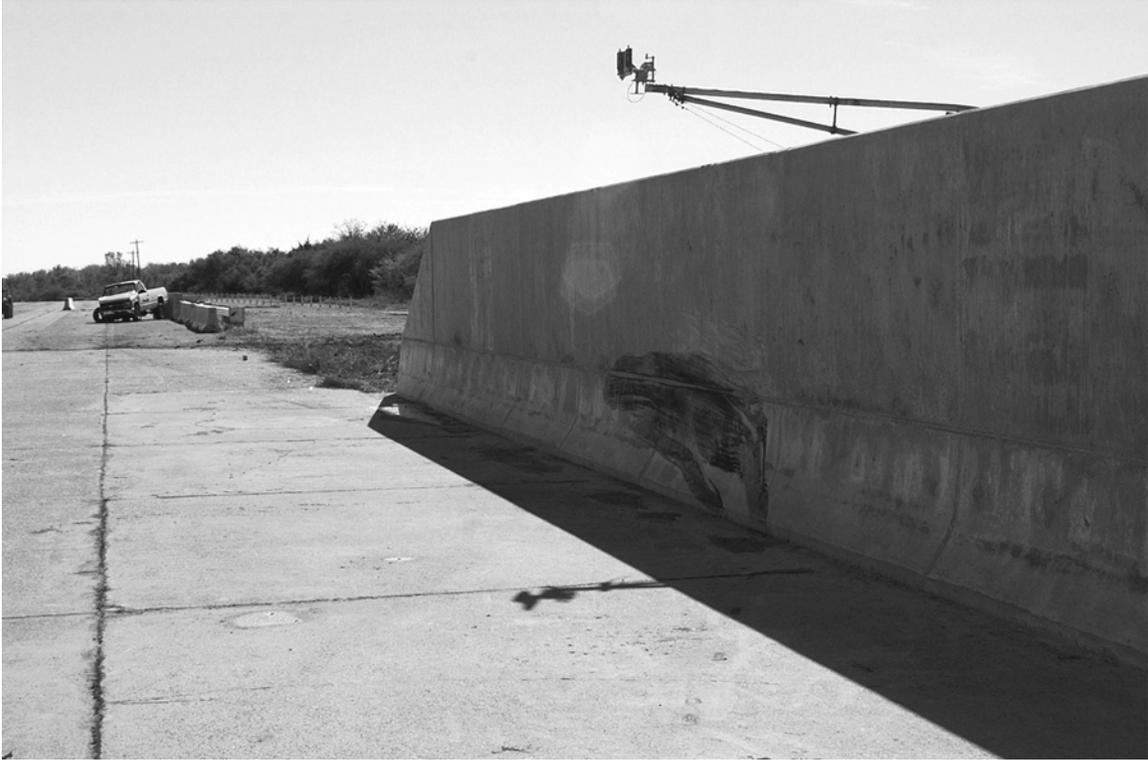
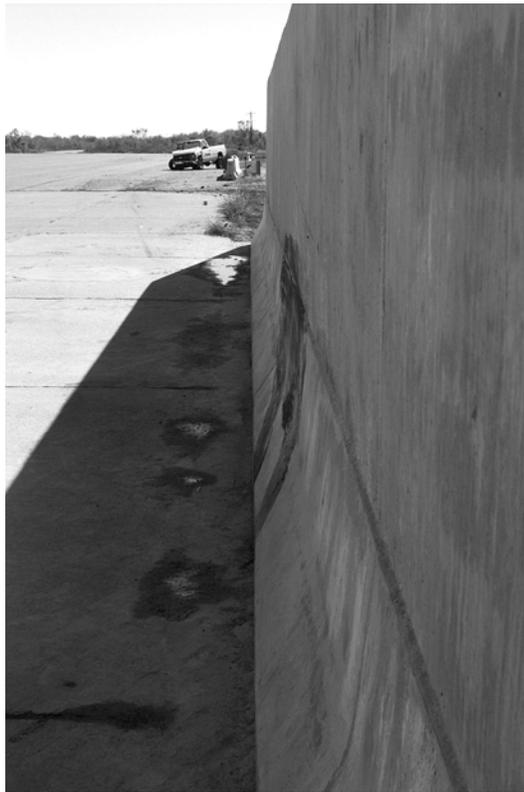
Figure 6. After Impact Trajectory for Test 408460-1.

The T501 bridge rail with soundwall sustained only cosmetic damage as shown in Figures 6 and 7. Tire marks on the face of the bridge rail started at 26.2 ft (8.0 m) from the end and extended 15.2 ft (4.6 m) downstream of impact.

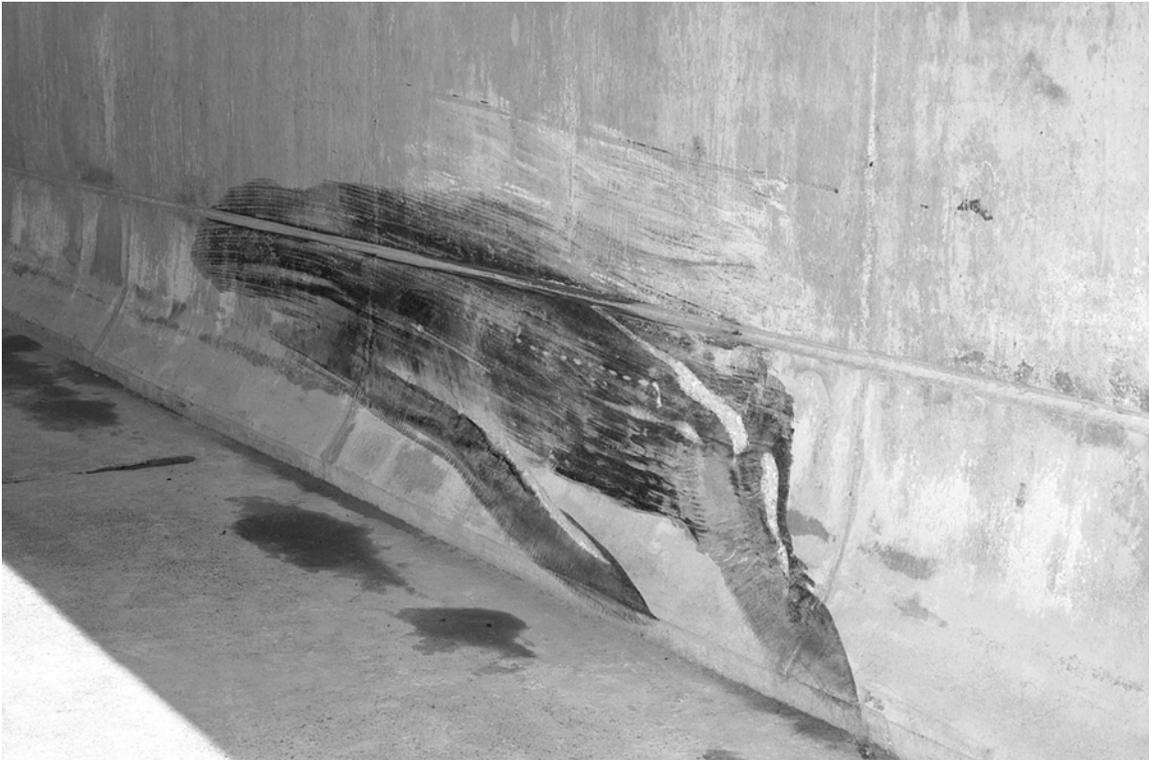
Figure 7. Installation after Test 408460-1.

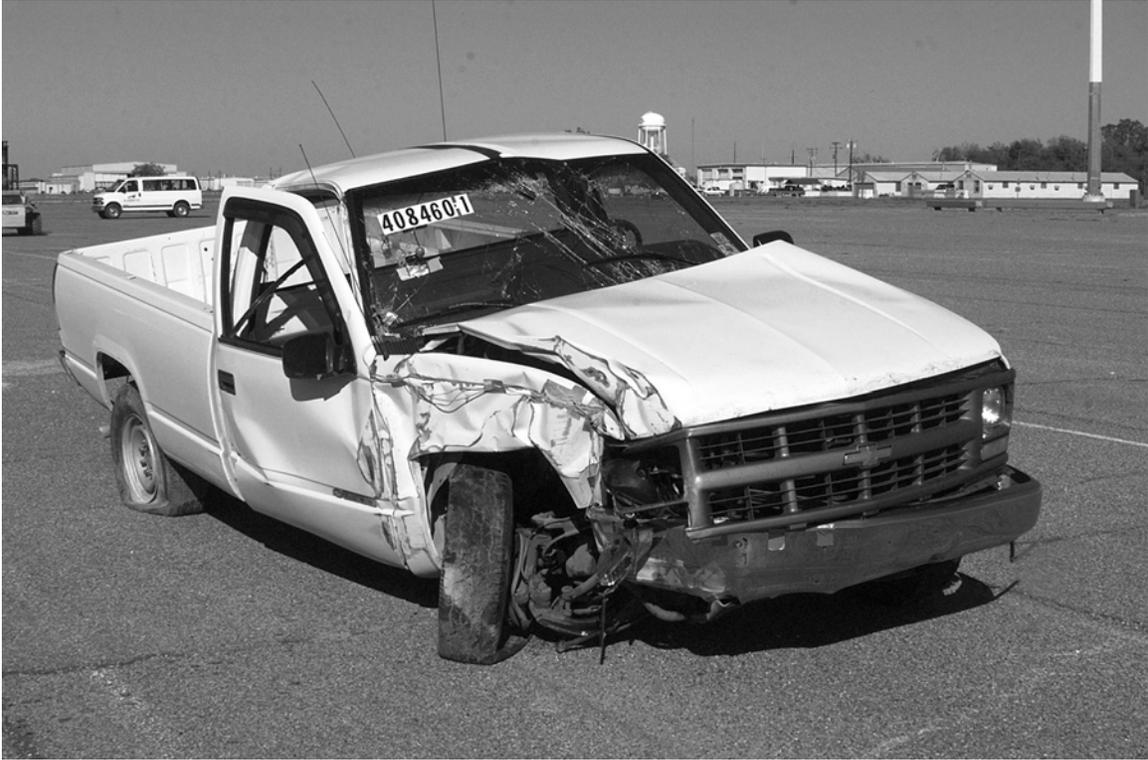
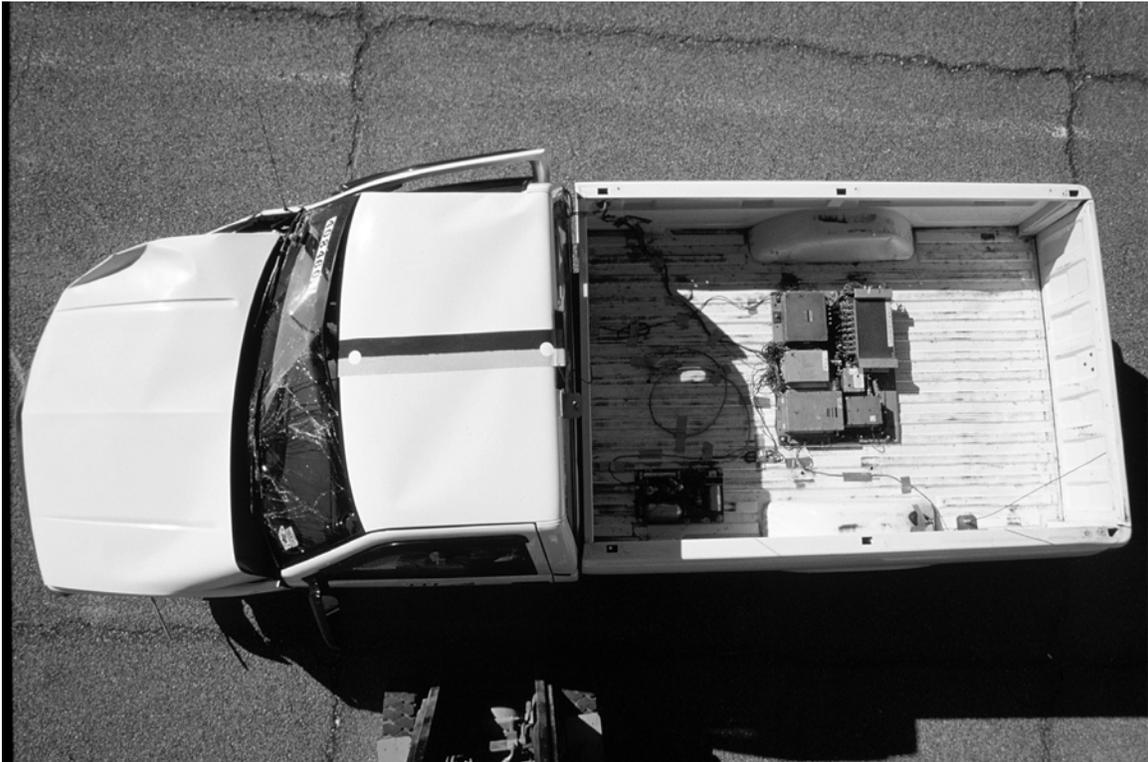
Figure 8. Vehicle after Test 408460-1.

The vehicle sustained structural damage to the right side, including the right lower A-arm, right outer tie rod end, and right side frame rail. As can be seen in Figure 8, the hood, front bumper, right front quarter panel, right front tire and rim, right door, right rear of the bed, and the right rear tire and rim were also damaged. The windshield was cracked, the right A-pillar was deformed, the right door glass was shattered, and the roof was deformed. Maximum exterior crush to the vehicle was 18.1 in. (460 mm) on the right front corner at bumper height. Maximum occupant compartment deformation was 6.3 in. (160 mm) to the right side of the firewall; however, this deformation was not considered to be a probable cause of serious injury. Photographs of the interior of the vehicle are shown in Figure 9. Exterior vehicle crush and occupant compartment measurements are shown in Appendix B, Tables 3 and 4.

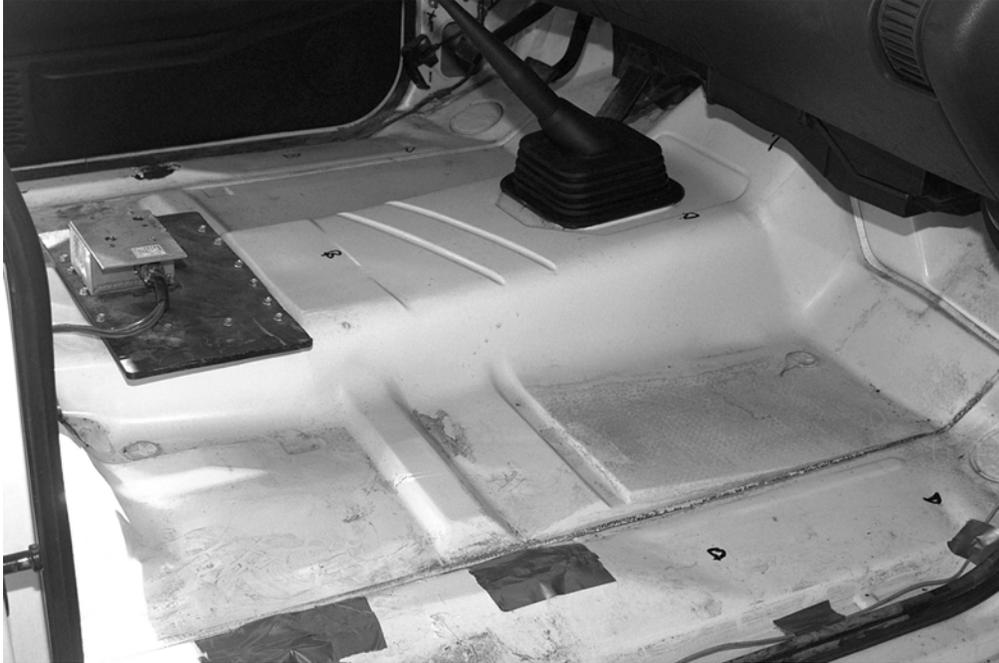
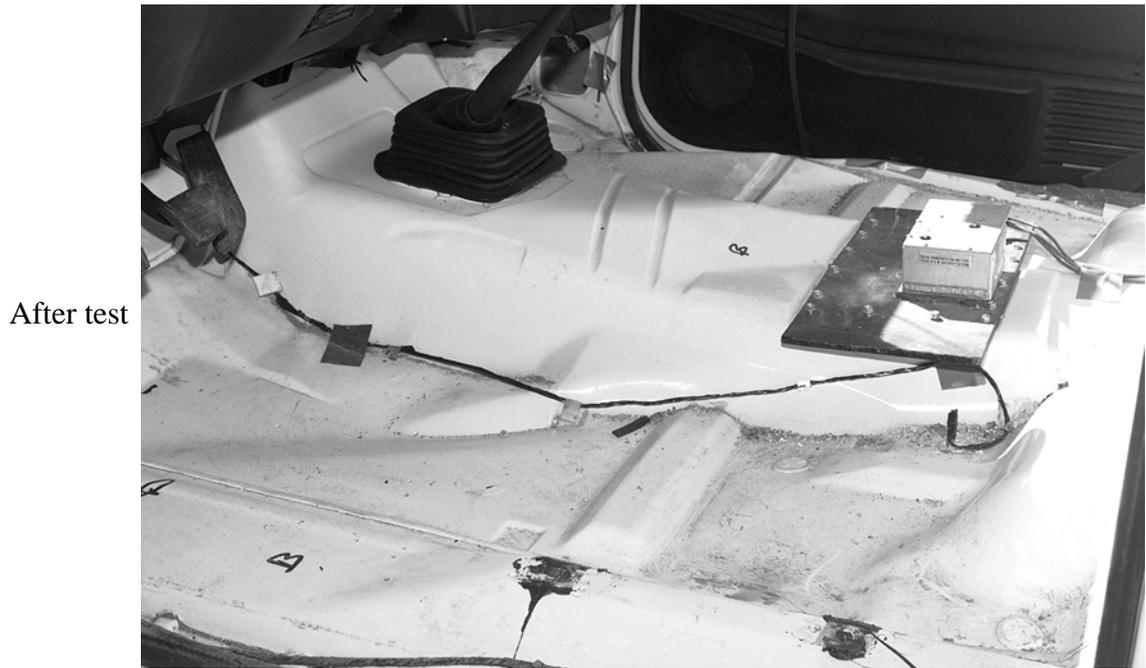
Before test

After test

Figure 9. Interior of Vehicle for Test 408460-1.

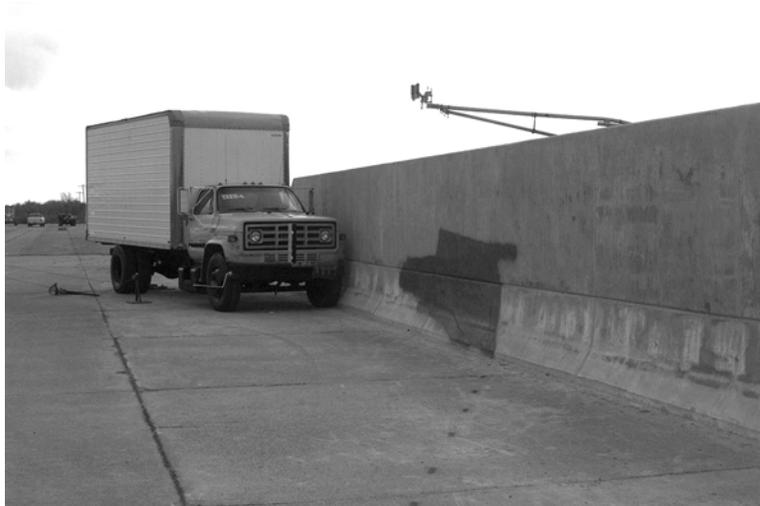
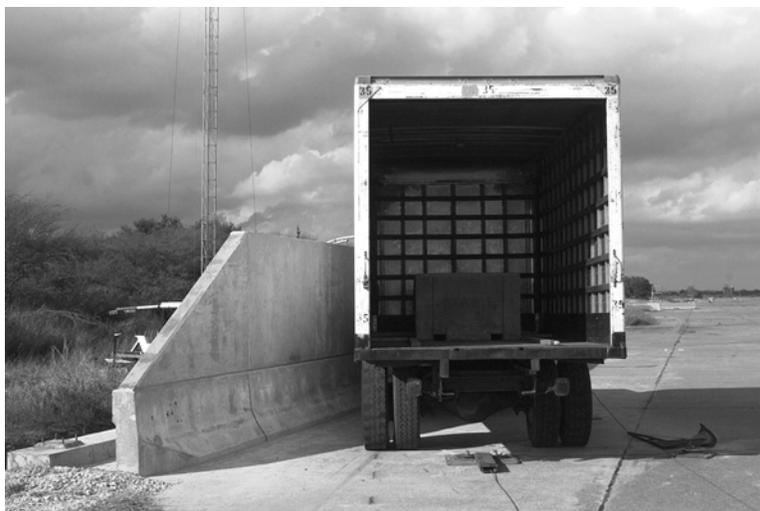
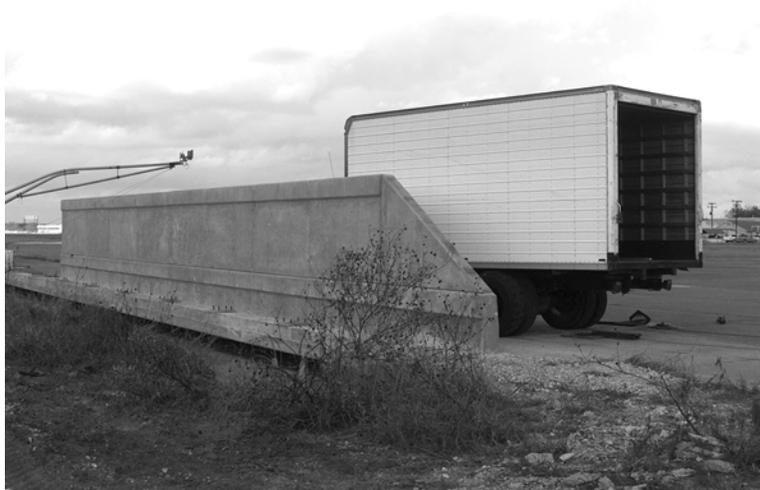
Figure 11. Vehicle/Installation Geometrics for Test 408460-2.

A 1988 GMC 7000 single-unit truck, shown in Figures 11 and 12, was used for the crash test. Test inertia weight of the vehicle was 17,621 lb (8000 kg), and its gross static weight was 17,621 lb (8000 kg). The height to the lower edge of the vehicle bumper was 22.0 in. (560 mm), and it was 33.9 in. (860 mm) to the upper edge of the bumper. Additional dimensions and information on the vehicle are given in Appendix B, Figure 19. The vehicle was directed into the installation using the cable reverse tow and guidance system, and was released to be free-wheeling and unrestrained just prior to impact.

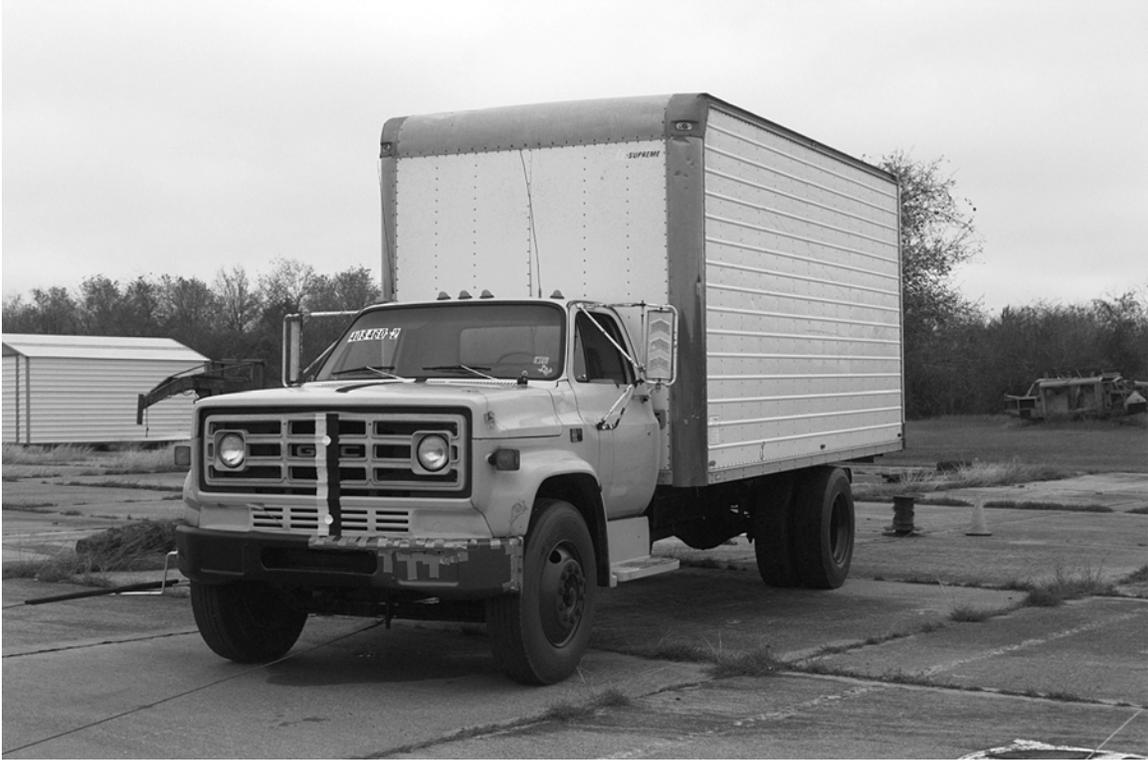
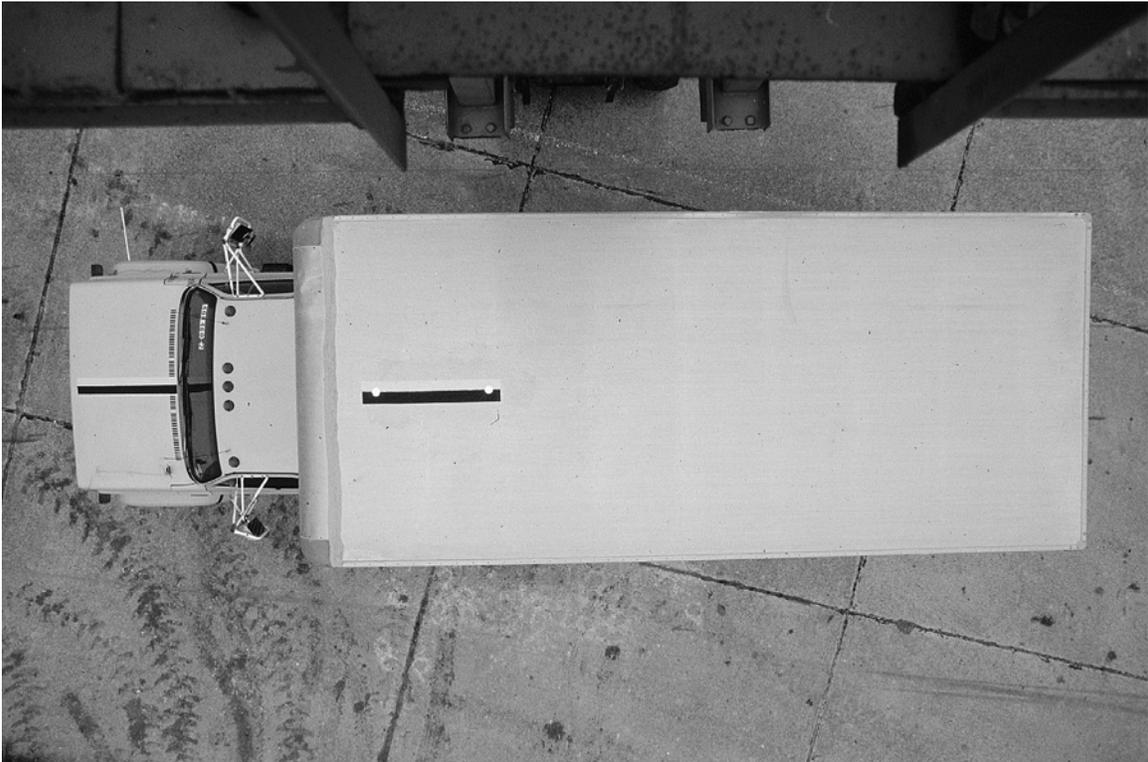
Figure 12. Vehicle before Test 408460-2.

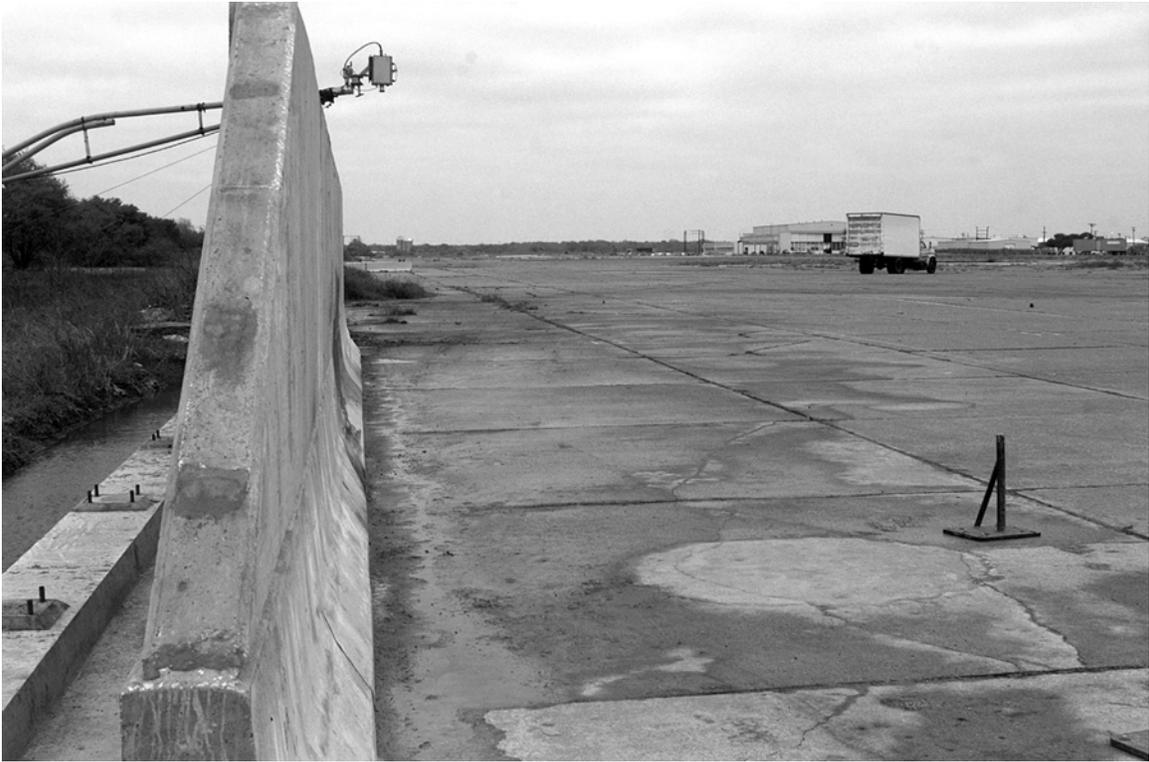
Figure 13. After Impact Trajectory for Test 408460-2.

Damage to the T501 bridge rail with soundwall was only cosmetic as shown in Figures 13 and 14. Tire marks were on the face of the bridge rail and scuff marks were on the face of the soundwall. Length of contact of the vehicle with the T501 bridge rail with soundwall began at 25.4 ft (7.75 m) from the end and extended 36.8 ft (11.23 m) downstream of impact.
