**NCHRP REPORT 350 EVALUATION OF THE
T501 BRIDGE RAIL WITH SOUNDWALL**

Report No. 408460-F
Project No. 120-xxA1004

Sponsored by
Texas Department of Transportation

January 2001

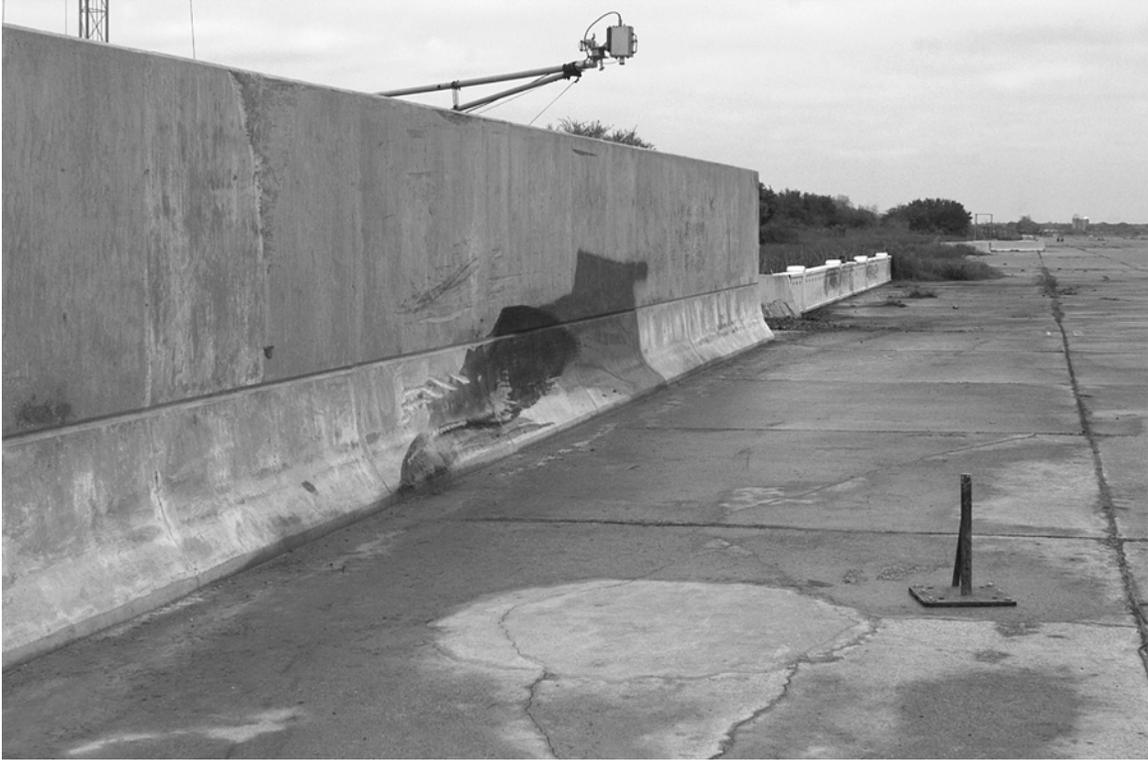
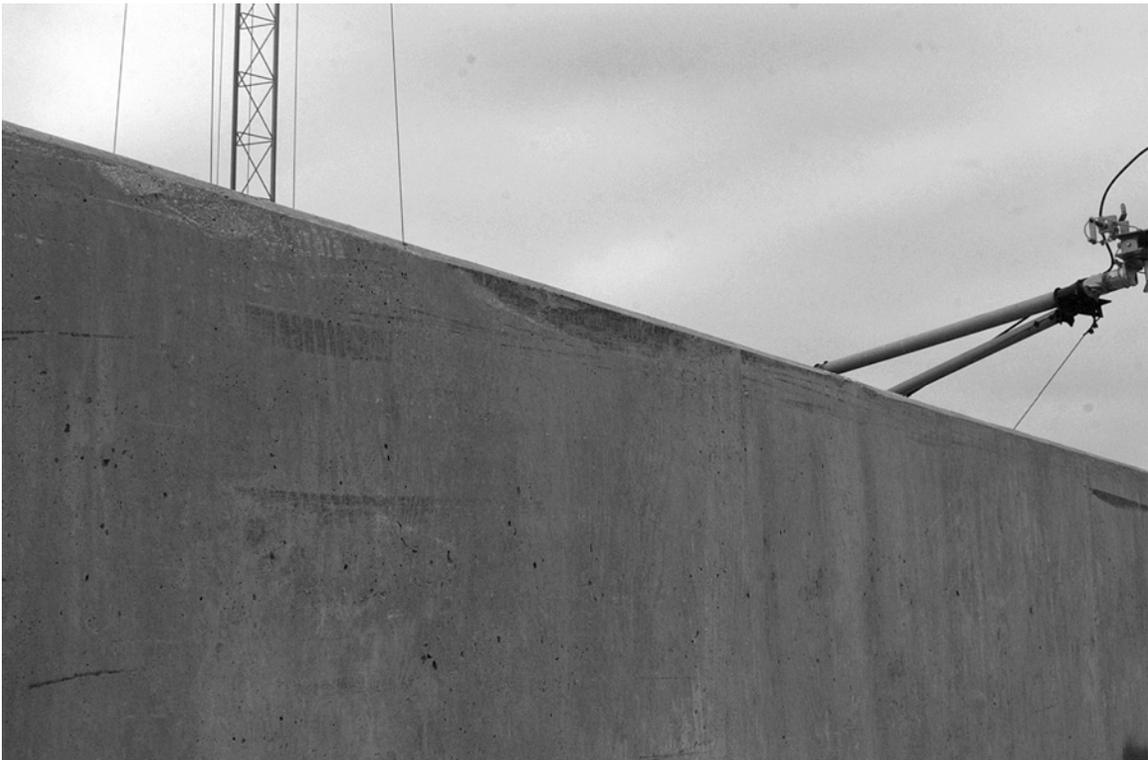
Figure 14. Installation after Test 408460-2.

Damage to the T501 bridge rail with soundwall was only cosmetic as shown in Figures 13 and 14. Tire marks were on the face of the bridge rail and scuff marks were on the face of the soundwall. Length of contact of the vehicle with the T501 bridge rail with soundwall began at 25.4 ft (7.75 m) from the end and extended 36.8 ft (11.23 m) downstream of impact.

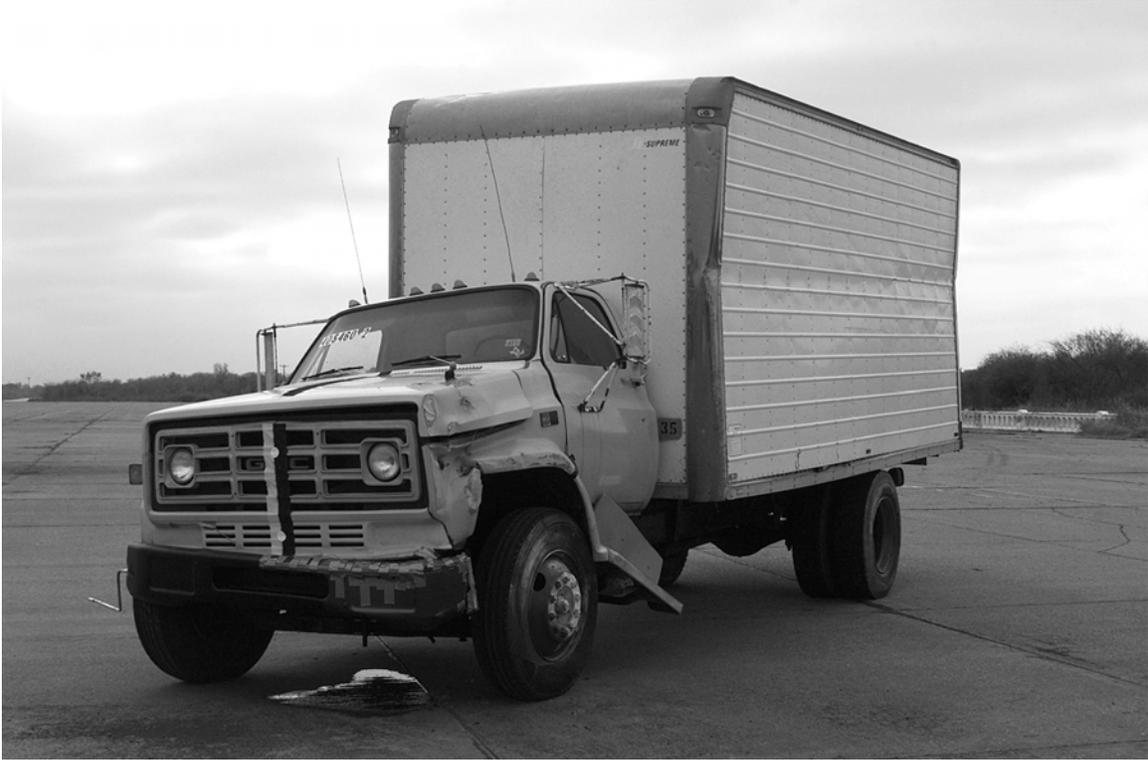
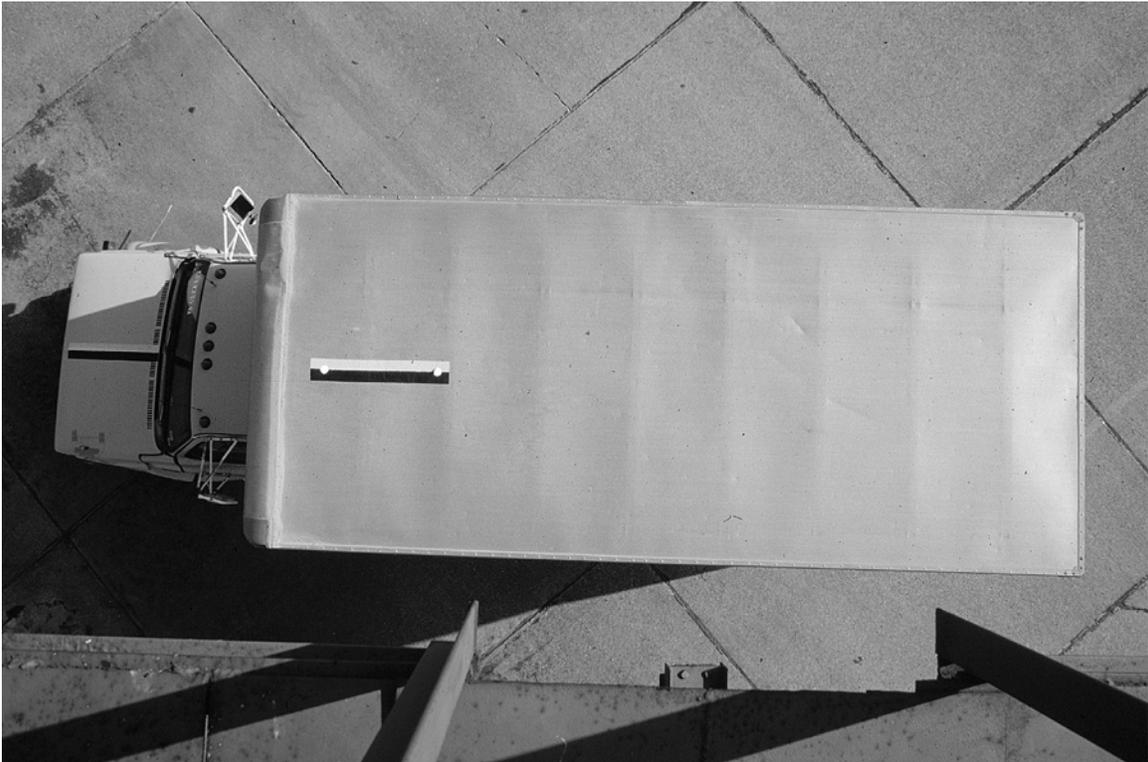
Figure 15. Vehicle after Test 408460-2.

The 8000S sustained structural damage which included the left and right U-bolts that restrain the front steering axle, hood, left springs and shocks, steering arm, and gear box. As can be seen in Figure 15, the front bumper, left quarter panel, left door step, left door, left side of the box and the left rear outside rim were deformed. No deformation into the occupant compartment occurred. Photographs of the interior of the vehicle are shown in Figure 16.

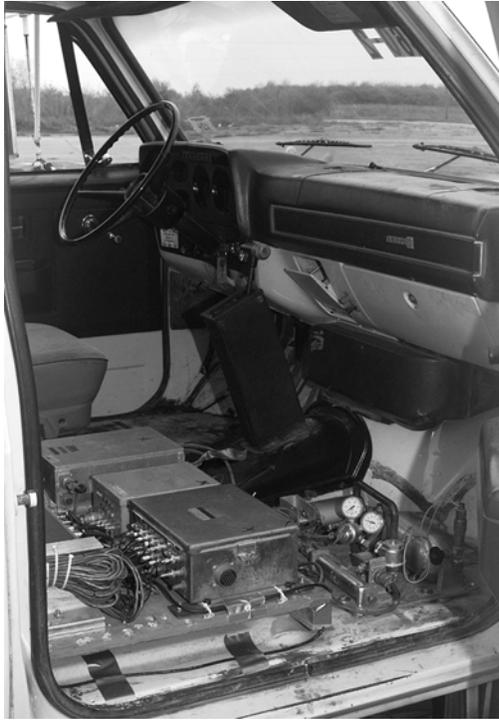
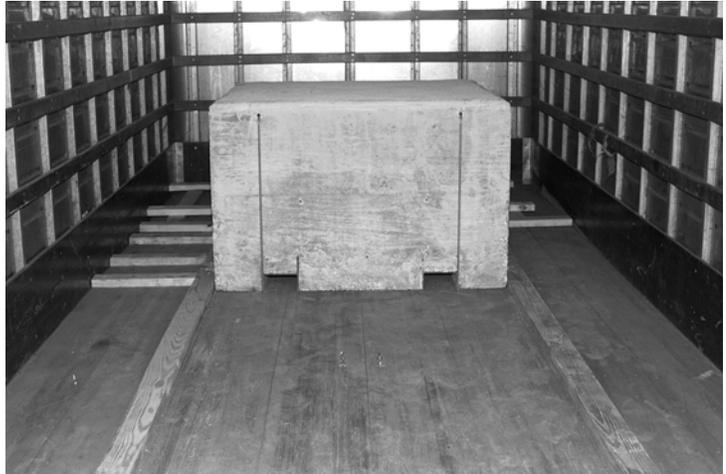
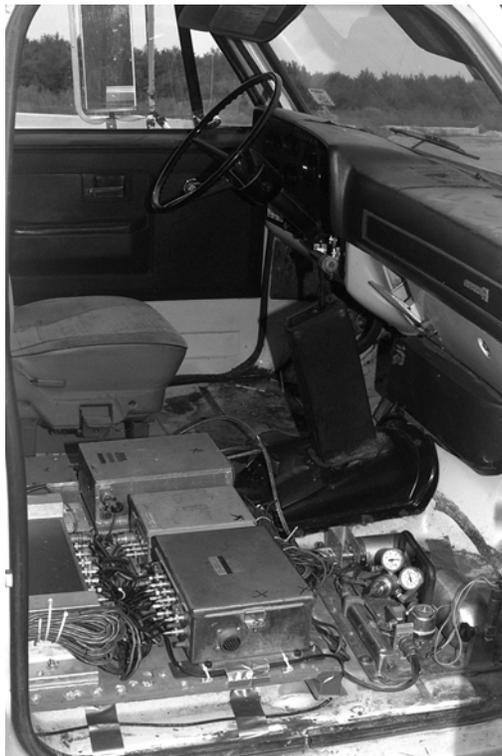
Before test

After test

Figure 16. Interior of Vehicle for Test 408460-2.

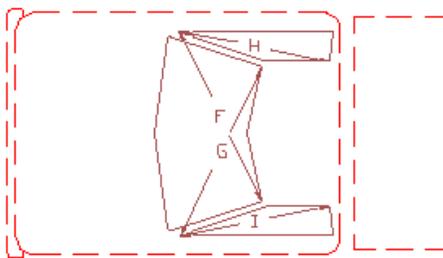
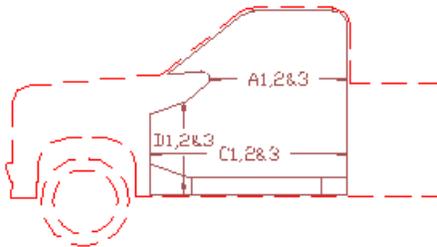
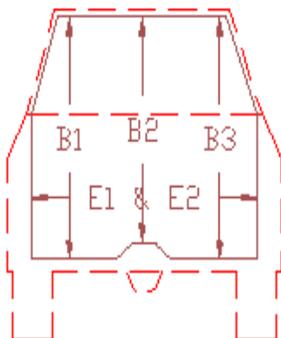
Occupant Compartment Deformation

BEFORE	AFTER
A1	902	919
A2	895	875
A3	911	851
B1	1082	1077
B2	1053	1033
B3	1074	1058
C1	1372	1372
C2	1354	1325
C3	1371	1211
D1	313	327
D2	159	182
D3	317	250
E1	1591	1607
E2	1595	1641
F	1463	1442
G	1463	1454
H	1245	1245
I	1245	1179
J	1525	1475

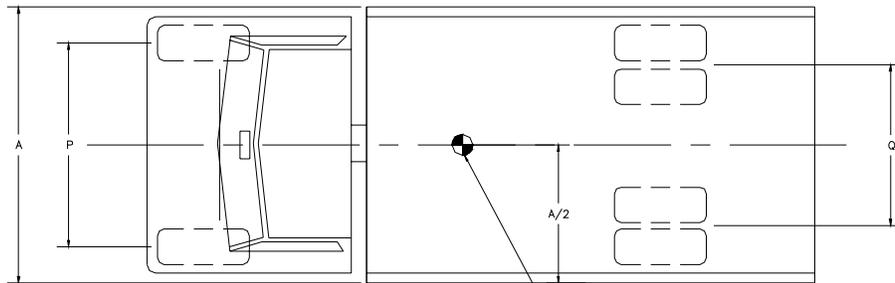
Accelerometer Locations--(mm)

X_f 1340 Y_f RT 320 Z_f 1070
 X_c 3150 Y_c 0 Z_c 1070
 X_r 5130 Y_r 0 Z_r 1100

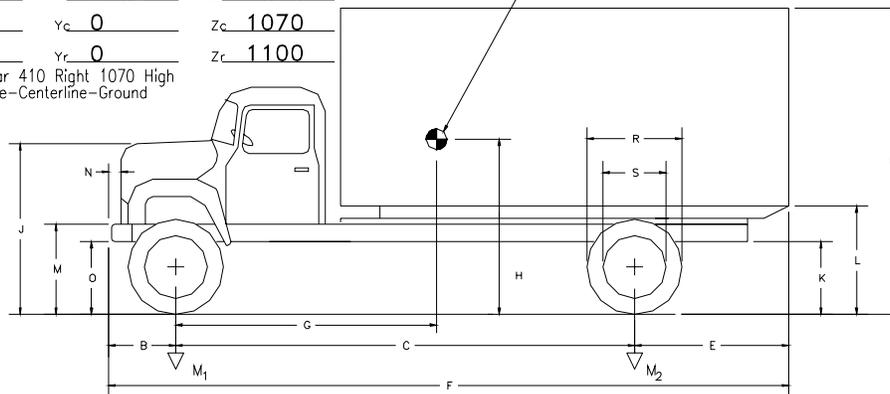
Figure 19. Vehicle Properties for Test 408460-2.

GEOMETRY--(mm)

A	<u>2240</u>	D	<u>3660</u>	G	<u>3105</u>	K	<u>745</u>	N	<u>90</u>	Q	<u>1840</u>
B	<u>760</u>	E	<u>2280</u>	H	<u>1230</u>	L	<u>1210</u>	O	<u>560</u>	R	<u>1020</u>
C	<u>5130</u>	F	<u>8170</u>	J	<u>1600</u>	M	<u>860</u>	P	<u>1920</u>	S	<u>595</u>

A 1988 GMC 7000 single-unit truck, shown in Figures 11 and 12, was used for the crash test. Test inertia weight of the vehicle was 17,621 lb (8000 kg), and its gross static weight was 17,621 lb (8000 kg). The height to the lower edge of the vehicle bumper was 22.0 in. (560 mm), and it was 33.9 in. (860 mm) to the upper edge of the bumper. Additional dimensions and information on the vehicle are given in Appendix B, Figure 19. The vehicle was directed into the installation using the cable reverse tow and guidance system, and was released to be free-wheeling and unrestrained just prior to impact.

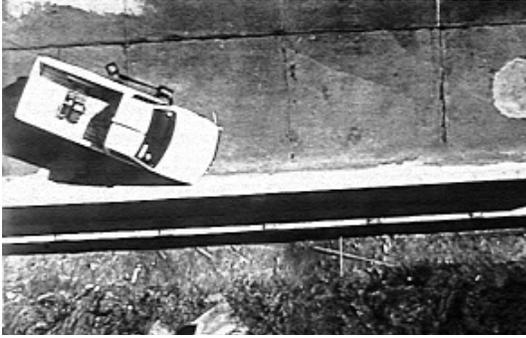
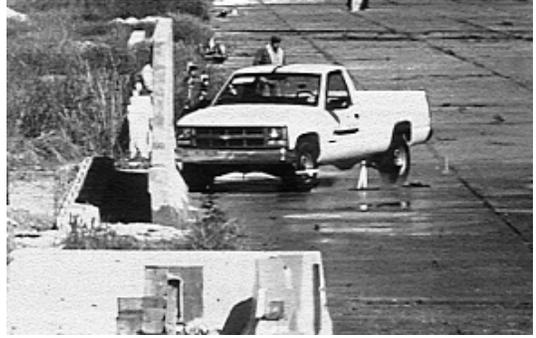
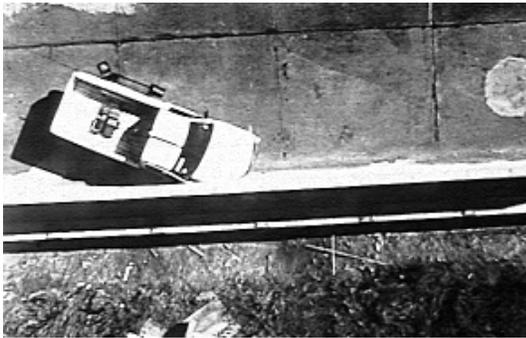
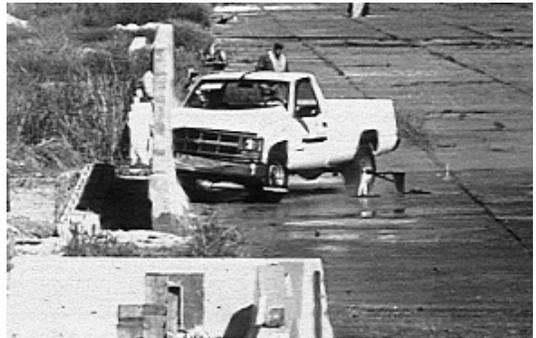
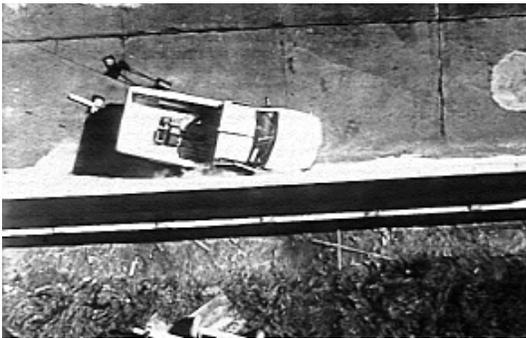
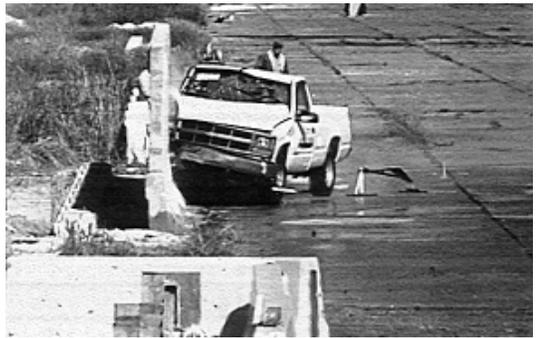
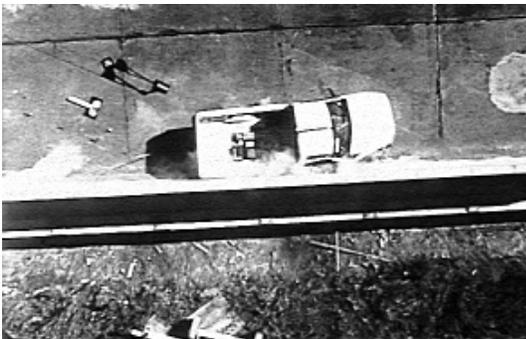
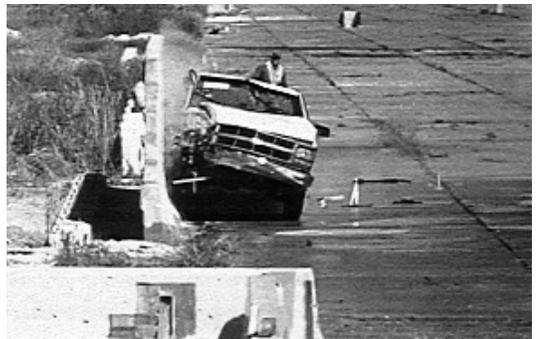
Figure 20. Sequential Photographs for Test 408460-1 (Overhead and Frontal Views).

0.000 s

0.047 s

0.117 s

0.211 s

The vehicle, traveling at 63.1 mi/h (101.6 km/h), impacted the T501 bridge rail with soundwall 26.2 ft (8.0 m) from the end at an impact angle of 25.5 degrees. Shortly after impact the right front tire began to climb the face of the bridge rail, and at 0.053 s the windshield cracked. At 0.183 s the vehicle was traveling parallel with the bridge rail at a speed of 47.4 mi/h (76.3 km/h). The rear of the vehicle contacted the bridge rail at 0.204 s. The vehicle lost contact with the bridge rail at 0.266 s and was traveling at a speed of 51.9 mi/h (83.5 km/h) and an exit angle of 4.1 degrees. The vehicle remained upright, brakes were applied at 3.5 s after impact, and the vehicle subsequently came to rest 237.5 ft (72.4 m) downstream of impact and 15.1 ft (4.6 m) forward of the face of the bridge rail. Sequential photographs of the test period are shown in Appendix C, Figures 20 and 21.

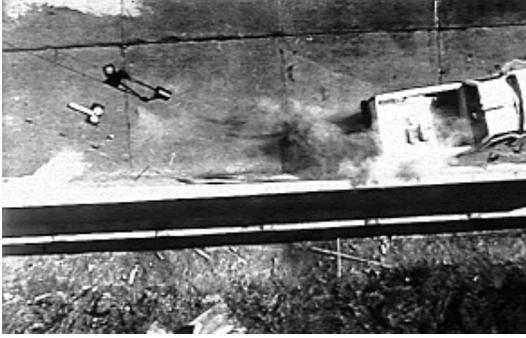
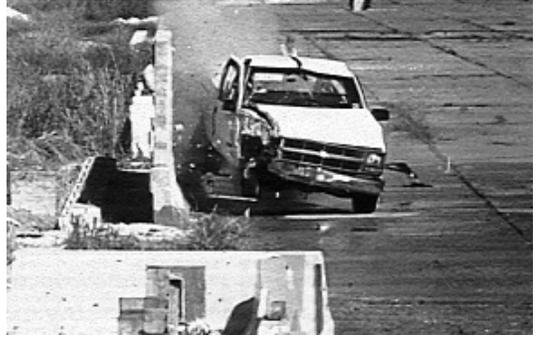
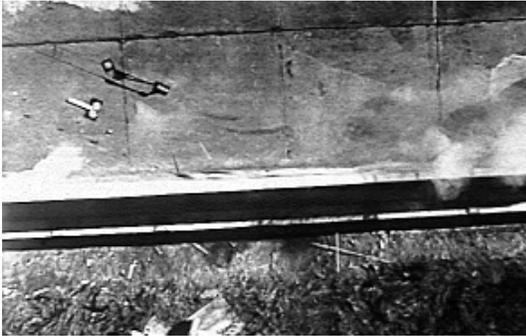
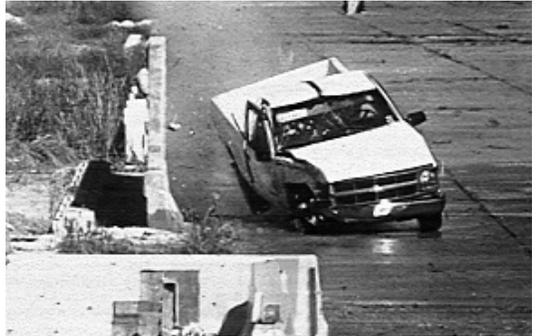
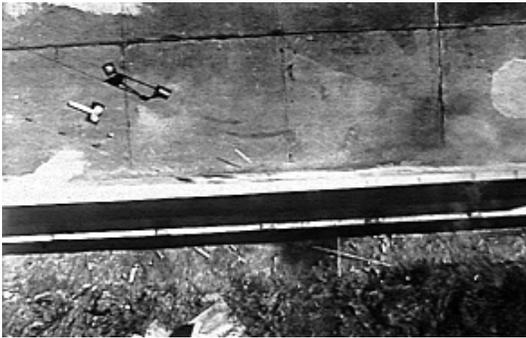
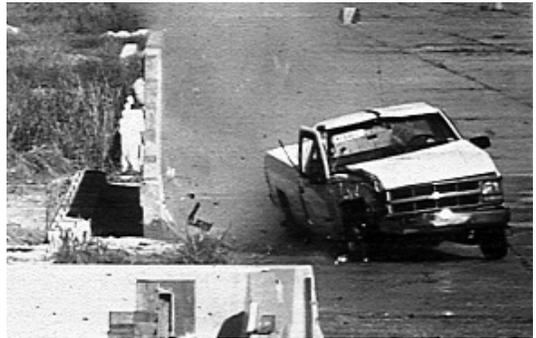
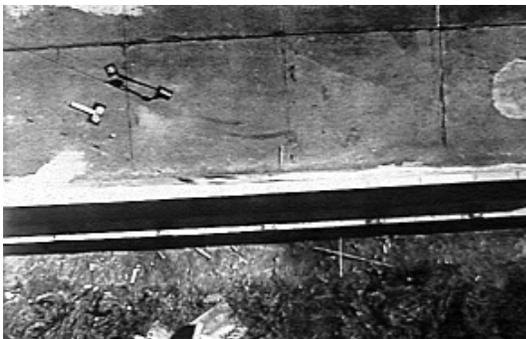
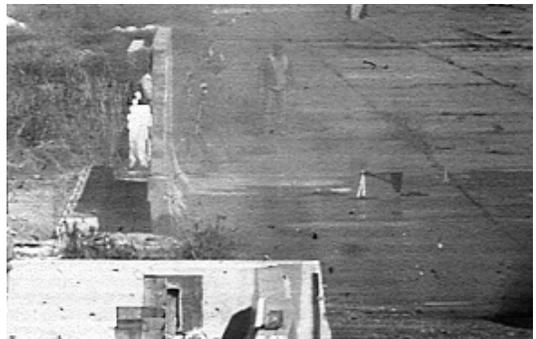
Figure 20. Sequential Photographs for Test 408460-1 (Overhead and Frontal Views) (continued).

0.422 s

0.656 s

0.939 s

2.018 s

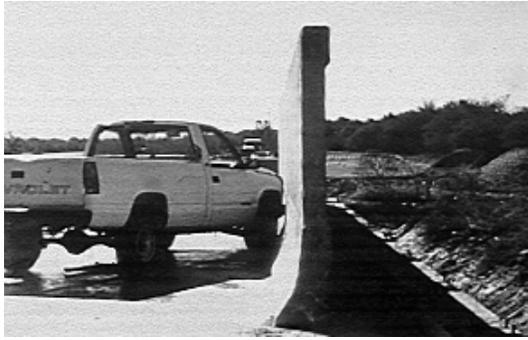
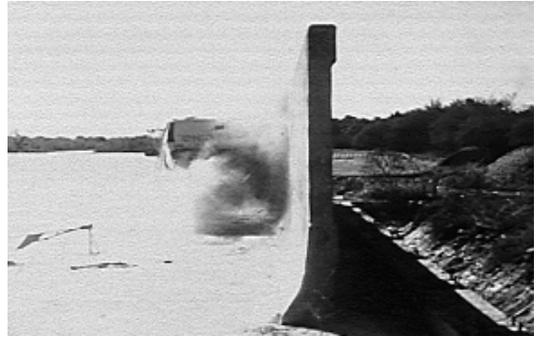
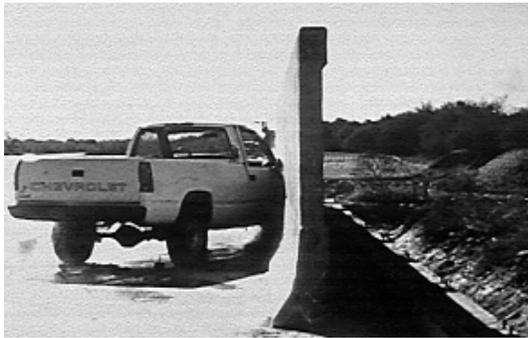
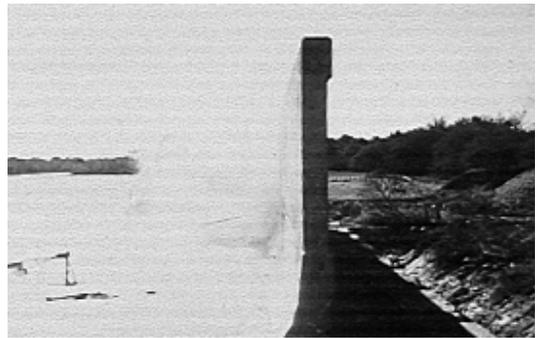
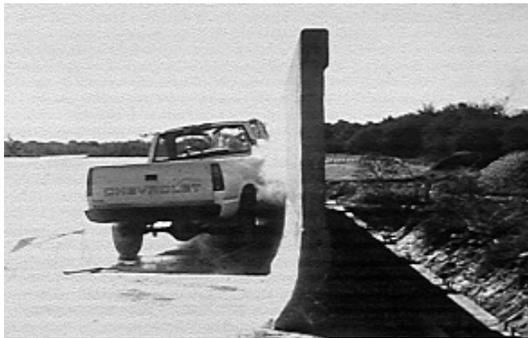
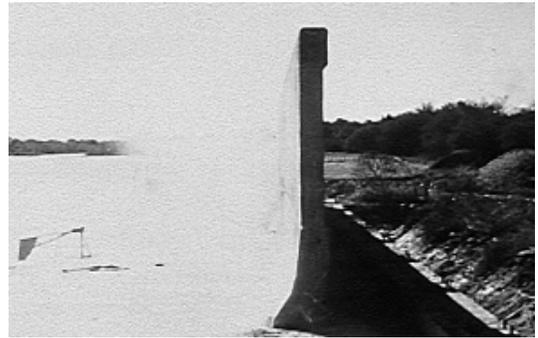
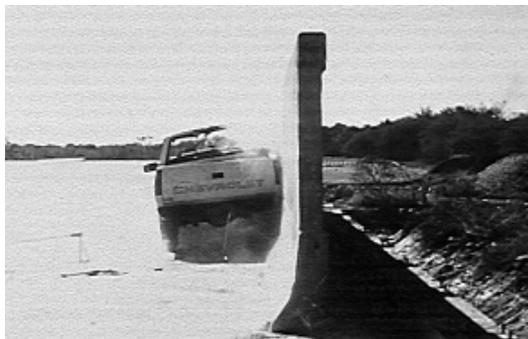
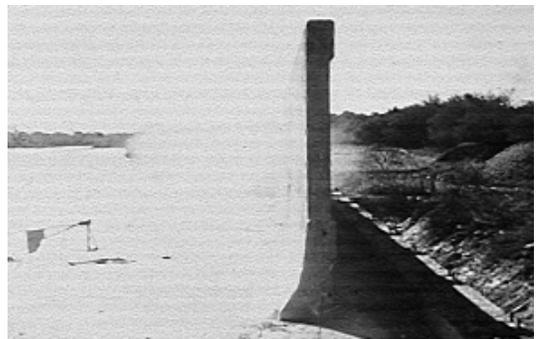
Figure 21. Sequential Photographs for Test 408460-1 (Rear View).

0.000 s

0.422 s

0.047 s

0.657 s

0.117 s

0.939 s

0.211 s

2.018 s

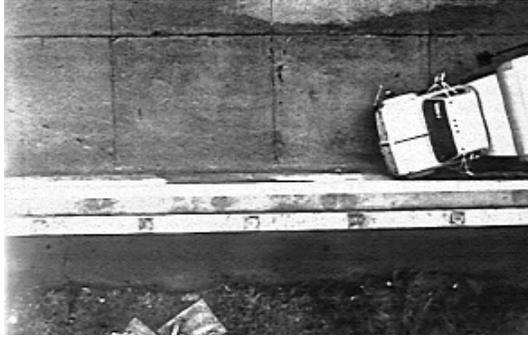
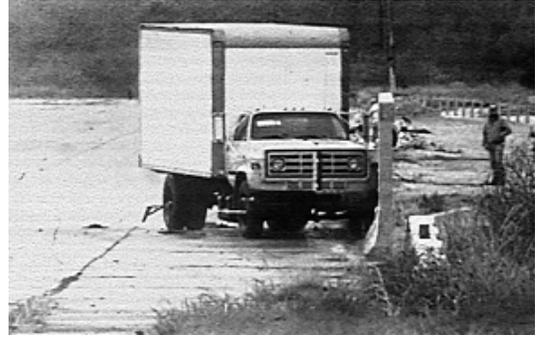
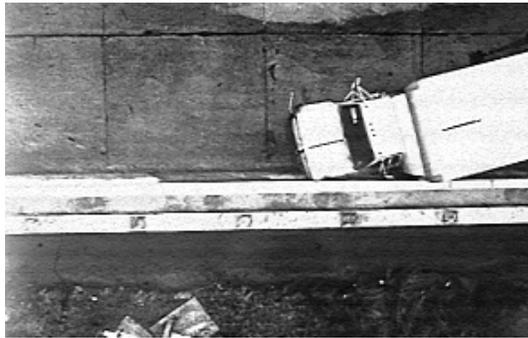
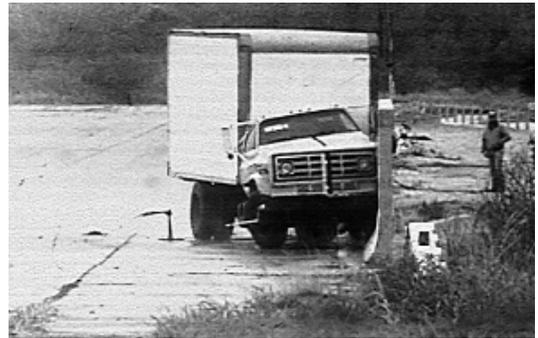
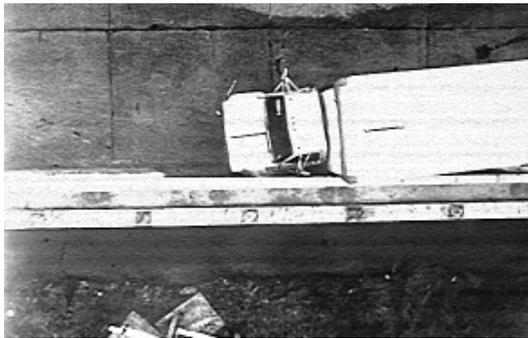
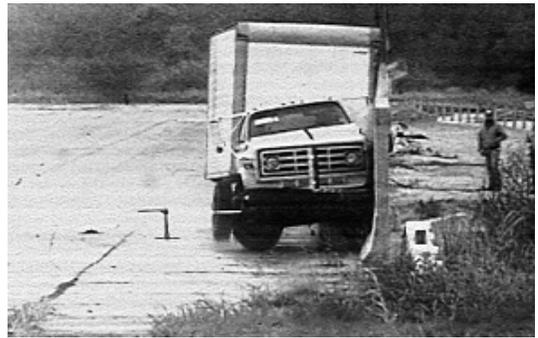
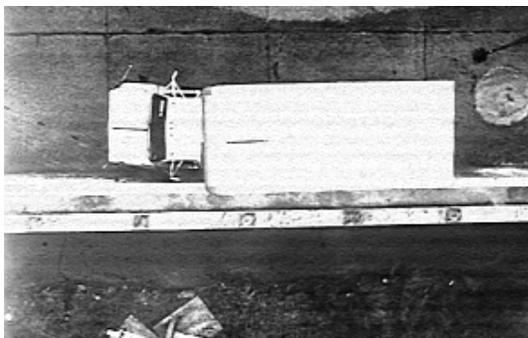
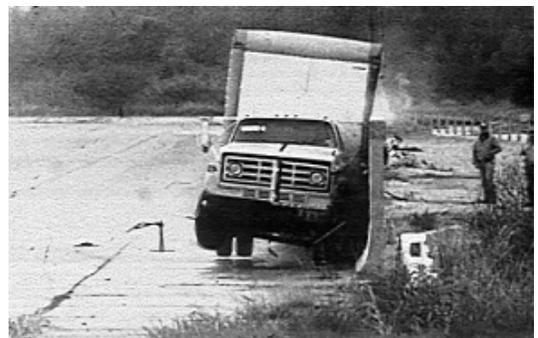
Figure 22. Sequential Photographs for Test 408460-2 (Overhead and Frontal Views).

0.000 s

0.094 s

0.188 s

0.329 s

The vehicle, traveling at a speed of 54.8 mi/h (83.4 km/h), impacted the T501 bridge rail with soundwall 25.4 ft (7.75 m) from the end of the bridge rail at an impact angle of 14.9 degrees. Shortly after impact the left front tire began to ride up the face of the bridge rail. At 0.042 s after impact the left front wheel steered toward the bridge rail and at 0.077 s the right front wheel steered toward the bridge rail. The front of the box van contacted the soundwall at 0.092 s. At 0.234 s the vehicle was traveling parallel with the bridge rail at a speed of 47.3 mi/h (76.1 km/h). The rear of the vehicle contacted the soundwall at 0.240 s. At 0.509 s the vehicle lost contact with the bridge rail and was traveling at a speed of 46.7 mi/h (75.2 km/h) and an exit angle of 2.1 degrees. Brakes on the vehicle were applied at 1.425 s after impact and the vehicle subsequently came to rest 300.0 ft (91.4 m) downstream of impact and 112.5 ft (34.3 m) forward of the face of the bridge rail. Sequential photographs of the test period are shown in Appendix C, Figures 22 and 23.

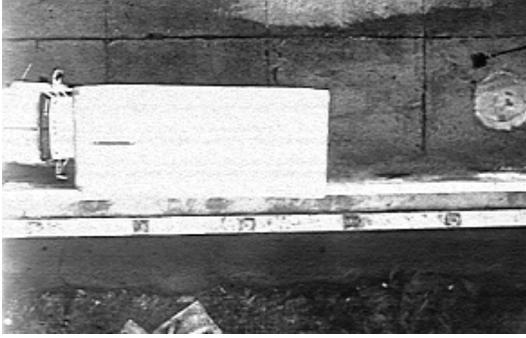
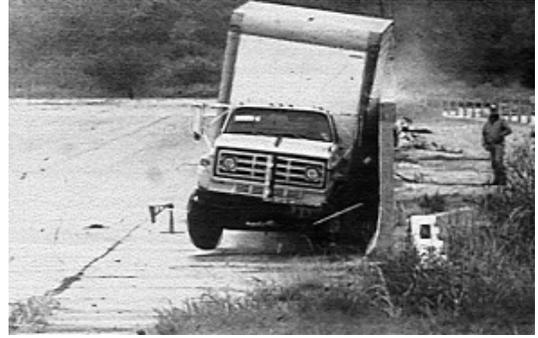
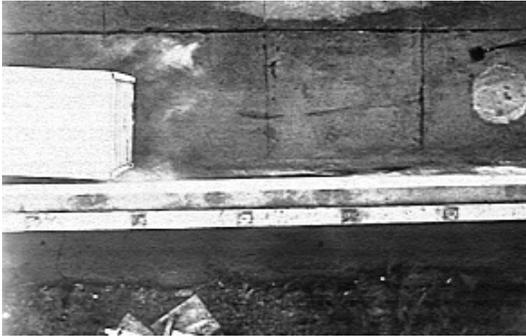
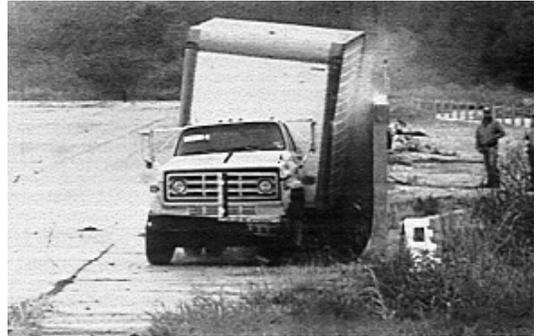
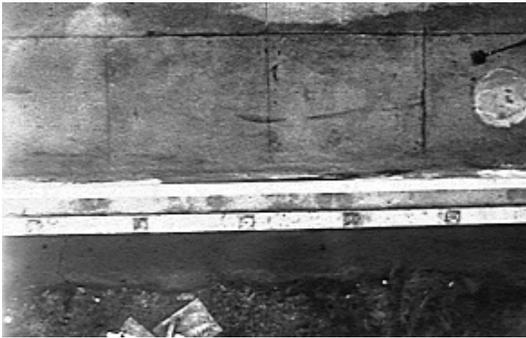
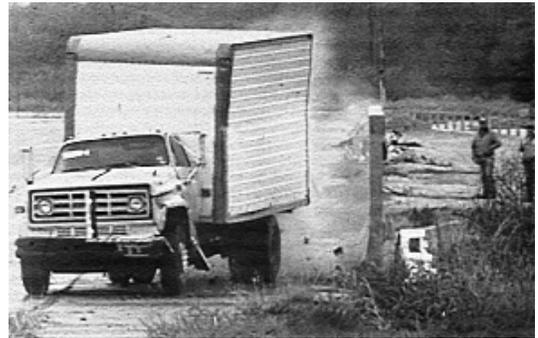
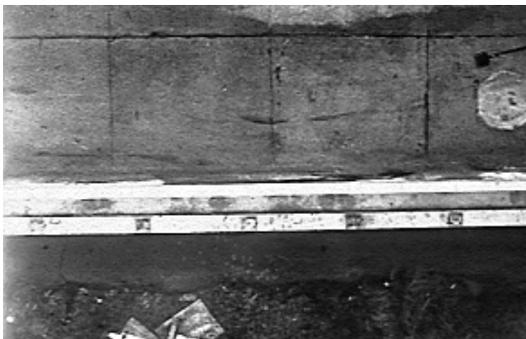
**Figure 22. Sequential Photographs for Test 408460-2
(Overhead and Frontal Views) (continued).**

0.469 s

0.704 s

1.174 s

2.347 s

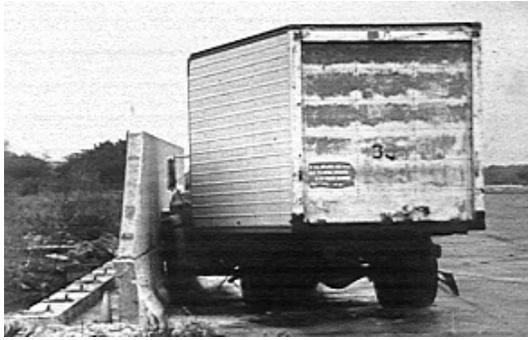
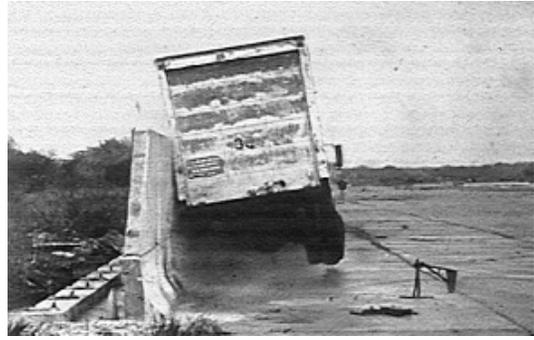
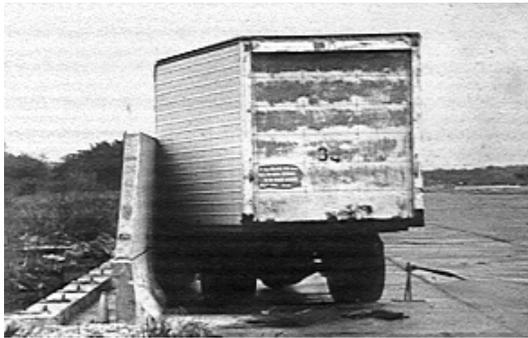
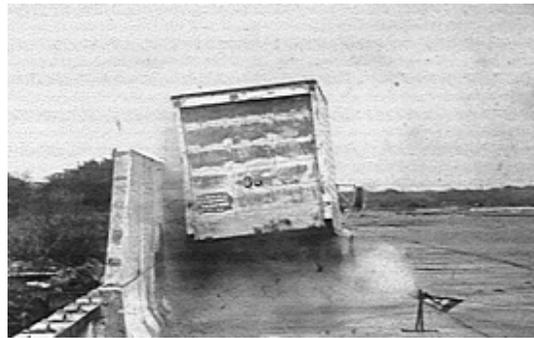
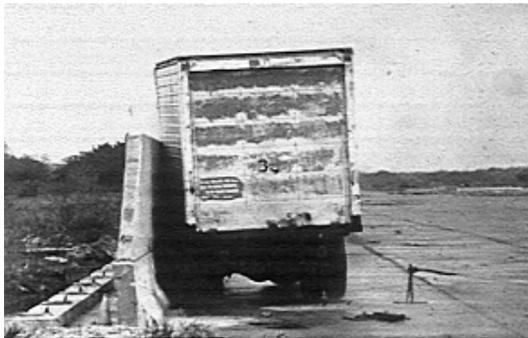
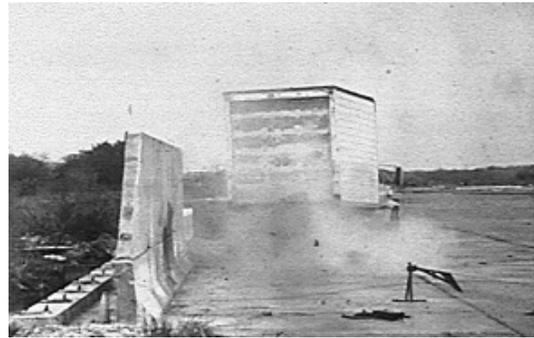
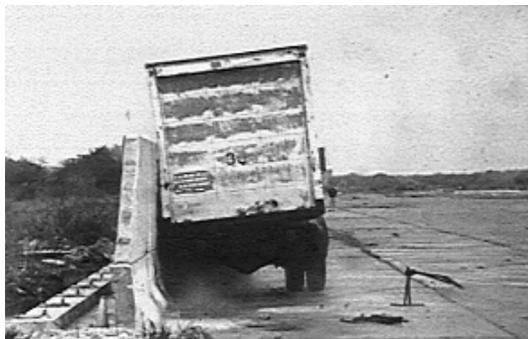
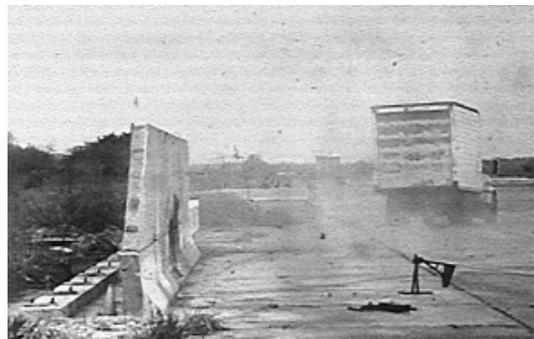
Figure 23. Sequential Photographs for Test 408460-2 (Rear View).

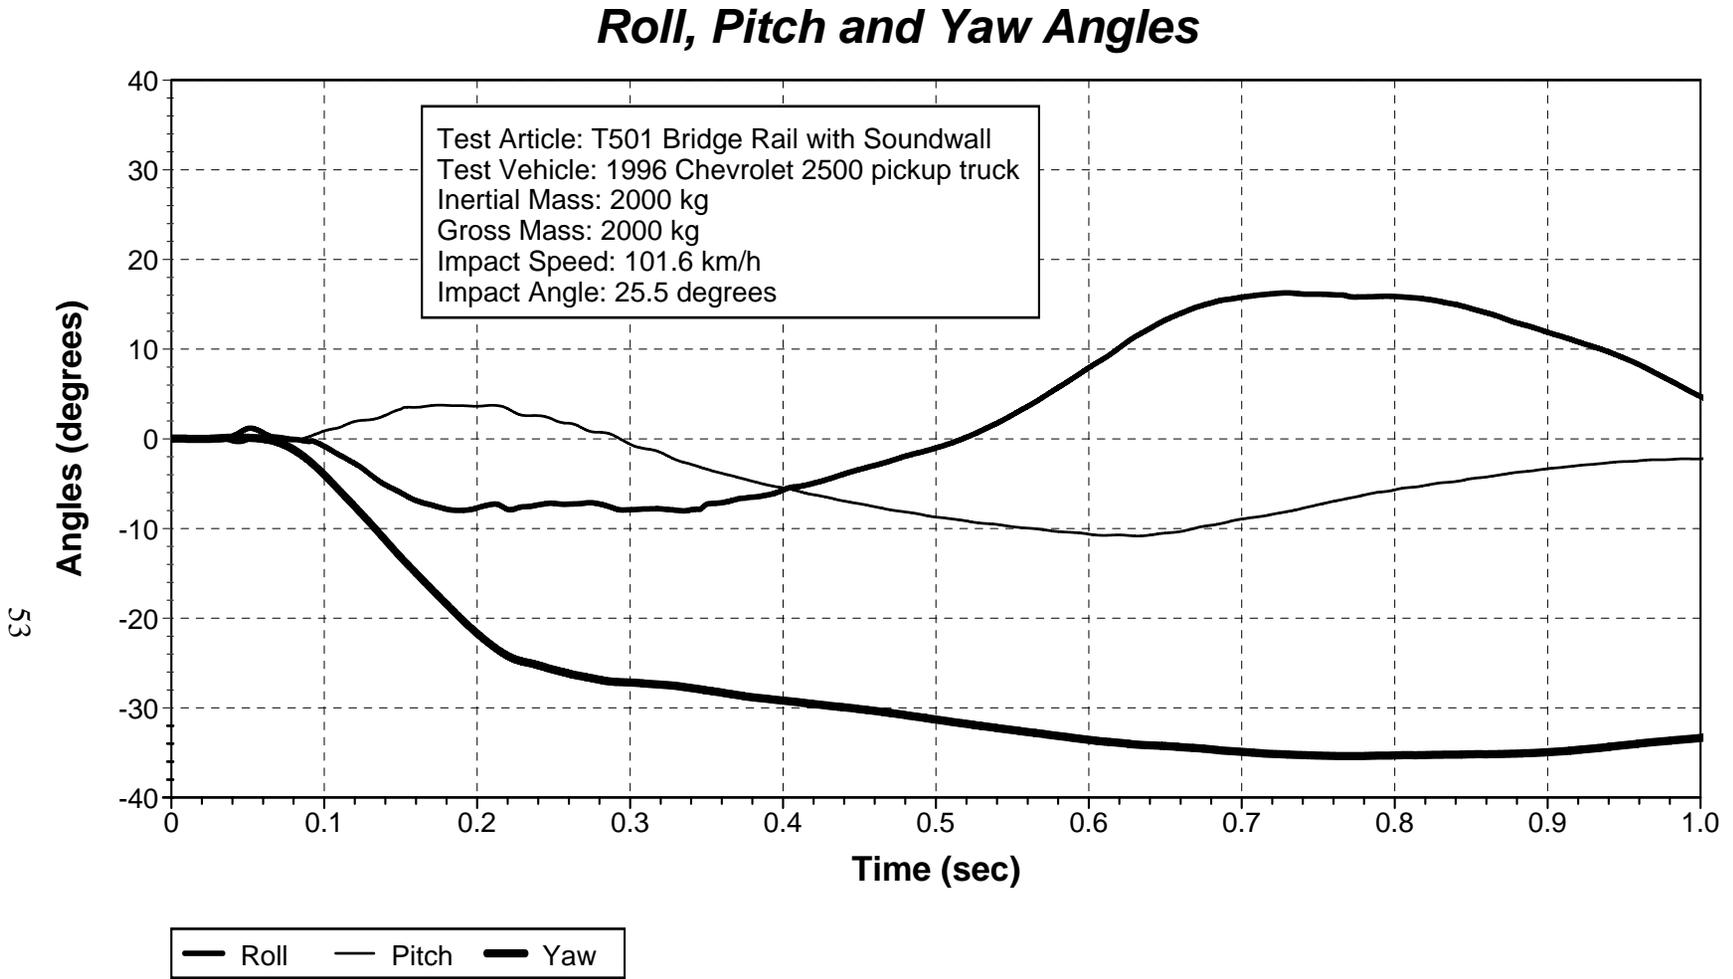
Figure 24. Vehicular Angular Displacements for Test 408460-1.

Data from the tri-axial accelerometer, located at the vehicle center of gravity, were digitized to compute occupant impact velocity and ridedown accelerations. The occupant impact velocity and ridedown accelerations in the longitudinal axis only are required from these data for evaluation of criterion L of *NCHRP Report 350*. In the longitudinal direction, occupant impact velocity was 21.7 ft/s (6.6 m/s) at 0.086 s, maximum 0.010-s ridedown acceleration was -6.5 g's from 0.090 to 0.100 s, and the maximum 0.050-s average was -9.9 g's between 0.009 and 0.059 s. The values in the lateral direction are given for information purposes only. In the lateral direction, the occupant impact velocity was 27.2 ft/s (8.3 m/s) at 0.086 s, the highest 0.010-s occupant ridedown acceleration was -7.6 g's from 0.223 to 0.233 s, and the maximum 0.050-s average was -14.5 g's between 0.185 and 0.235 s. These data and other information pertinent to the test are presented in Figure 10. Vehicle angular displacements are plotted in Appendix D, Figure 24, and accelerations versus time traces are shown in Appendix E, Figures 26 through 31.

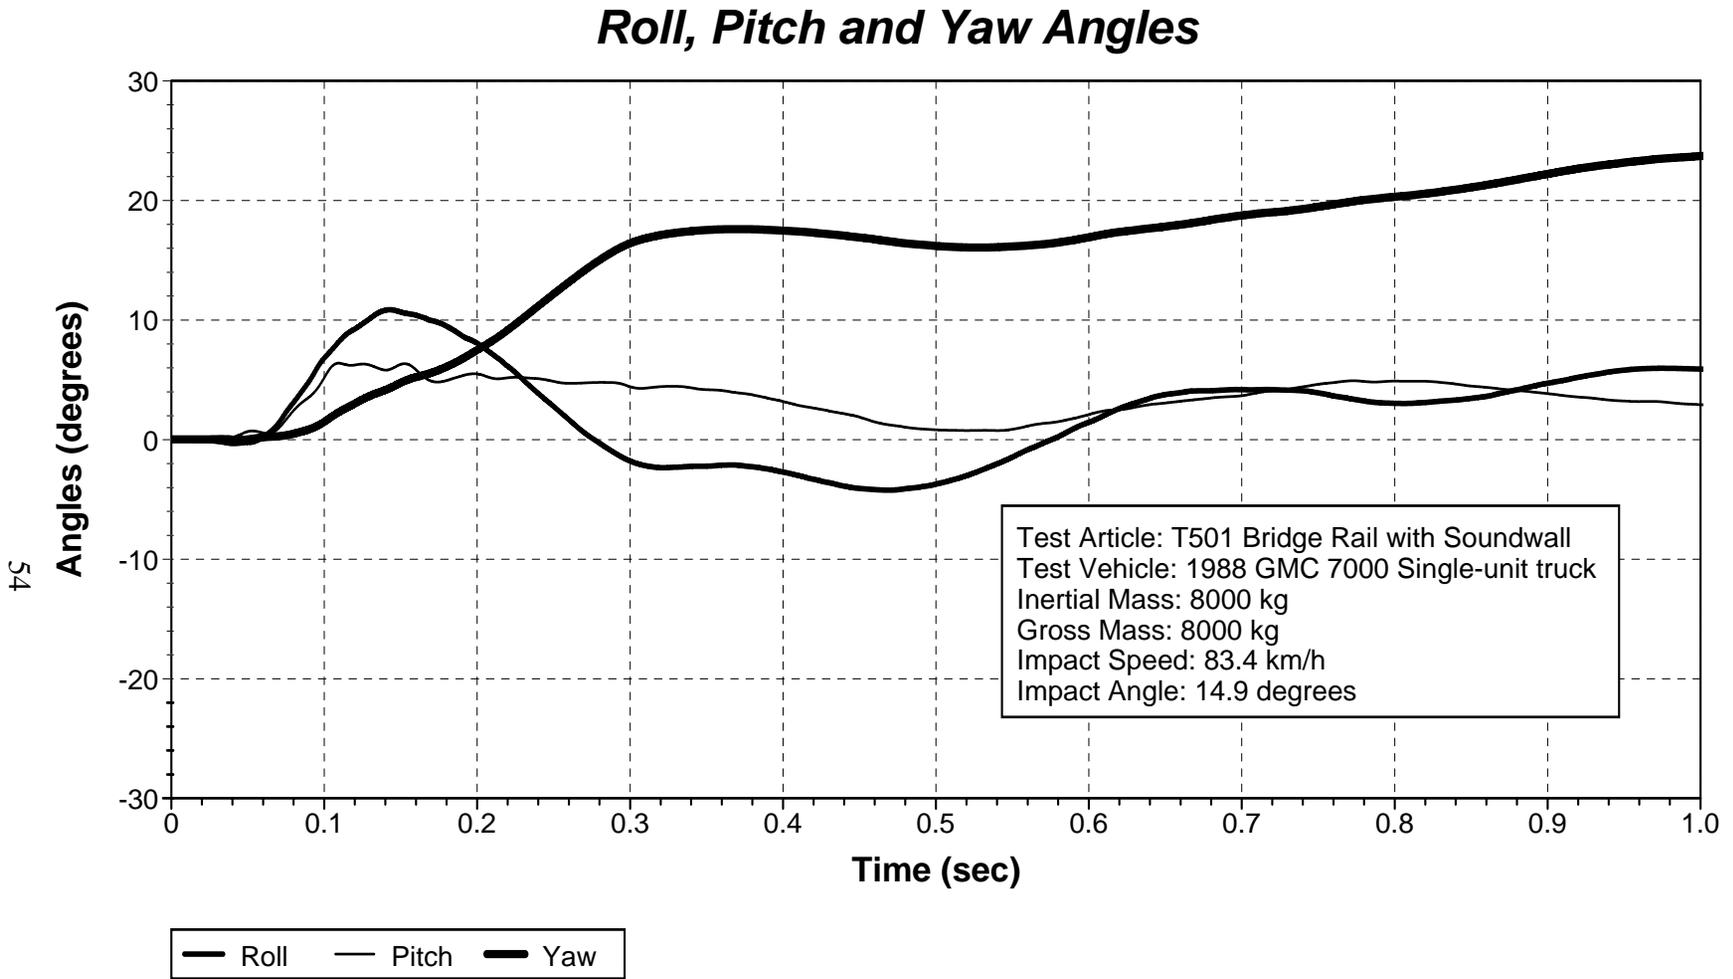
Figure 25. Vehicular Angular Displacements for Test 408460-2.

Occupant risk factors are not required for the test with the 8000S vehicle; however, these factors were computed and are reported for information purposes only. Data from the accelerometer located at the vehicle center of gravity were digitized for evaluation of occupant risk and were computed as follows. In the longitudinal direction, the occupant impact velocity was 7.9 ft/s (2.4 m/s) at 0.176 s, the highest 0.010-s occupant ridedown acceleration was -2.8 g's from 0.254 to 0.264 s, and the maximum 0.050-s average acceleration was -2.6 g's between 0.066 and 0.116 s. In the lateral direction, the occupant impact velocity was 13.8 ft/s (4.2 m/s) at 0.176 s, the highest 0.010-s occupant ridedown acceleration was 10.2 g's from 0.254 to 0.264 s and the maximum 0.050-s average was 6.2 g's between 0.073 and 0.123 s. These data and other pertinent information from the test are summarized in Figure 17. Vehicle angular displacements are plotted in Appendix D, Figure 25, and accelerations versus time traces are presented in Appendix E, Figures 32 through 38.

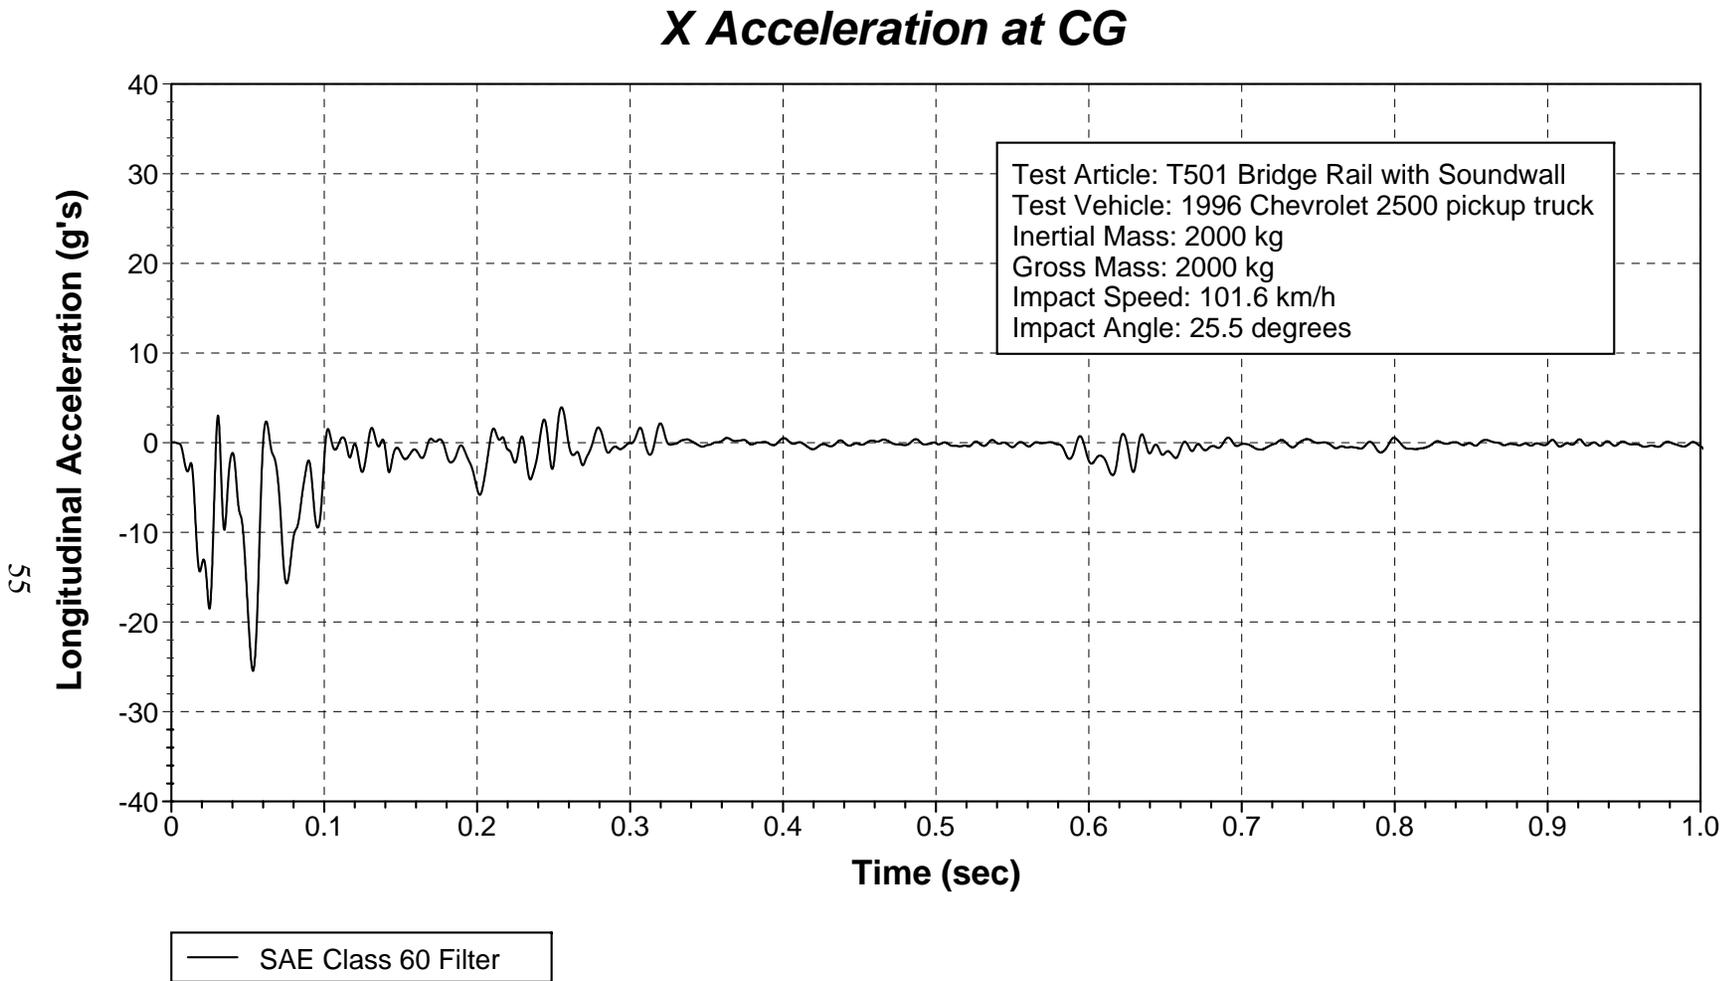
Figure 26. Vehicle Longitudinal Accelerometer Trace for Test 408460-1 (Accelerometer Located at Center of Gravity).

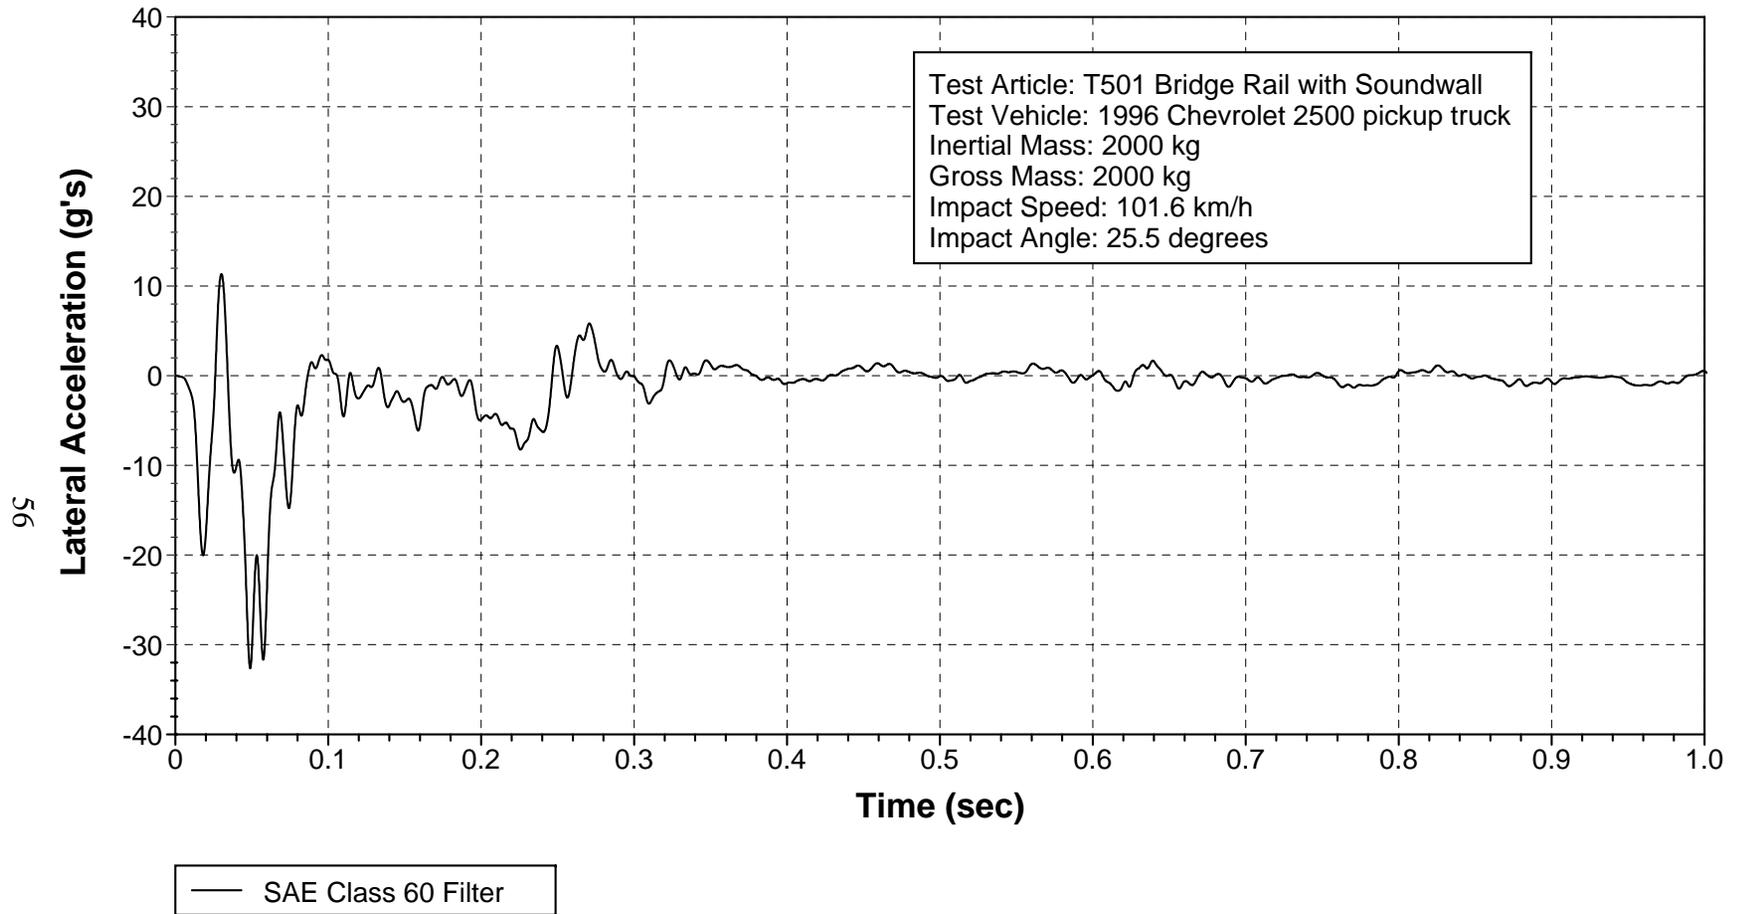
Y Acceleration at CG

**Figure 27. Vehicle Lateral Accelerometer Trace for Test 408460-1
(Accelerometer Located at Center of Gravity).**
