**NCHRP REPORT 350 EVALUATION OF THE
T501 BRIDGE RAIL WITH SOUNDWALL**

Report No. 408460-F
Project No. 120-xxA1004

Sponsored by
Texas Department of Transportation

January 2001

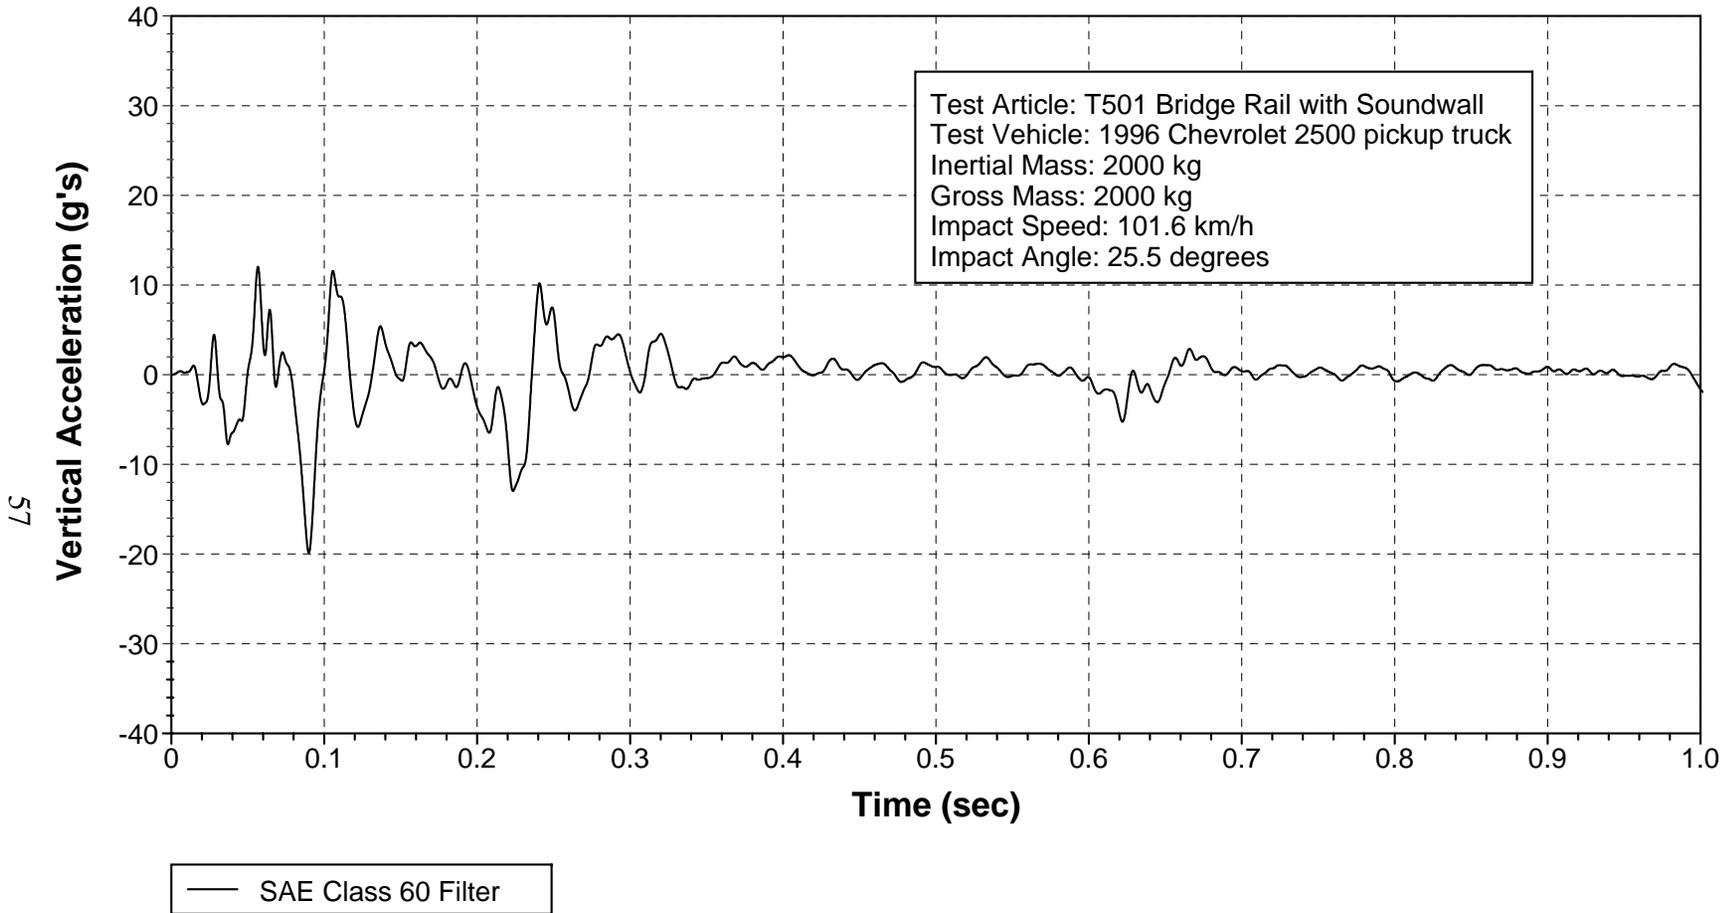
Z Acceleration at CG

Figure 28. Vehicle Vertical Accelerometer Trace for Test 408460-1
(Accelerometer Located at Center of Gravity).

Data from the tri-axial accelerometer, located at the vehicle center of gravity, were digitized to compute occupant impact velocity and ridedown accelerations. The occupant impact velocity and ridedown accelerations in the longitudinal axis only are required from these data for evaluation of criterion L of *NCHRP Report 350*. In the longitudinal direction, occupant impact velocity was 21.7 ft/s (6.6 m/s) at 0.086 s, maximum 0.010-s ridedown acceleration was -6.5 g's from 0.090 to 0.100 s, and the maximum 0.050-s average was -9.9 g's between 0.009 and 0.059 s. The values in the lateral direction are given for information purposes only. In the lateral direction, the occupant impact velocity was 27.2 ft/s (8.3 m/s) at 0.086 s, the highest 0.010-s occupant ridedown acceleration was -7.6 g's from 0.223 to 0.233 s, and the maximum 0.050-s average was -14.5 g's between 0.185 and 0.235 s. These data and other information pertinent to the test are presented in Figure 10. Vehicle angular displacements are plotted in Appendix D, Figure 24, and accelerations versus time traces are shown in Appendix E, Figures 26 through 31.

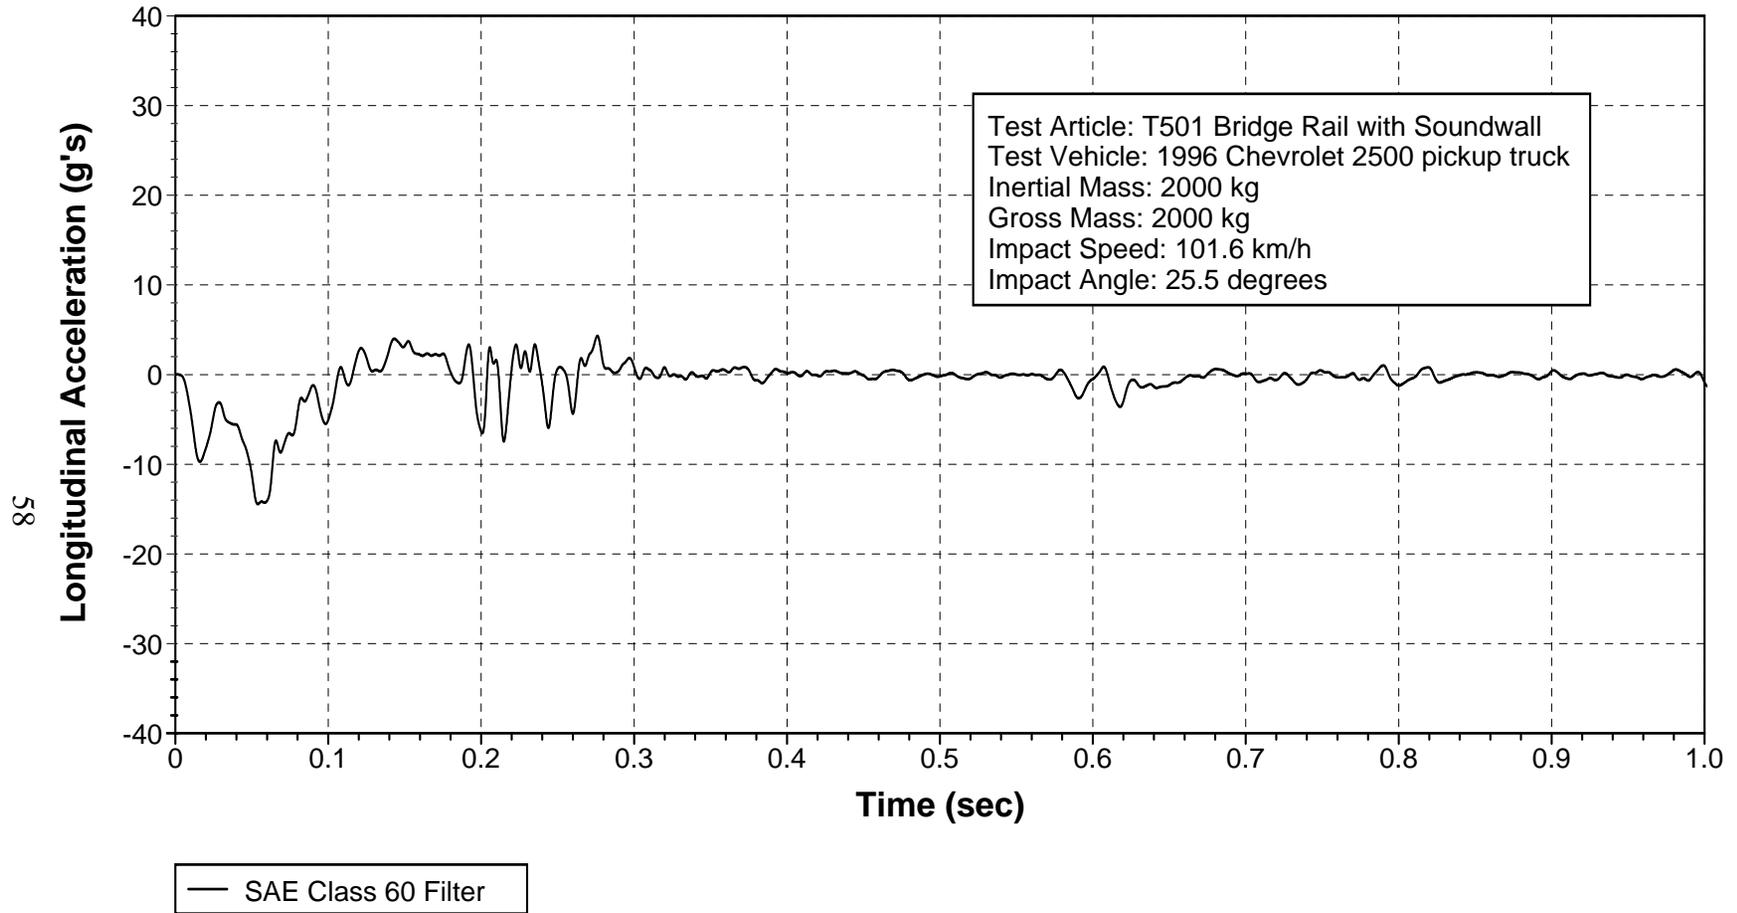
X Acceleration Over Rear Axle

**Figure 29. Vehicle Longitudinal Accelerometer Trace for Test 408460-1
(Accelerometer Located Over Rear Axle).**

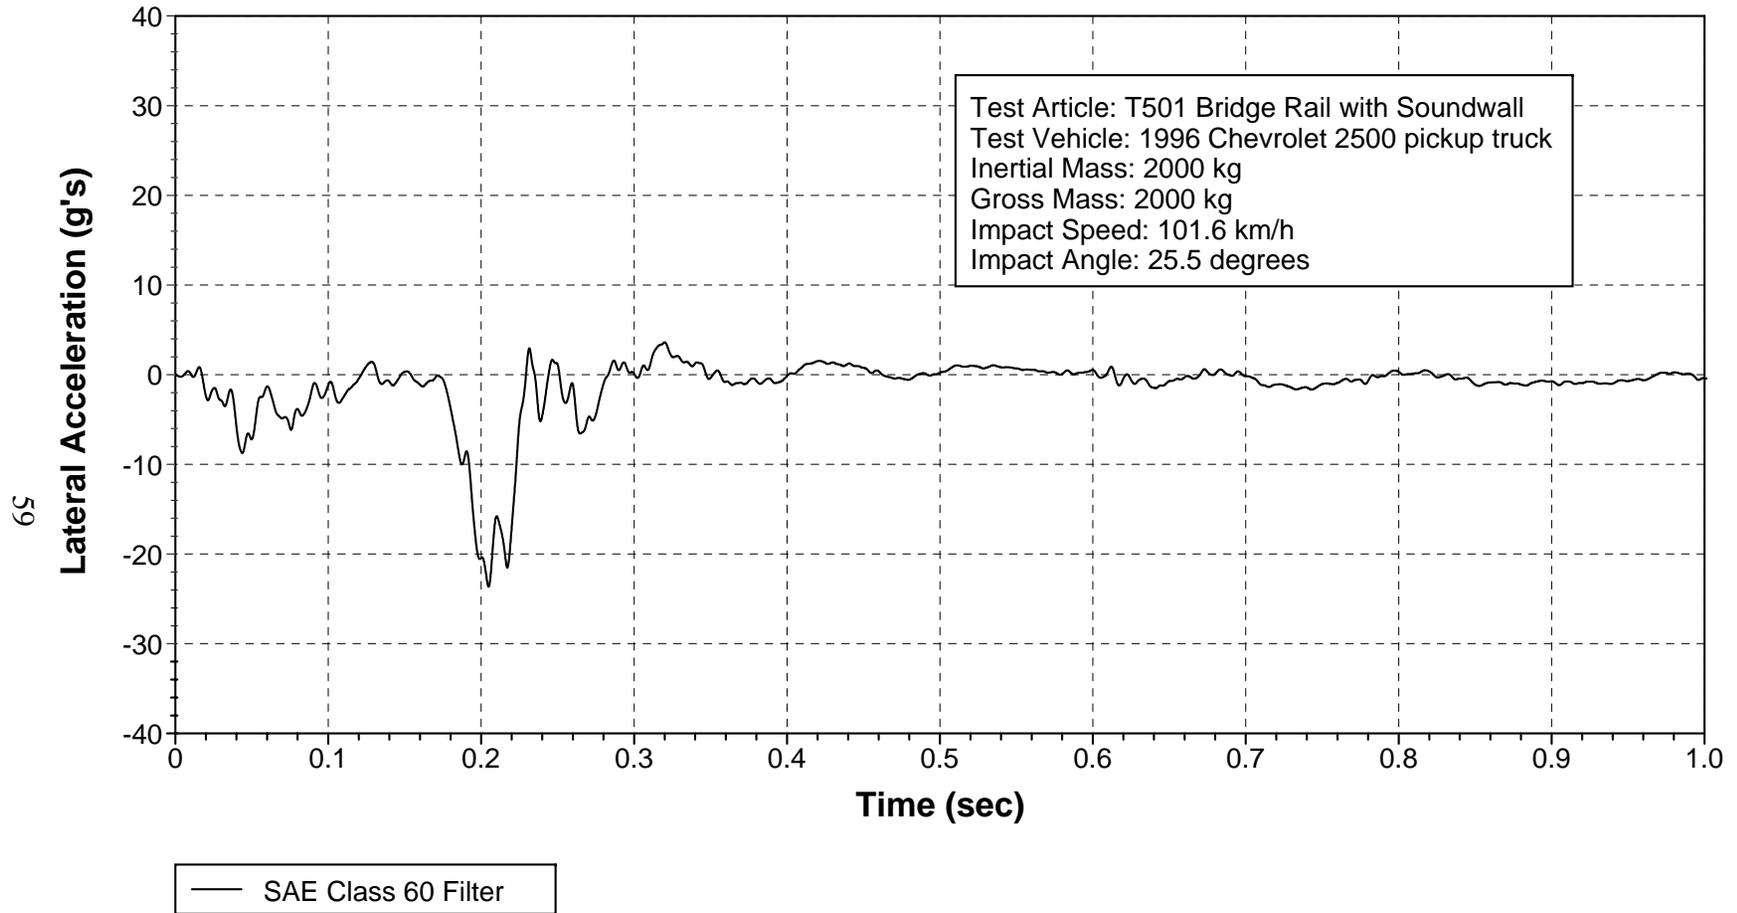
Y Acceleration Over Rear Axle

**Figure 30. Vehicle Lateral Accelerometer Trace for Test 408460-1
(Accelerometer Located Over Rear Axle).**

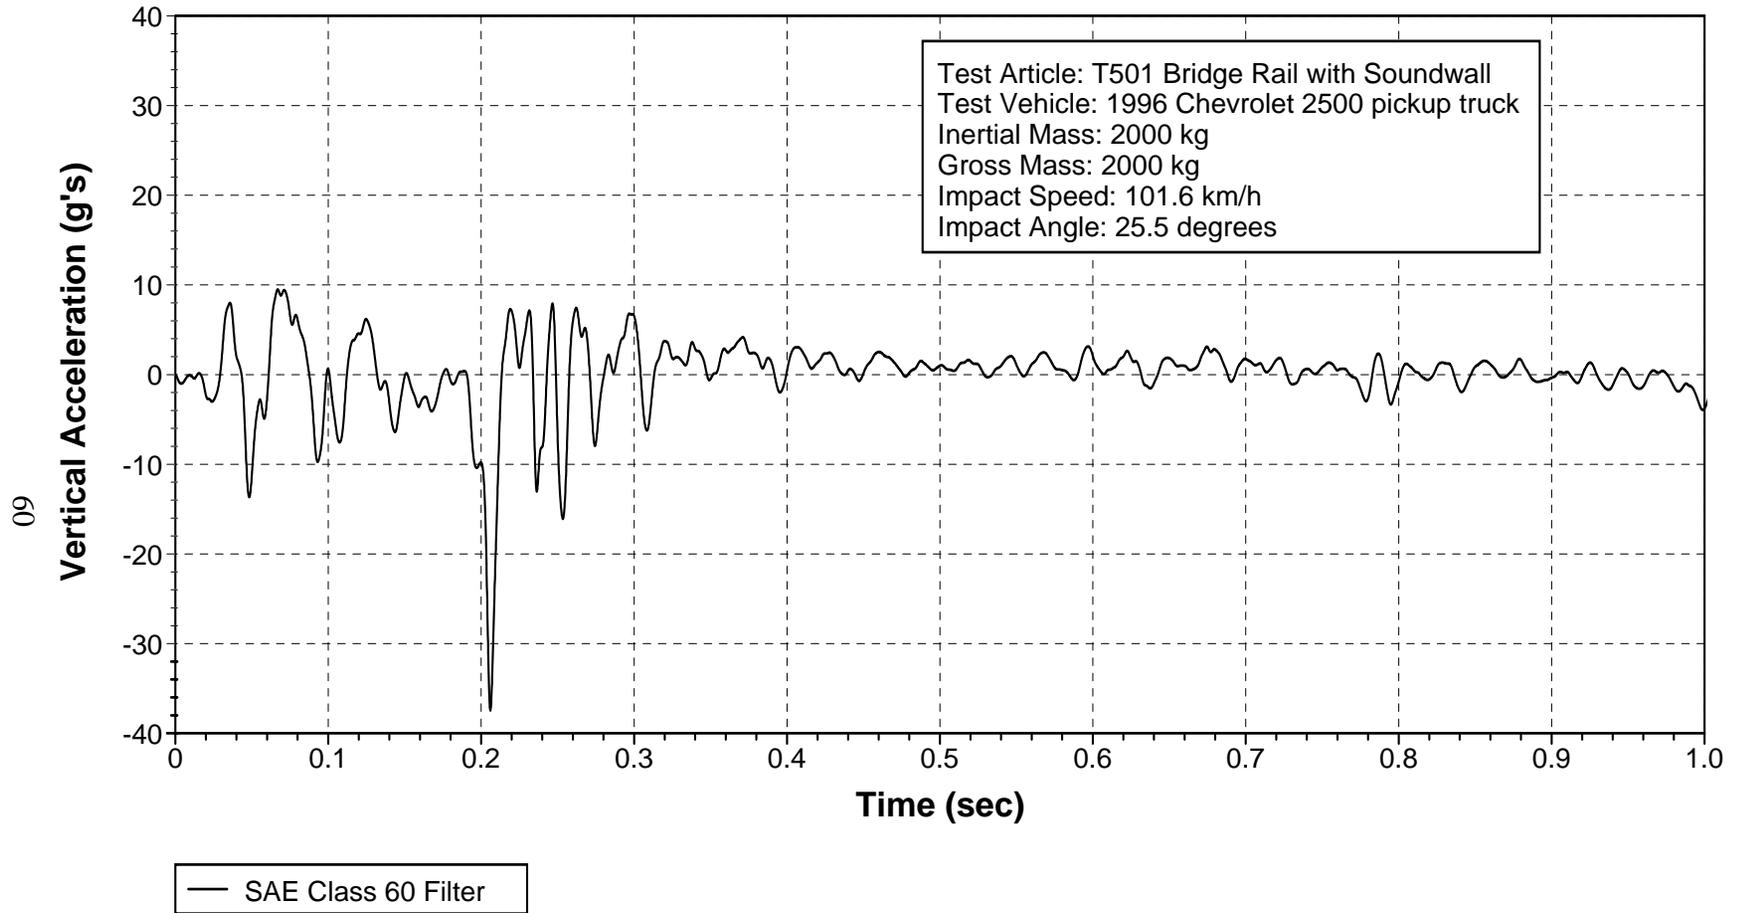
Z Acceleration Over Rear Axle

**Figure 31. Vehicle Vertical Accelerometer Trace for Test 408460-1
(Accelerometer Located Over Rear Axle).**

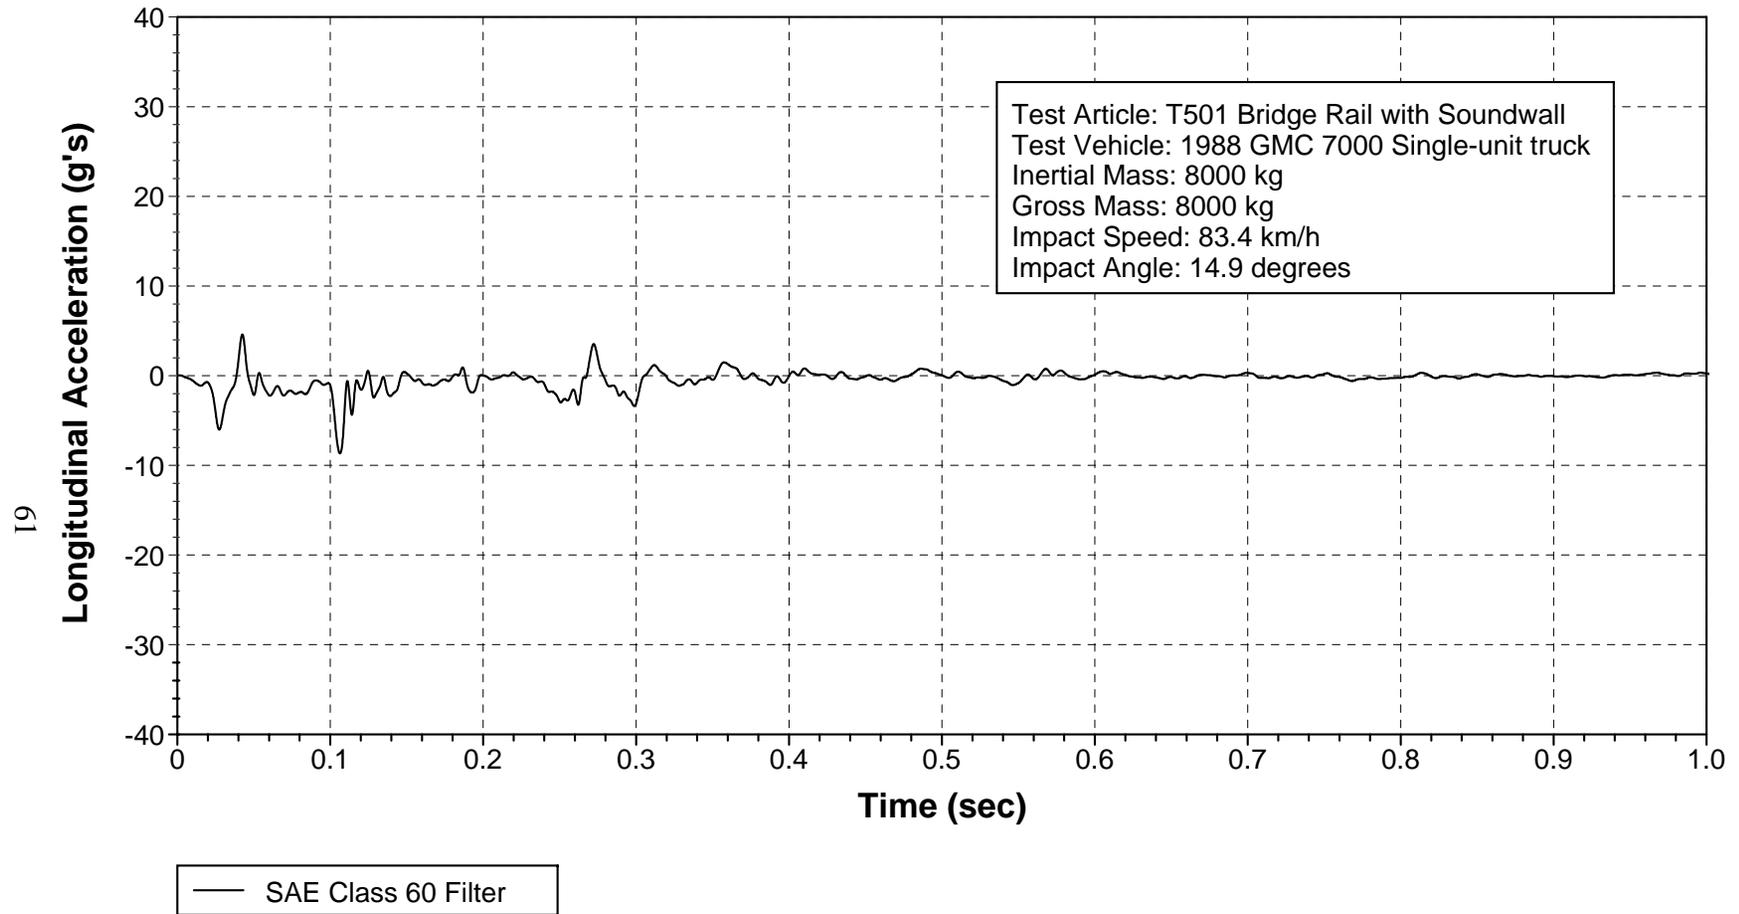
X Acceleration at CG

**Figure 32. Vehicle Longitudinal Accelerometer Trace for Test 408460-2
(Accelerometer Located at Center of Gravity).**

Occupant risk factors are not required for the test with the 8000S vehicle; however, these factors were computed and are reported for information purposes only. Data from the accelerometer located at the vehicle center of gravity were digitized for evaluation of occupant risk and were computed as follows. In the longitudinal direction, the occupant impact velocity was 7.9 ft/s (2.4 m/s) at 0.176 s, the highest 0.010-s occupant ridedown acceleration was -2.8 g's from 0.254 to 0.264 s, and the maximum 0.050-s average acceleration was -2.6 g's between 0.066 and 0.116 s. In the lateral direction, the occupant impact velocity was 13.8 ft/s (4.2 m/s) at 0.176 s, the highest 0.010-s occupant ridedown acceleration was 10.2 g's from 0.254 to 0.264 s and the maximum 0.050-s average was 6.2 g's between 0.073 and 0.123 s. These data and other pertinent information from the test are summarized in Figure 17. Vehicle angular displacements are plotted in Appendix D, Figure 25, and accelerations versus time traces are presented in Appendix E, Figures 32 through 38.

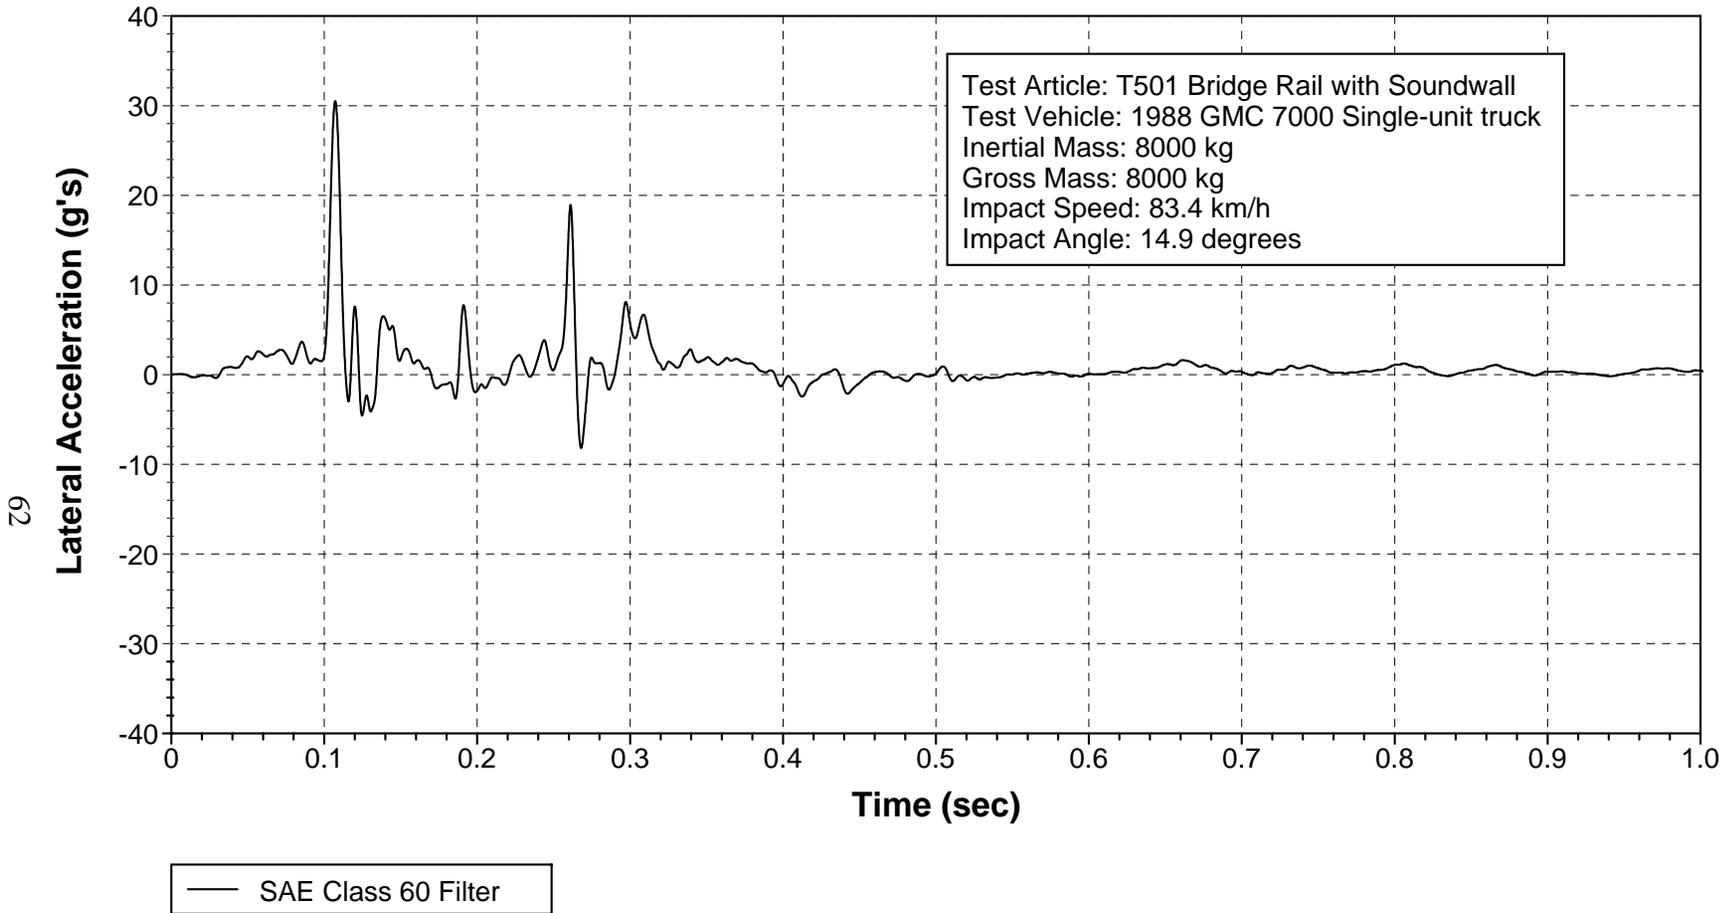
Y Acceleration at CG

**Figure 33. Vehicle Lateral Accelerometer Trace for Test 408460-2
(Accelerometer Located at Center of Gravity).**

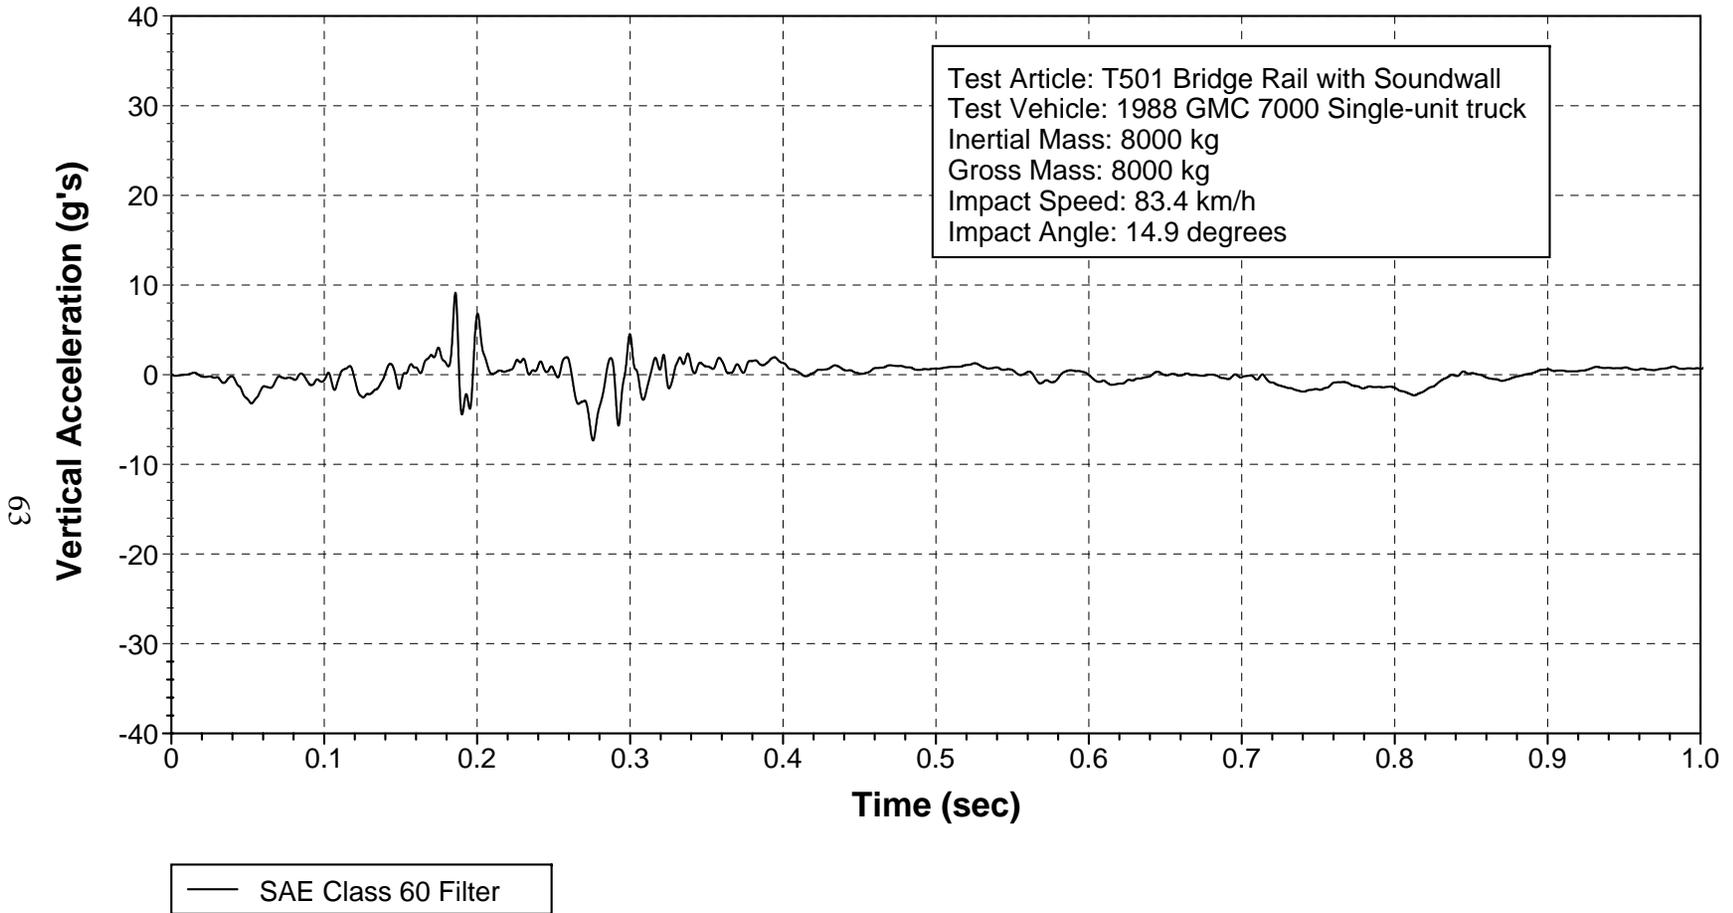
Z Acceleration at CG

**Figure 34. Vehicle Vertical Accelerometer Trace for Test 408460-2
(Accelerometer Located at Center of Gravity).**

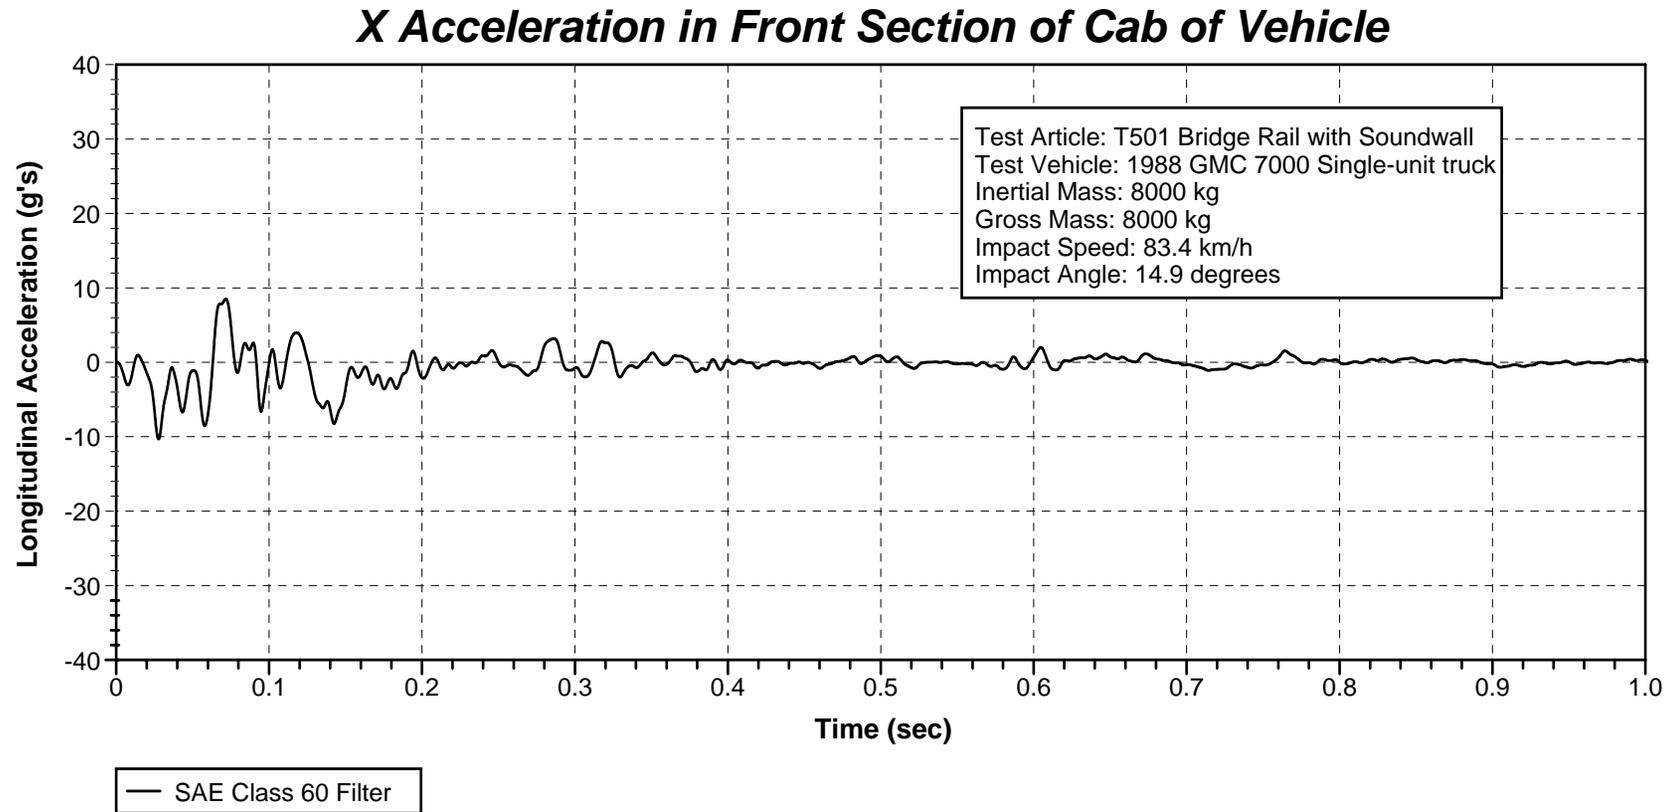
**Figure 35. Vehicle Longitudinal Accelerometer Trace for Test 408460-2
(Accelerometer Located in Cab of Vehicle).**

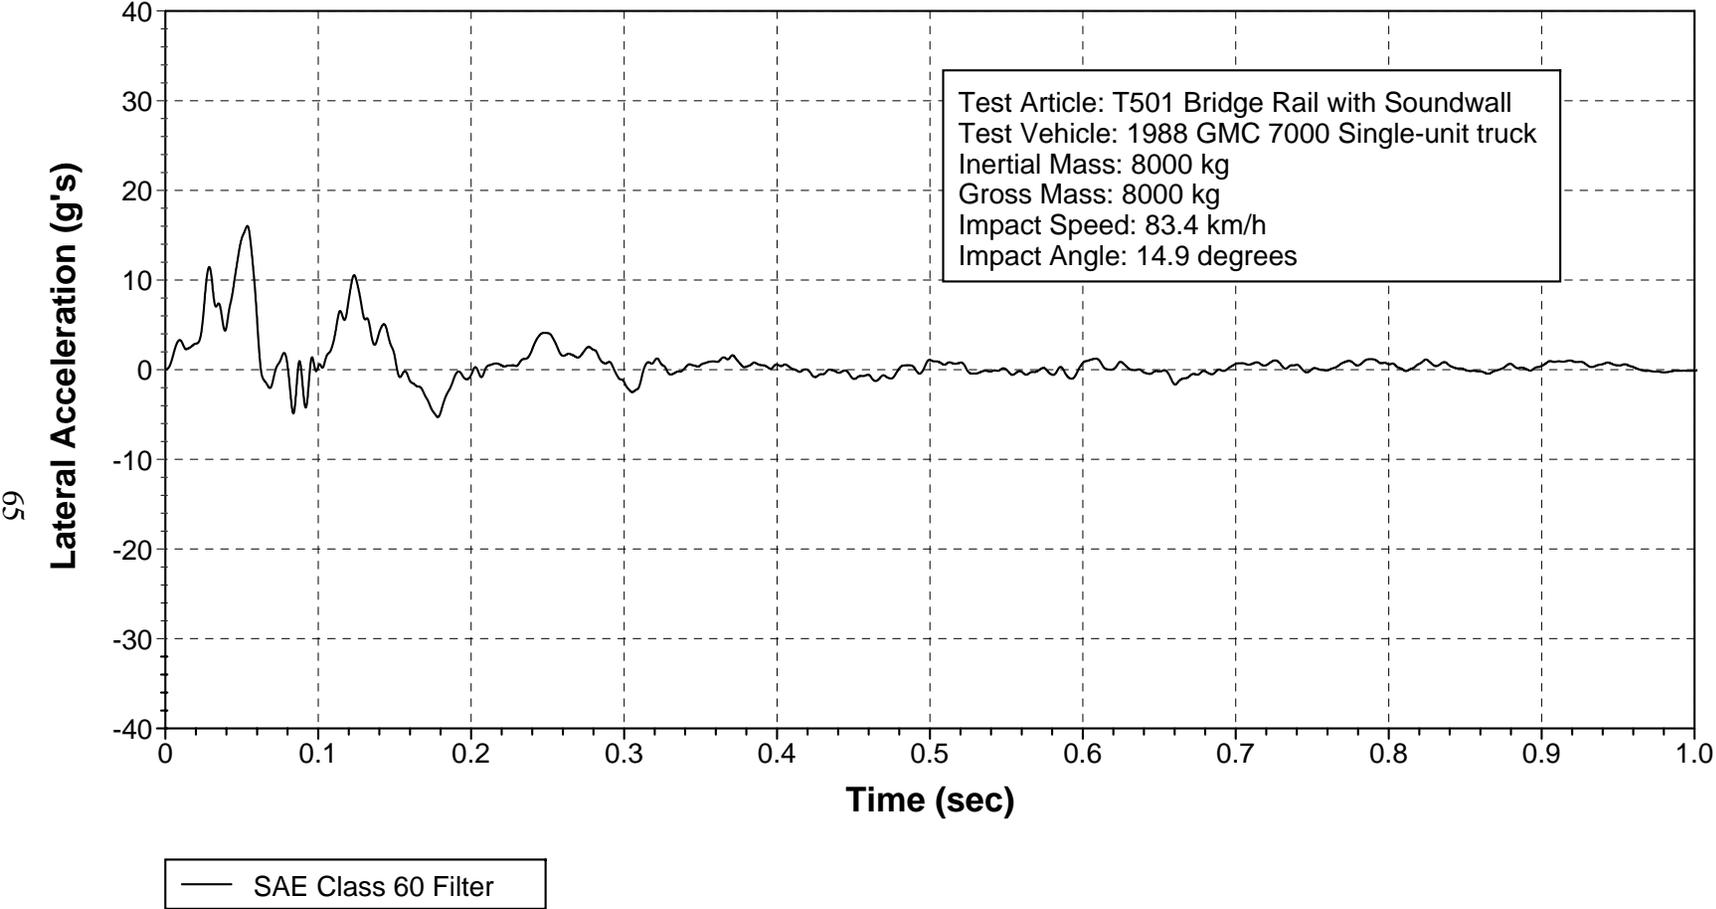
Y Acceleration in Front Section of Cab of Vehicle

Figure 36. Vehicle Lateral Accelerometer Trace for Test 408460-2 (Accelerometer Located in Cab of Vehicle).

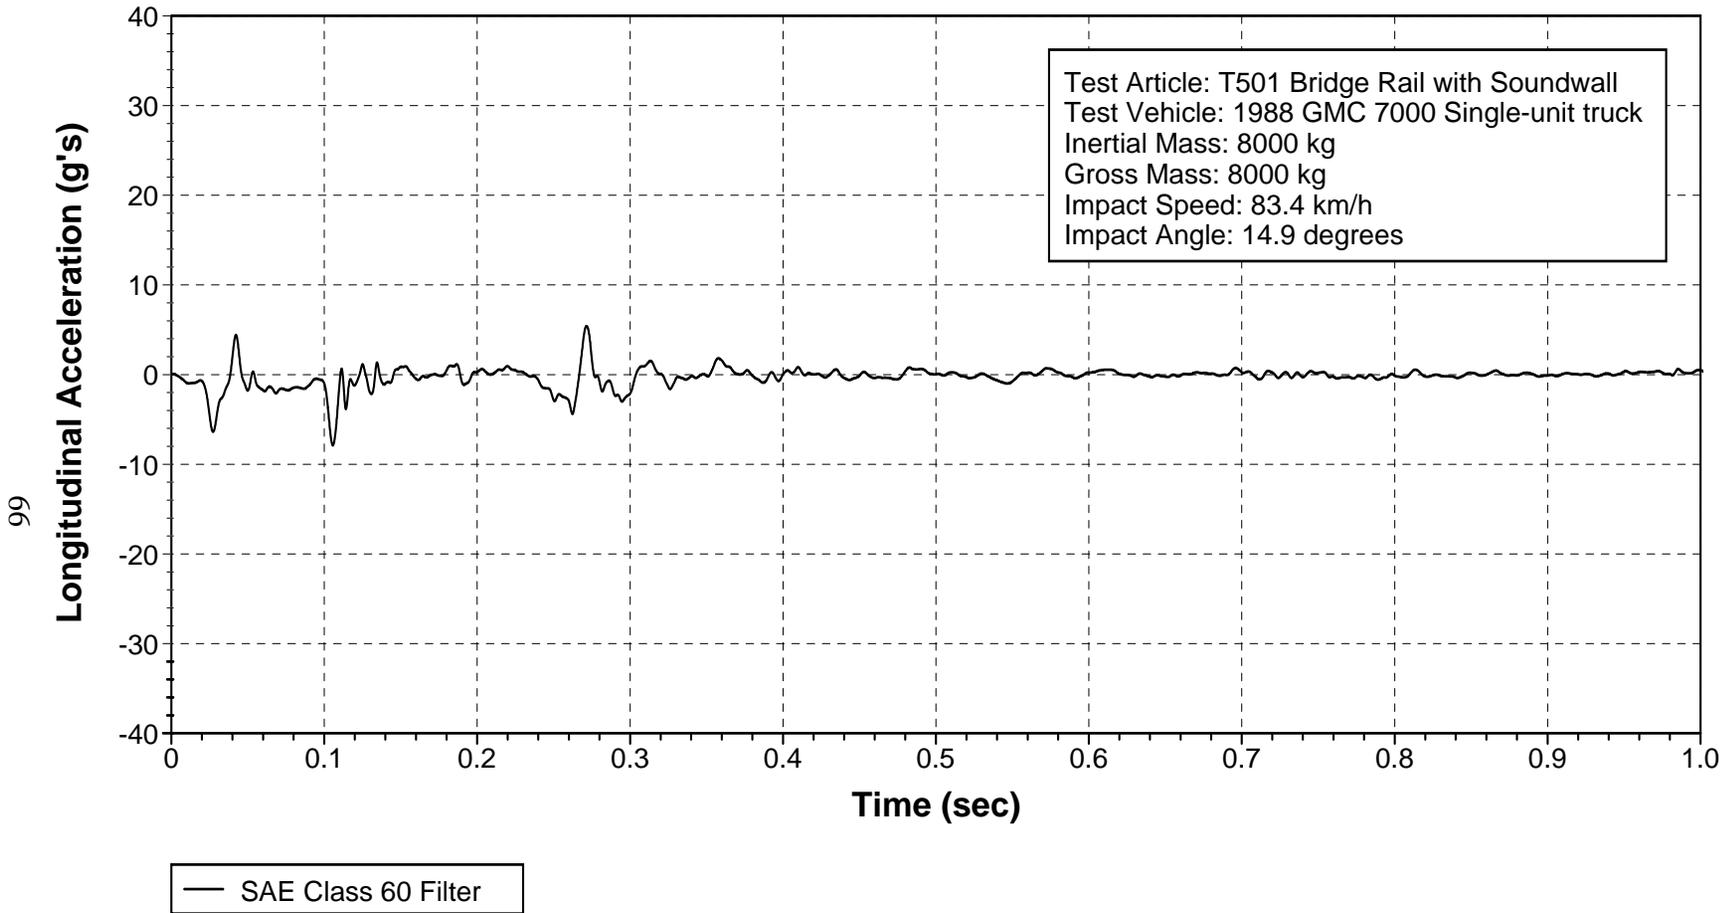
X Acceleration Over Rear Axle

**Figure 37. Vehicle Longitudinal Accelerometer Trace for Test 408460-2
(Accelerometer Located Over Rear Axle).**

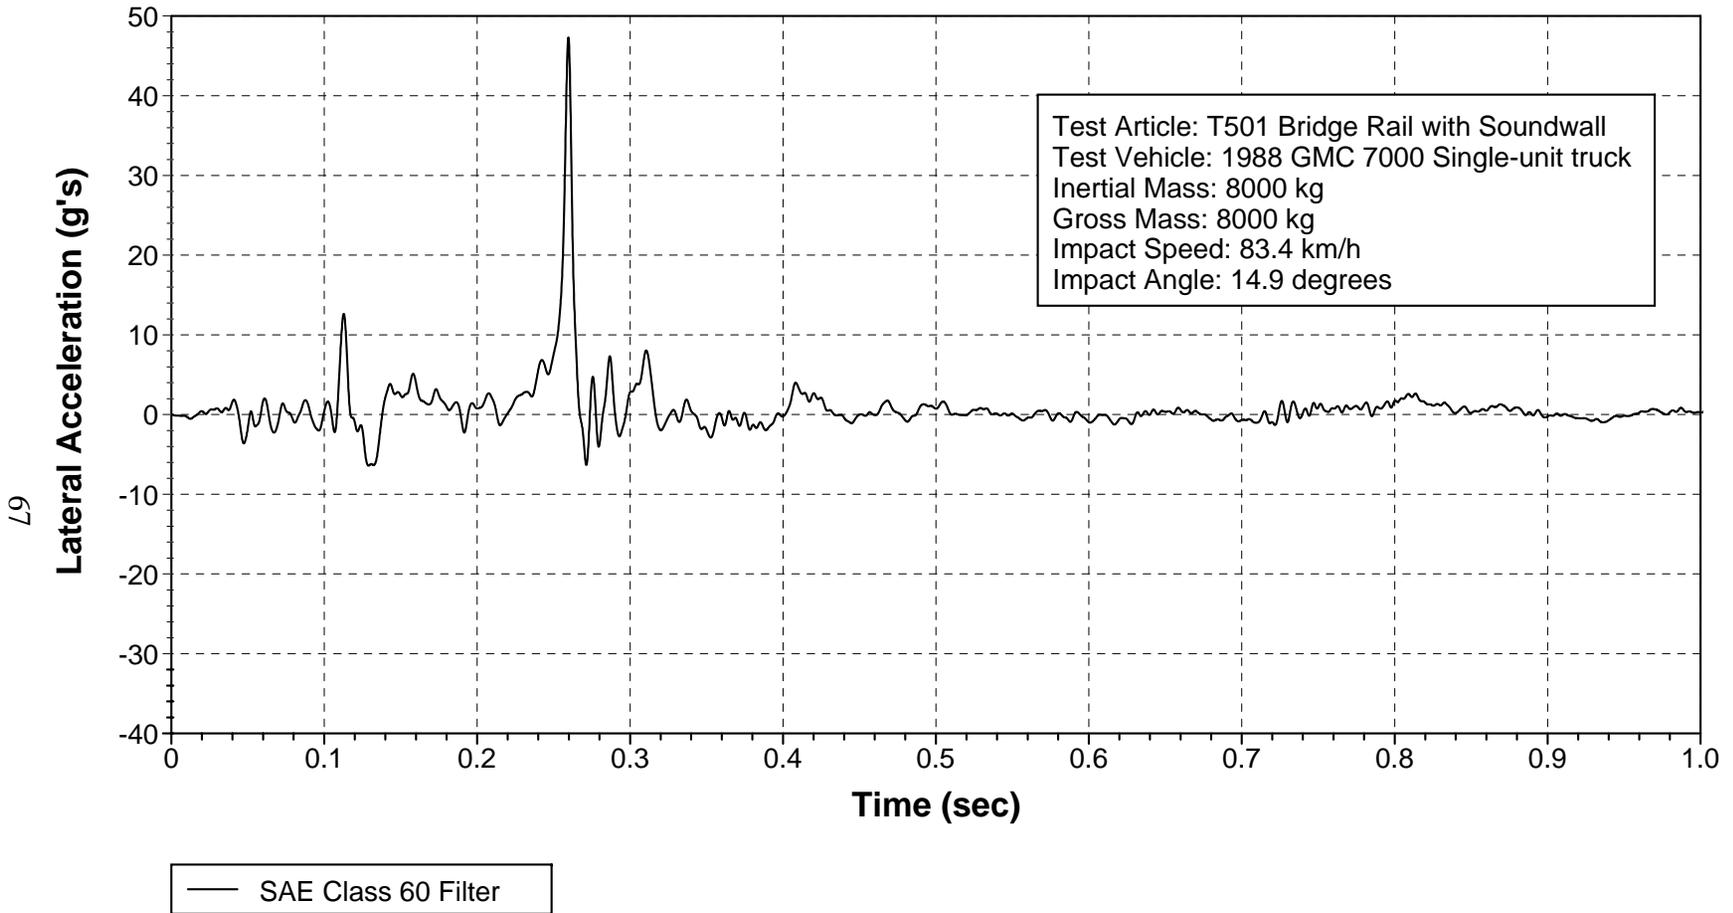
Y Acceleration Over Rear Axle

Figure 38. Vehicle Lateral Accelerometer Trace for Test 408460-2 (Accelerometer Located Over Rear Axle).
